MARTZ/HANSON/HEATH PROPERTIES  
BANK STABILIZATION OAK GROVE, MN

Riverbank  
Stabilization

Project Summary

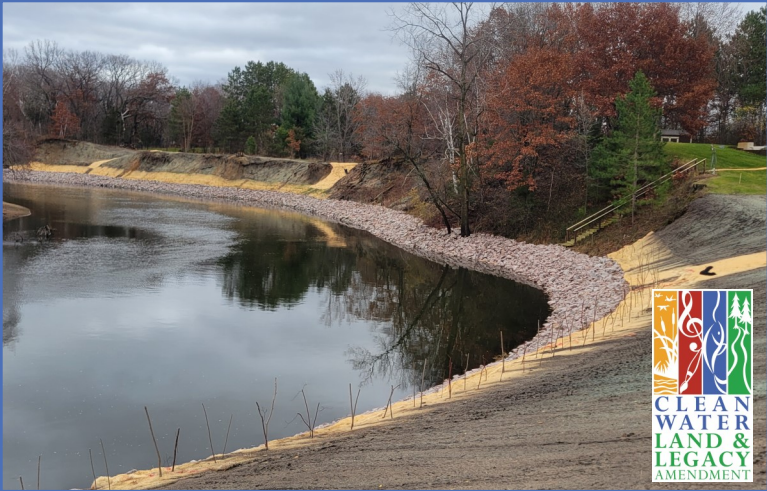
Post-construction November, 2024. Photo faces upstream.

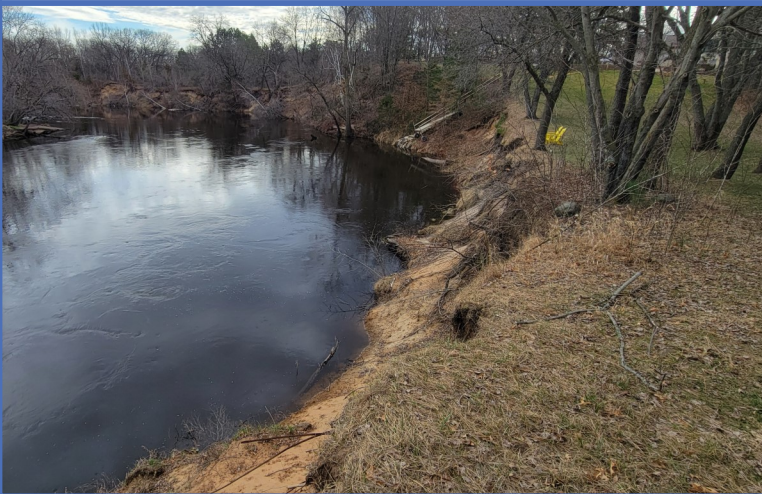
Pre-project conditions consisted of a severely eroded, vertical bank with numerous fallen trees. Bank heights reached 40-feet with water depth exceeding 10-feet at the toe in places. Portions of the bank were receding in large chunks year over year.
