MARTIN LAKE

Pre-Buffer Conditions

ANOKA
CONSERVATION
DISTRICT

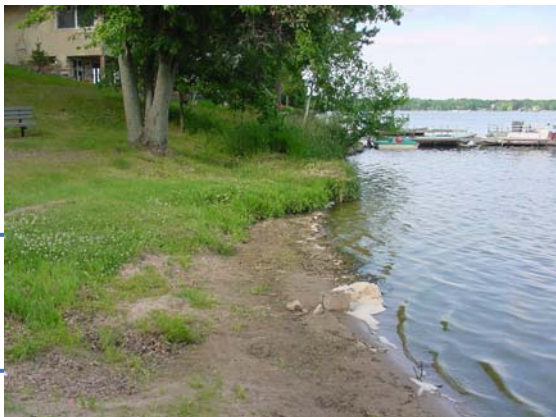
The area between the fishing pier and the boat launch of Rum River South County Park was maintained as mown turf down to the river's edge resulting in:

- Loss of vegetation near the river due to existing vegetation's intolerance to flooding
- Large population of Canada Geese
- Loss of plant diversity
- Loss of fish and wildlife habitat

Rum River restoration site prior to buffer installation (May 2000)

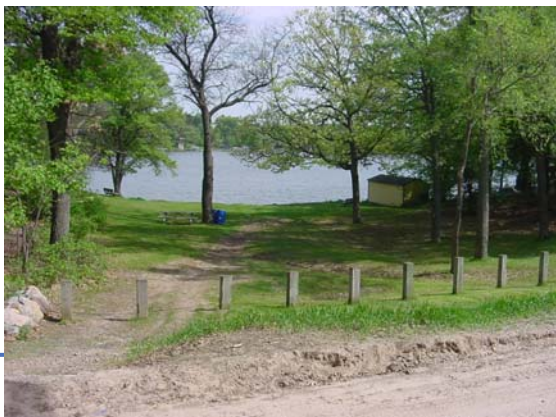
A swale is excavated to catch runoff from the boat ramp and parking lot (June 2001)

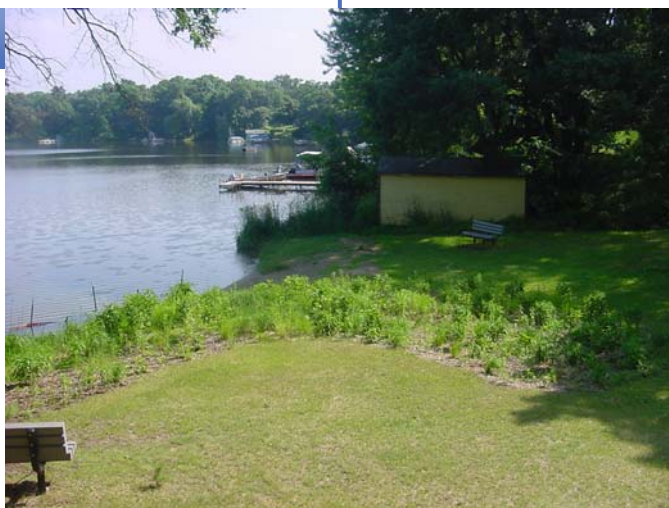
June 2002 ▶

During the first year's growth the area is monitored for moisture levels and weed growth. By the second growing season the planting only needs periodic weeding.

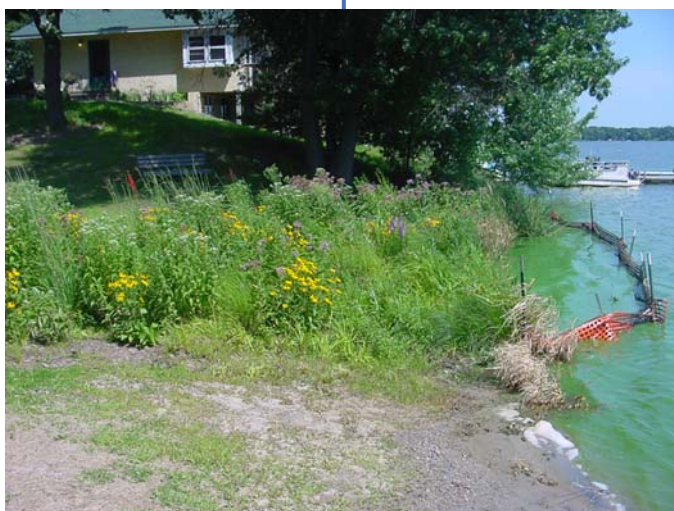
◀ August 2002

Two years after planting the area is densely covered with vegetation, in stark contrast with the bare soils existing before restoration. The ambers and yellows that arrive in the fall provide visual interest throughout the winter. Periodic weeding will continue for several years until the natives have become well established.
