AYMAR PROPERTY

Pre-Buffer Conditions

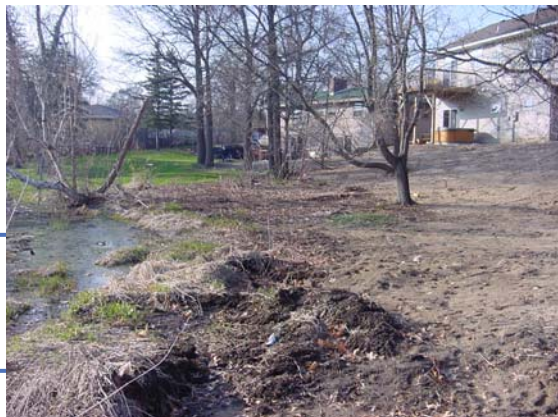
Work with large machinery has left the soil bare. (April 2002)

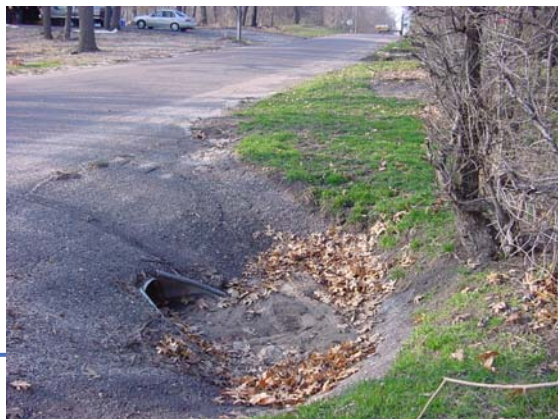
A culvert directs water through the Aymar property into Coon Lake. The buffer is designed to intercept this flow (April 2002)

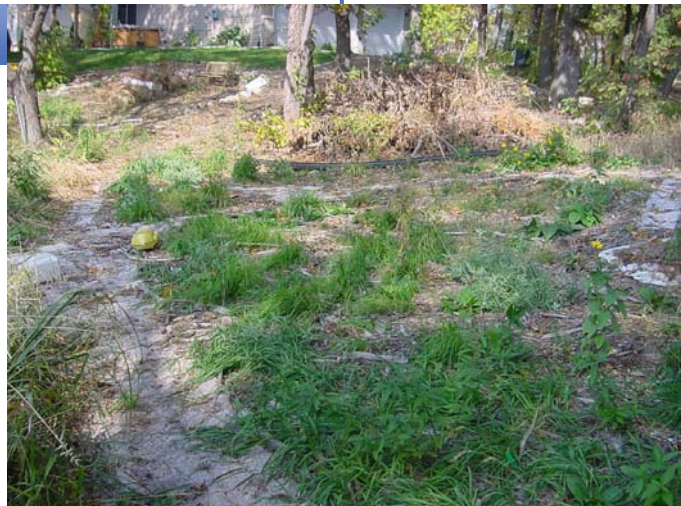
October 2003 ▶

After one season the upland plants have shown good growth. Occasional weeding is needed until the plants have become well established in 3 or 4 years.

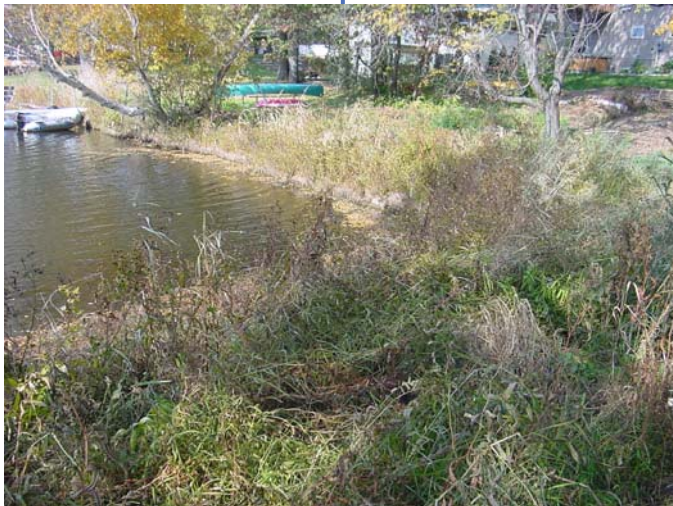
◀ October 2003

One year after planting, the wet meadow zone is already dense with native plants. This zone also requires more maintenance attention because of the vigorous growth in the saturated conditions.
