METCALF RESIDENCE

Pre-Buffer Conditions

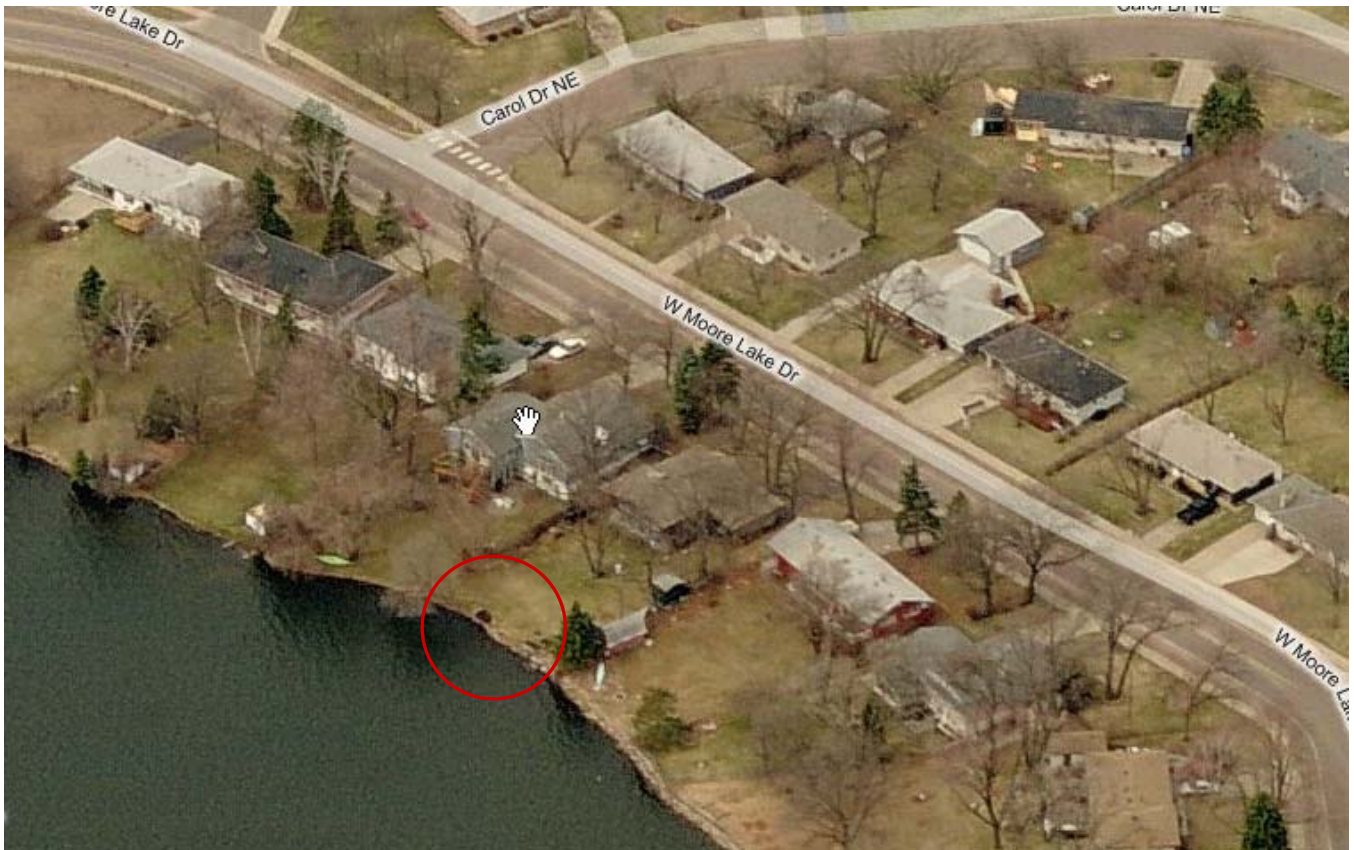
The Metcalf property lies on the shore of Moore Lake. Prior to the restoration, the shoreline consisted of a concrete wall in disrepair and damaged due to frost heaving. The plant community was dominated by turf grass, a variety of invasive plant species, and limited native plant species. As a result, there was:

- Active shoreline erosion due to limited root structure to withstand wave action and animal activity
- Direct conveyance of nutrients and pollution into Moore Lake, increasing algae and unwanted aquatic vegetation blooms
- Limited plant diversity
- Limited wildlife habitat
