2010 Anoka Water Almanac

Water Quality and Quantity Conditions of Anoka County, MN

**A Report of Activities by
Watershed Organizations and the
Anoka Conservation District**

Prepared by the Anoka Conservation District

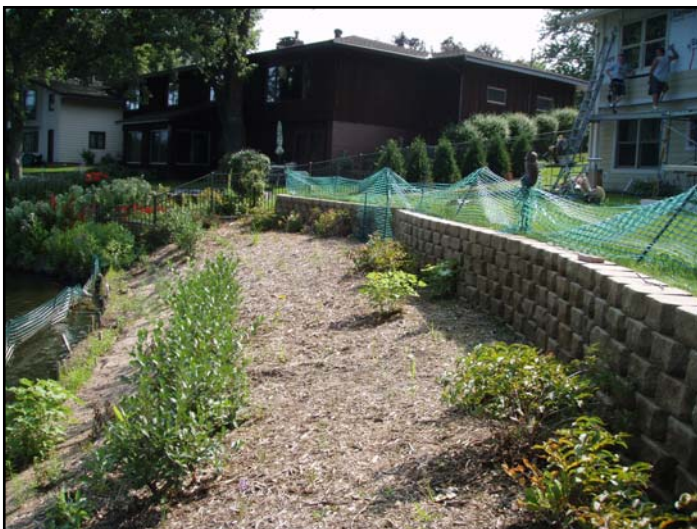
Example project - Lakeshore restoration project on Locke Lake completed in 2010. ACD technical/design assistance and partial construction funding was provided to the landowner through the RCWD BMP cost-share program. More details on projects installed in RCWD are included in a separate report produced by the Anoka Conservation District.

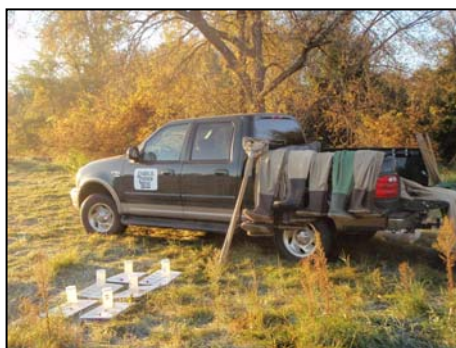
Andover High School biomonitoring site at Coon Creek in 2010.

The invertebrate community suggests Coon Creek's health is average compared to other nearby streams. The stream's habitat is relatively sparse, mostly due to past excavations aimed at making the creek perform like a ditch. The supplemental stream water chemistry readings taken during biomonitoring indicate a higher than expected level of dissolved pollutants, as measured by conductivity. Conductivity and salinity were similar to, though not as extreme as, some urbanized streams at the same time of year. The source could be road salts, failing septic systems, and/or chemical wastes. Turbidity was also high. These factors, as well as the general lack of habitat in this ditched stream, probably limit the invertebrate community.

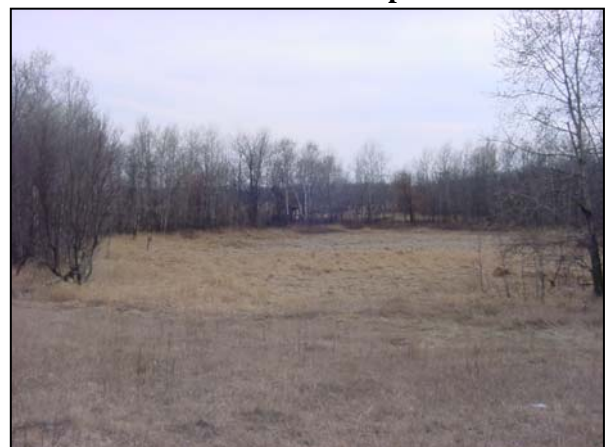
Photo of Bunker Wetland in April

This wetland has had dramatic hydrological change during the 13 years it has been monitored. From 1996 to 2005 a monitoring well was placed what was considered to be the wetland edge. During this ten year monitoring period it was discovered the water level was decreasing. Our goal, using the jurisdictional wetland hydrology standard, was to keep this and all of our monitoring sites on the wetland edge. With exception of the first two years of monitoring, 1996, 1997, and, a higher than normal precipitation year in 2003, the water level was below the threshold of twelve inches to be considered a jurisdictional wetland. Seven out of ten years failed to meet wetland hydrology standards. Additionally, the water levels had dropped to a level that the monitoring well was no longer considered to be within an acceptable distance of the wetland edge. In 2006 it was decided to move the well down slope in order to capture the full range of hydrology reading throughout the year.

In 2006 the ACD installed a second hydrology monitoring well. This well is located in the middle of the wetland within the most diverse vegetative community. The water level has been at or near the surface in spring and followed predictable summer draw downs and fall recharge patterns. As the area around the wetland is developed, our particular focus will be how wetland hydrology correlates to invasive species expansion into native vegetative communities.

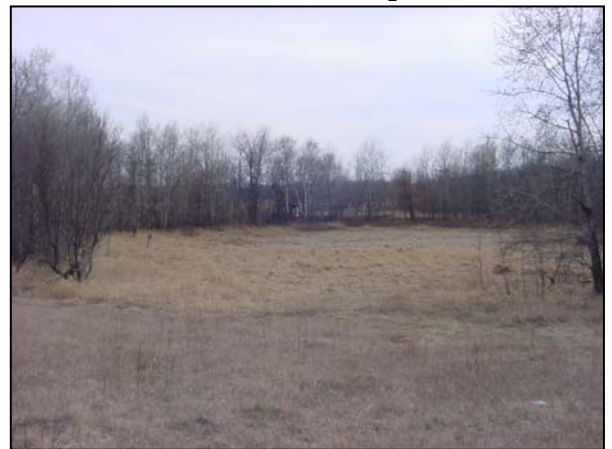
Photo of Bunker Wetland in April

Reference Wetland. The purpose of vegetation surveys is to document vegetation changes associated with hydrological changes, invasive species, and other disturbance.

This wetland has had dramatic hydrological change during the 13 years it has been monitored. From 1996 to 2005 a monitoring well was placed what was considered to be the wetland edge. During this ten year monitoring period it was discovered the water level was decreasing. Our goal, using the jurisdictional wetland hydrology standard, was to keep this and all of our monitoring sites on the wetland edge. With exception of the first two years of monitoring, 1996, 1997, and, a higher than normal precipitation year in 2003, the water level was below the threshold of twelve inches to be considered a jurisdictional wetland. Seven out of ten years failed to meet wetland hydrology standards. Additionally, the water levels had dropped to a level that the monitoring well was no longer considered to be within an acceptable distance of the wetland edge. In 2006 it was decided to move the well down slope in order to capture the full range of hydrology reading throughout the year.
