2009 Anoka Water Almanac

**Water Quality and Quantity
Conditions of Anoka County, MN**

**A Report of Activities by
Watershed Organizations and the
Anoka Conservation District**

Prepared by the Anoka Conservation District

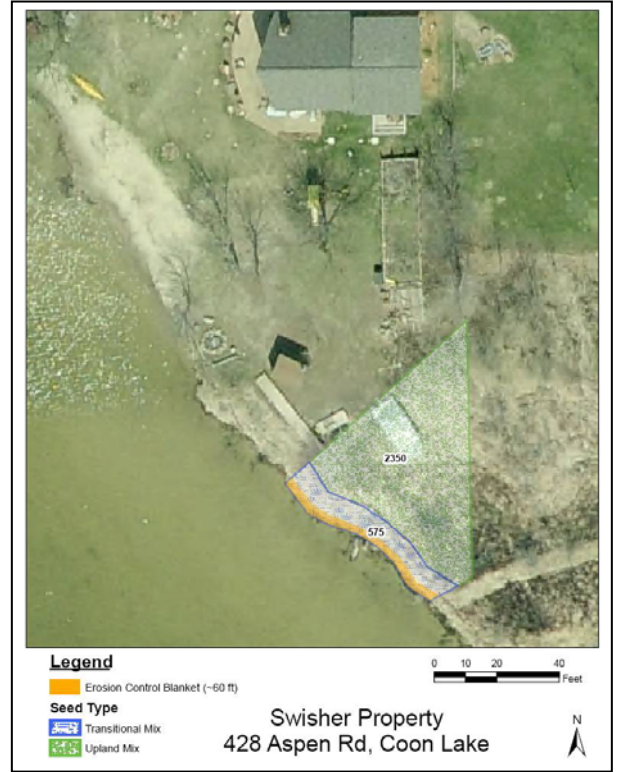
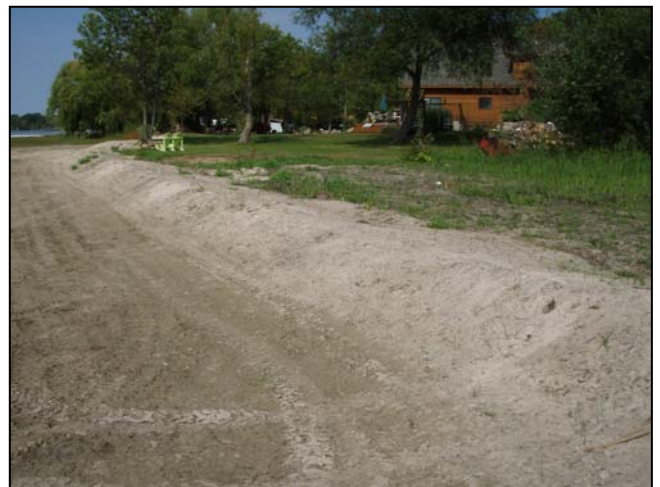
The project will involve stabilizing a lakeshore area and seeding it with native plants. The process of seeding will include herbicide treatment of existing weedy vegetation, seeding, straw mulch, watering, and maintenance by mowing during the first year or more. Erosion control will include an erosion control blanket and coconut-fiber biog if lake water levels necessitate it. In total, this project will encompass 60 linear feet of shoreline and 2,925 square feet. The grant contract specifies the project must be maintained for at least five years.

This project, as originally planned, would restore a portion of Coon Lake shoreline with native plants and provide some erosion protection. The project has been designed by the Anoka Conservation District. Benefits of this project will include filtering runoff to the lake, preventing erosion, and near-shore wildlife habitat. Additionally, a large amount of trash will be removed from the area. In part, this project will correct some past illegal lakeshore modifications (another reason cost share funds were rescinded).

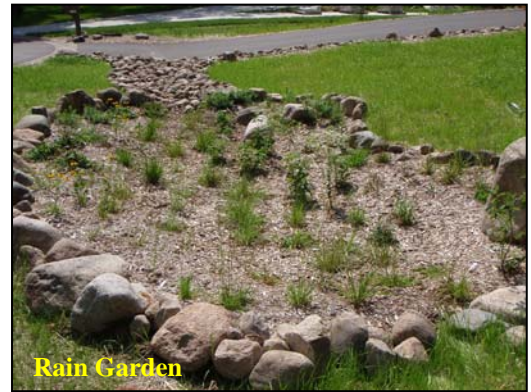
Rain Garden

Additionally, the Braido's have built a rain garden to capture runoff from the driveway of their new Green Star/Energy Star home. The rain garden provides a place for storm water to infiltrate and includes native plants. The rain garden was completed in 2009.

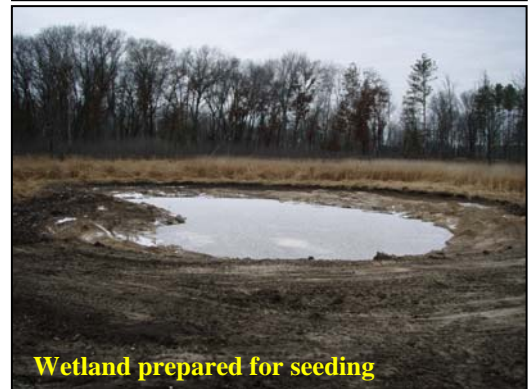
Wetland prepared for seeding

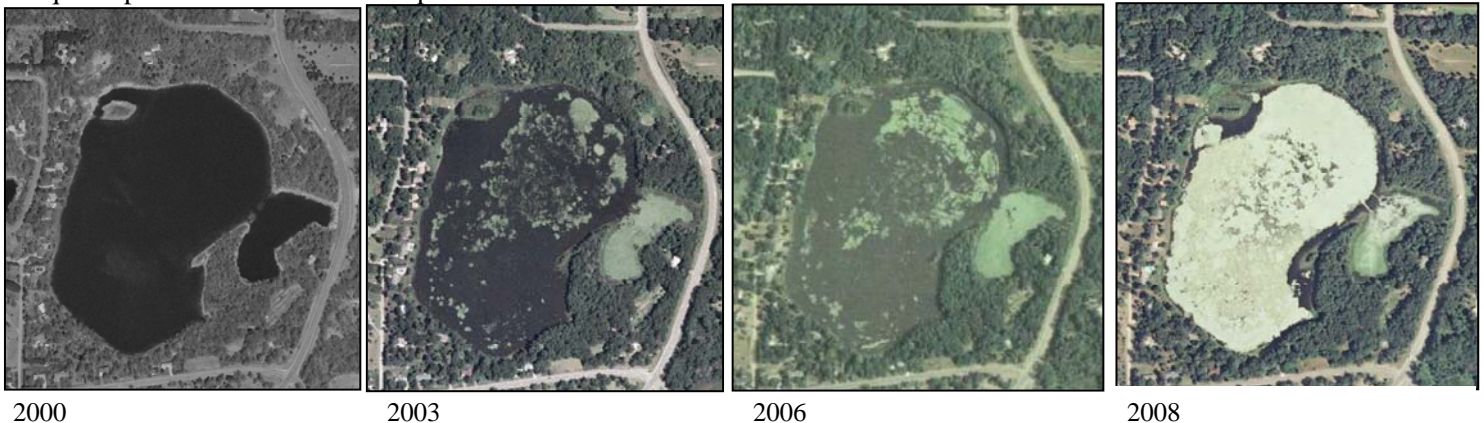
Aerial photos showing increase in aquatic plants, particularly between 2006 and 2008. Light green areas are aquatic plants. Black areas are open water.

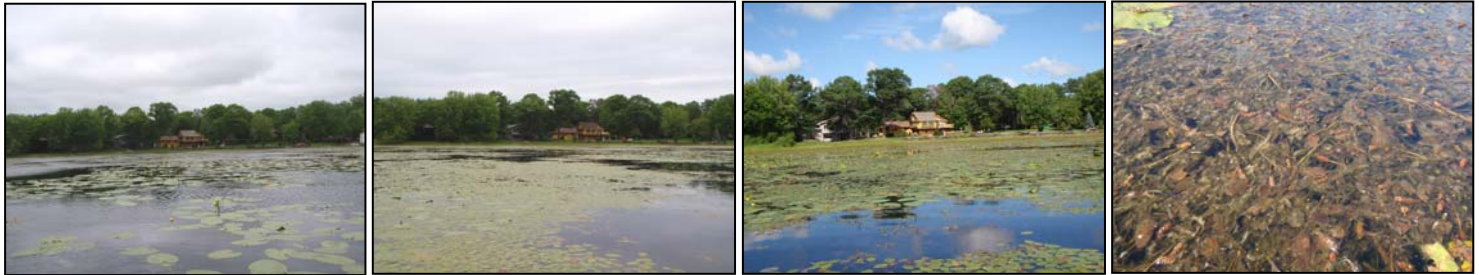
Photos of aquatic plant growth in Rogers Lake.

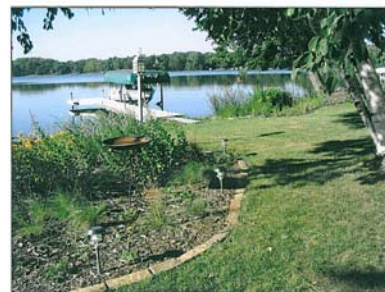
A lakeshore restoration with native plants that filters runoff, provides fish and wild habitat, and looks beautiful.

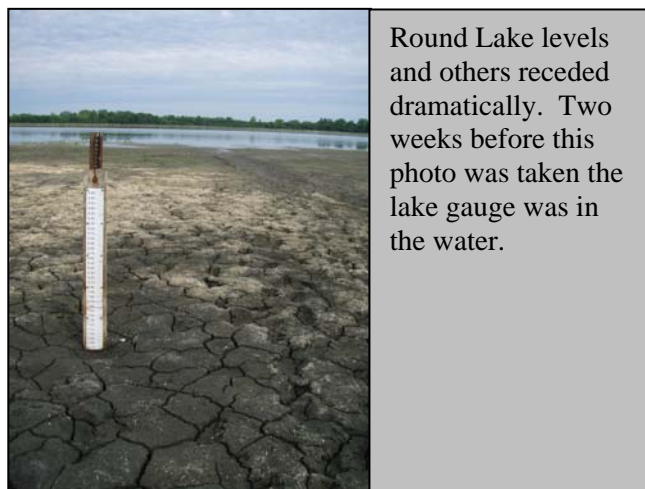
Round Lake Levels 2005-2009

Results: Water levels were measured 19 to 27 times, despite difficulties caused by record or near-record low water due to drought. Water levels on all three lakes dropped until late July when more substantial rainfall began. Round Lake reached a record low. Itasca Lake was 0.62 ft higher than its record low from 2000. Rogers Lake was still about two feet higher than its record low, but over three feet lower than the record high. Water levels became so low that volunteers were unable to read the lake gauge with binoculars, and Anoka Conservation District staff began taking readings by trudging through the near-shore muck in chest waters.

Ordinary High Water Levels (OHW), the elevation below which a DNR permit is needed to perform work, are listed for each lake on the graph.

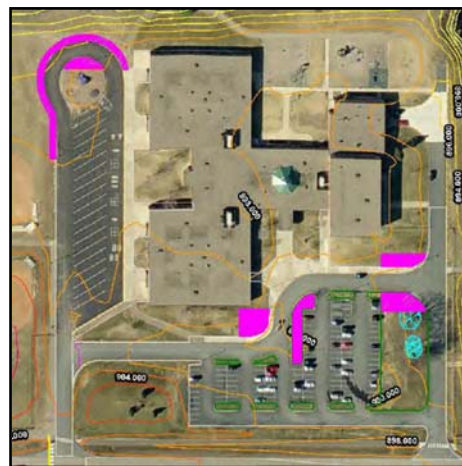
Campus Retrofit Concept

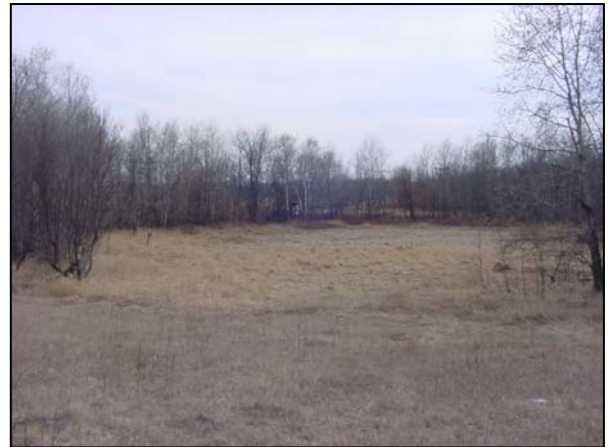
Photo of Bunker Wetland in April

This wetland has had dramatic hydrological change during the 13 years it has been monitored. From 1996 to 2005 a monitoring well was placed what was considered to be the wetland edge. During this ten year monitoring period it was discovered the water level was decreasing. Our goal, using the jurisdictional wetland hydrology standard, was to keep this, and all of our monitoring sites on the wetland edge. With exception of the first two years of monitoring, 1996, 1997, and, a higher than normal precipitation year in 2003, the water level was below the threshold of twelve inches to be considered a jurisdictional wetland. Seven out of ten years failed to meet wetland hydrology standards. Additionally, the water levels had dropped to a level that the monitoring well was

no longer considered to be within an acceptable distance of the wetland edge. In 2006 it was decided to move the well down slope in order to capture the full range of hydrology reading throughout the year.

In 2006 the ACD installed a second hydrology monitoring well. This well is located in the middle of the wetland within the most diverse vegetative community. The water level has been at or near the surface in spring and following predictable summer draw downs and fall recharge patterns. As the area around the wetland is developed, our particular focus will be how wetland hydrology correlates to invasive species expansion into native vegetative communities.

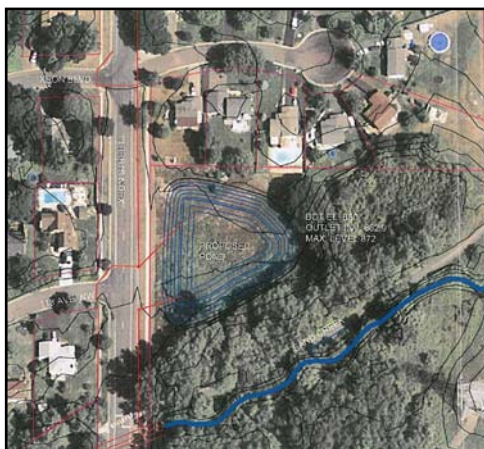
Pond Retrofit Concept

Catchment	Retrofit Project	Number of BMPs	% TP Reduction	TP Reduction (lb/yr)	Estimated Installation Cost	Cost/lb TP Reduction	O&M Term (years)	Annual O&M Cost per BMP	Estimated Term Cost/lb/yr (includes O&M)
SC-R1	New Pond	1	49%	9.3	\$109,460	\$11,770	30	\$253	\$420
SC-R2*	Neighborhood Retrofit	10	30%	4.9	\$41,385	\$8,446	10	\$75	\$998
SC-R3	Neighborhood Retrofit	19	10%	12.1	\$77,493	\$6,404	10	\$75	\$758
SC-R4*	Neighborhood Retrofit	11	30%	5.7	\$45,397	\$7,964	10	\$75	\$941
SC-R5*	Neighborhood Retrofit	10	30%	4.9	\$41,385	\$8,446	10	\$75	\$998
SC-R6	Pond Modification	1	11%	13.3	\$7,104	\$534	10	\$3,340	\$305
SC-R7	Pond Modification	1	35%	16	\$14,400	\$900	30	\$453	\$58

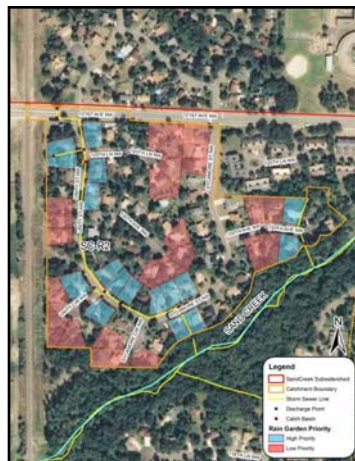
Neighborhood Rain Garden Retrofit

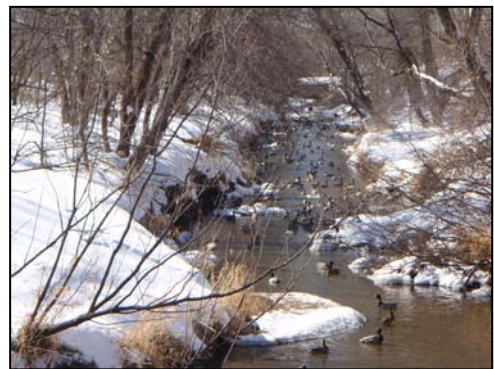
Waterfowl congregating on Pleasure Creek near Evergreen Blvd in Coon Rapids, February 2010. 250+ ducks were present in about 350 meters of creek.

ducks have been observed in Coon Rapids near Evergreen Boulevard (see photo). The ducks keep the water from icing over.

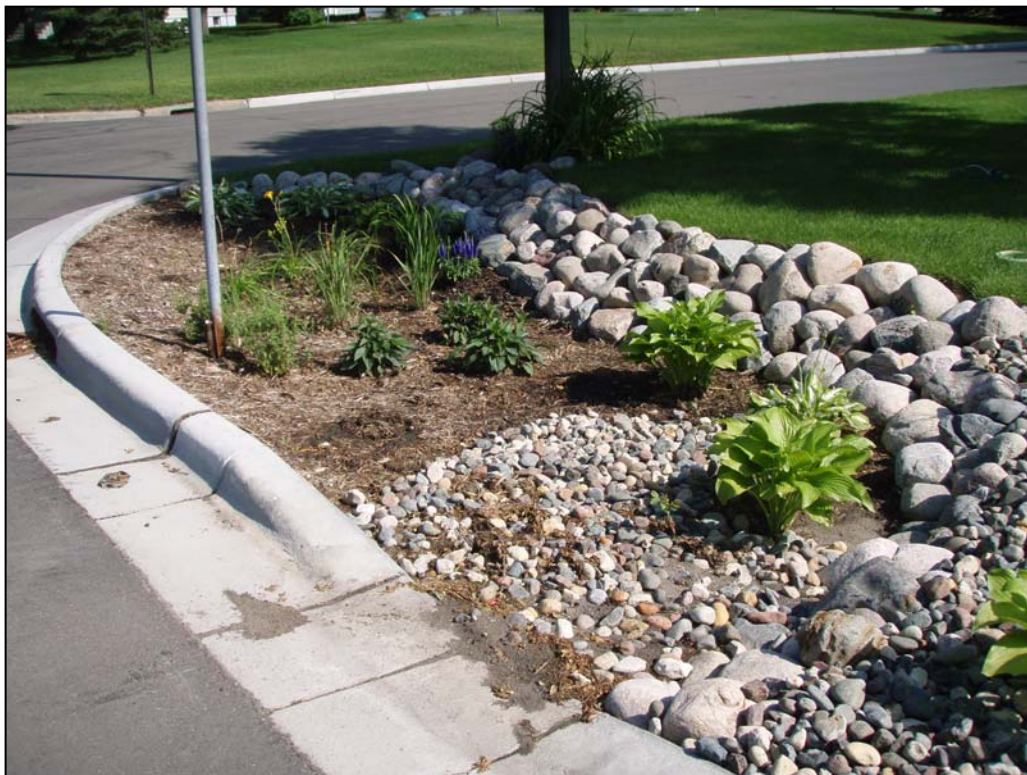
The Hogetvedt's installed a rain garden at their residence at the corner of Sylvan Lane and Rainbow Street. The rain garden captures and treats street runoff in the Oak Glen Creek watershed. Oak Glen Creek suffers from serious erosion problems because of excessive volumes and rates of stormwater. This rain garden is ideally situated at the bottom of a slope and just upstream of a gutter. It is a curb-cut style rain garden which treats water that would otherwise enter the curbside gutter. The garden includes an approximately 27 ft x 6 ft planting area and a boulder retaining wall which helps provide additional storage volume and is aesthetically pleasing. The garden is functioning well by trapping sediment and infiltrating water.

This rain garden was a partnership of the Hogetvedt's, the City of Fridley, and the Anoka Conservation District. The Hogetvedt's provided labor and some materials. The City of Fridley performed the curb cut and excavation. The Anoka Conservation District provided a grant for certain materials expenses and advised the design and construction. Ongoing maintenance will be the landowner's responsibility.

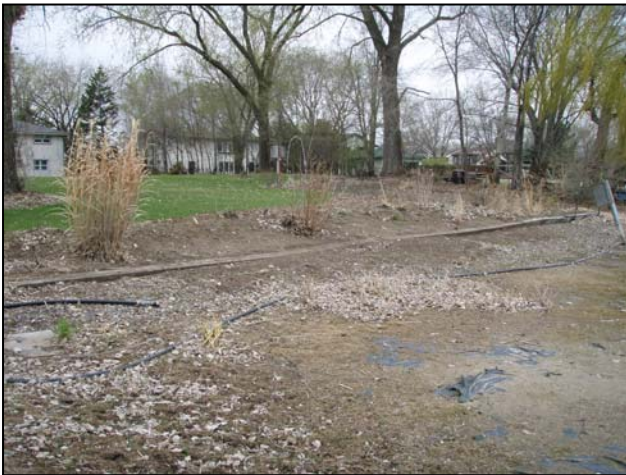
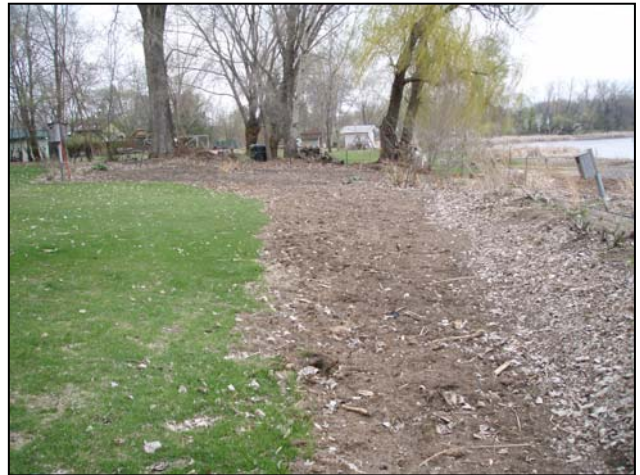
Warnke Lakeshore Restoration – planned for 2010

The Warnke property is on the West side of Laddie Lake in the City of Blaine. Currently there is very little lakeshore vegetation other than turf grass and some shrubs planted by the landowners. The owners would like to improve their shoreline and protect water quality by planting a buffer. Native plugs will be used to establish a buffer above the existing timber wall. A transitional/wet soil seed mix will be raked into the soil below the wall and above the normal water level. Wildlife exclusion fencing will be used to protect the shoreline and seeding from geese. Ultimately, this buffer will filter and infiltrate surface runoff from the property as well as provide shoreline stabilization and habitat.

The Anoka Conservation District is coordinating this project. The ACD has approved a grant to the landowners for a portion of the materials costs for this project, created the project design (below) and will advise installation. Installation is planned for 2010.
