# 2011 Anoka Water Almanac

## Water Quality and Quantity Conditions of Anoka County, MN

A Report of Activities by  
Watershed Organizations and the  
Anoka Conservation District

Prepared by the Anoka Conservation District

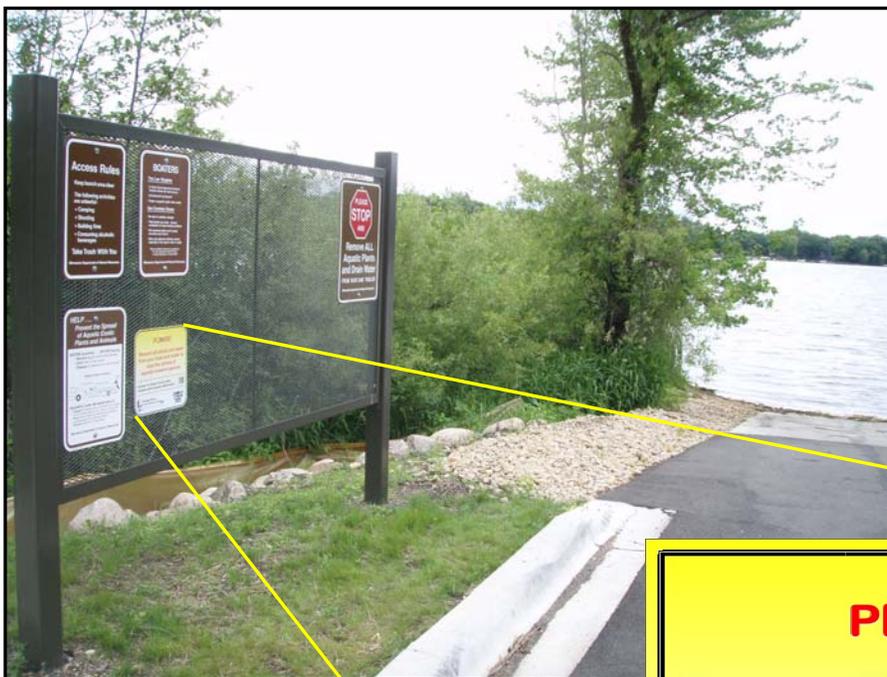
### New SRWMO Sign at the Martin Lake Public Boat Landing

**Results:** In 2011 the SRWMO contracted with the ACD to replace vandalized SRWMO signage at the Martin Lake boat landing. That signage asks boaters to take measures that prevent that spread of aquatic invasive species. This signage is designed to be a local voice that reinforces messages in DNR signage on this topic. These signs had been installed on the five major recreational lakes in 2007. While the signs at other locations are in good condition, the sign at Martin Lake was destroyed by vandals. The ACD replaced the sign at Martin Lake with another Aluminum sign.

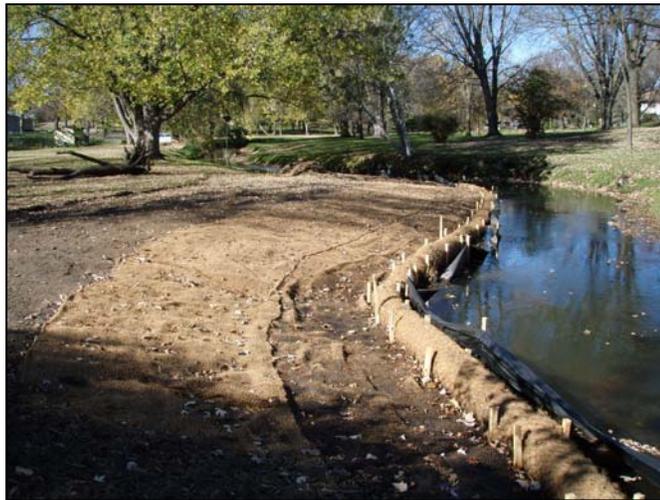
**Site after grading and stabilization, but before planting**

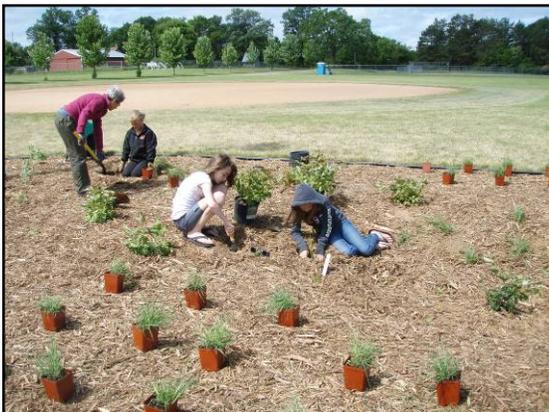
**Example project** – Students planting one of three rain gardens installed at Rice Lake Elementary in 2011. ACD provided technical/design assistance and construction oversight. The project was fully funded by the RCWD cost share program, and Clean Water Funds (from the Clean Water, Land, and Legacy Amendment). The school agreed to do long-term maintenance. More details on projects installed in RCWD are included in a separate report produced by the Anoka Conservation District.

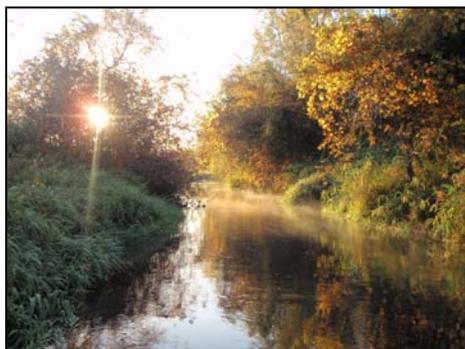
Coon Creek at Andover High School sampling site.

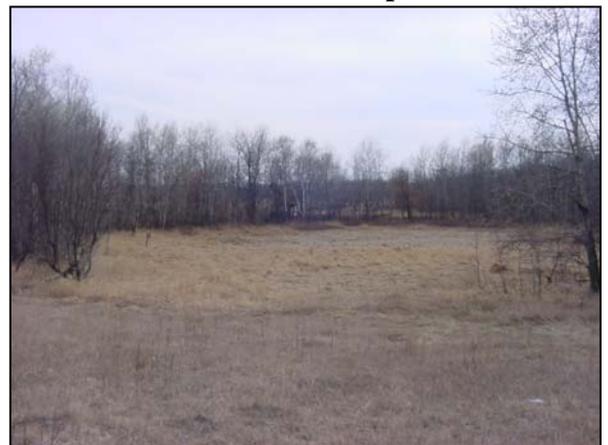
**Photo of Bunker Wetland in April**

Study of this wetland is two-fold. First, to measure the wetland hydrology on a continuously basis during the growing season, as part of the ACD's network of reference wetlands, which gives an indication of how shallow water tables, (<40 inches) are reacting for jurisdictional purposes. In 1996, the ACD placed a well on the wetland edge to measure growing season hydrology. We found, with the exception of the first two years, the water levels were at or below the required level. In fact, Seven out of ten years failed to meet wetland hydrology standards. We also found the water table was decreasing over time. Thus, the edge was no longer considered a jurisdictional wetland. This

created the question of how the water table is reacting to changes in the local landscape. Therefore, in 2006 it was decided to move the well down slope, and add an additional well in the center of the wetland. This allows us to capture the full range of hydrology readings throughout the growing season.

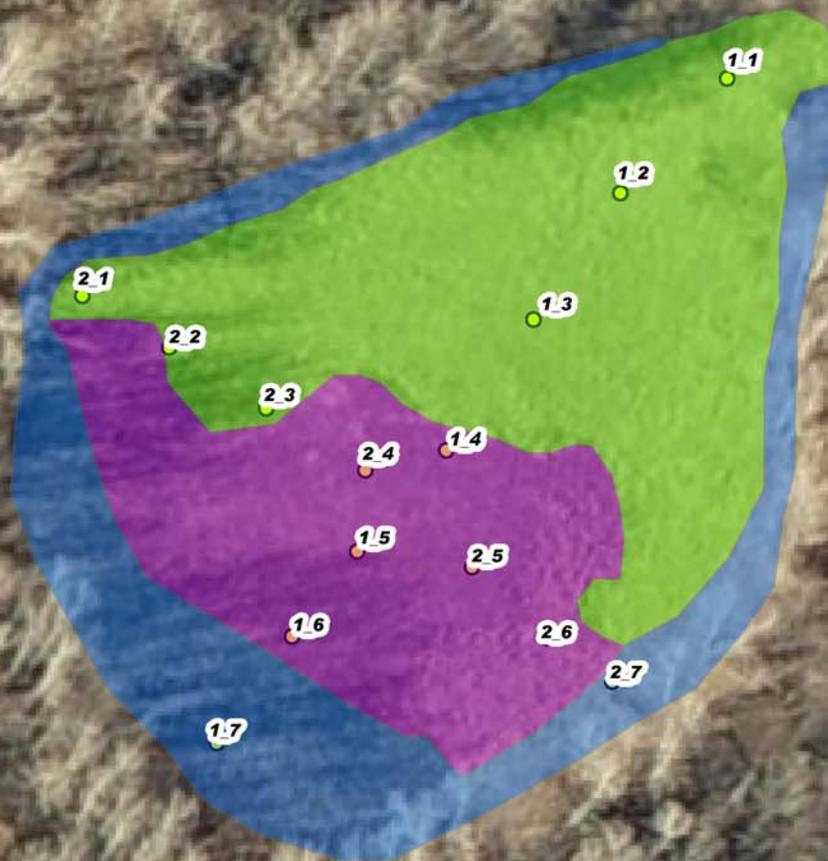
# 2010 Bunker Hills Reference Wetland Vegetation Inventory

## 2010 Plant Communities

The center of this wetland contains the native species and is the most diverse of all the plant communities. It has a clear boundary, but is adjacent to the non-native community. Therefore, encroachment will be closely monitored. The native diversity is likely due to the hydrology being less affected than the perimeter. The early 2011 growing season had higher than normal precipitation leading to prolonged inundation. This caused the formation of algae mats in some of the sample plots. This also may have caused the facultative species of Canada Thistle, and Stinging Nettle to decrease in population.

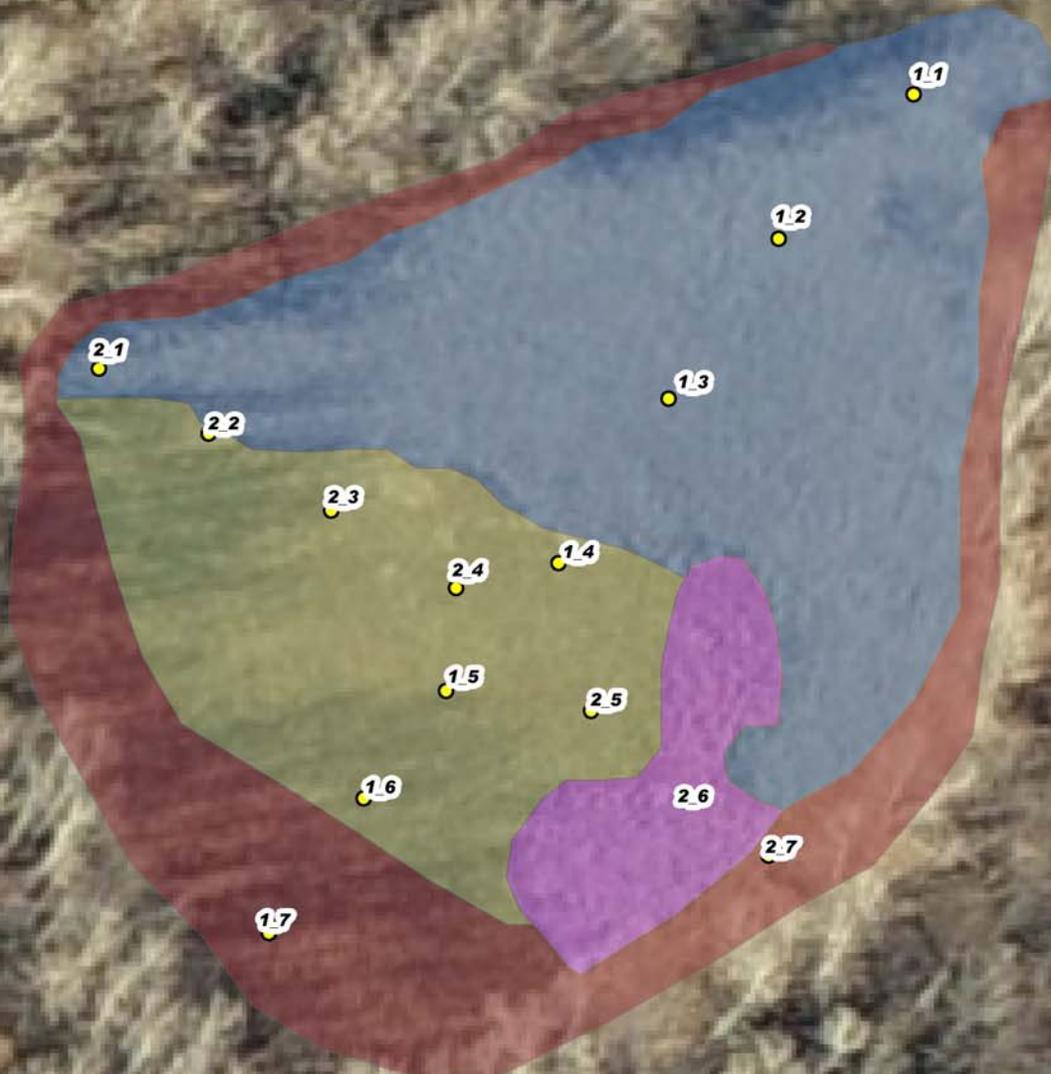
# 2009 Bunker Hills Reference Wetland Vegetation Inventory

## 2009 Plant Communities
