2012 Anoka Water Almanac

**Water Quality and Quantity
Conditions of Anoka County, MN**

**A Report of Activities by
Watershed Organizations and the
Anoka Conservation District**

Prepared by the Anoka Conservation District

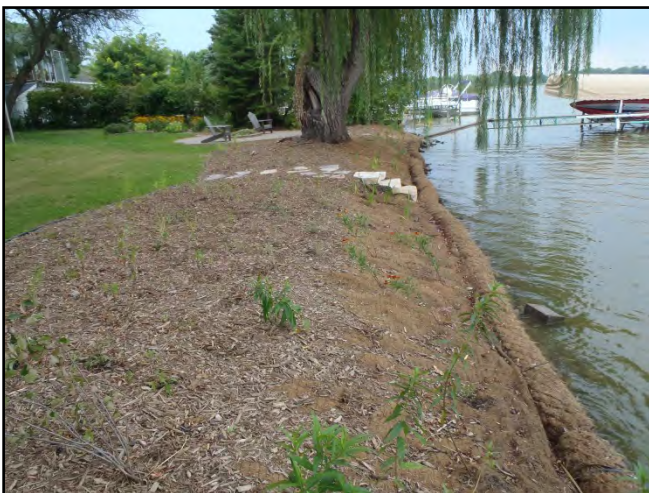
Example project – The photo on the left shows a lakeshore restoration on Reshanau Lake in Lino Lakes. ACD provided technical/design assistance and construction oversight. The project received cost share funds through the RCWD cost share program. More details on projects installed in RCWD are included in a separate report produced by the Anoka Conservation District.

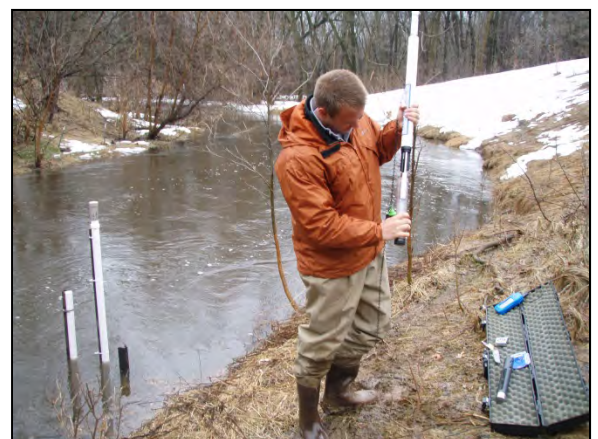
Staff deploying the Hydrolab MS5. In the background are the Hydrolab casing (shorter) and a Measura continuous water level monitoring device.

Coon Creek at Vale Street was monitored immediately before, during, and after storms with a Hydrolab MS5 water quality sonde. The sonde was suspended inside a PVC pipe by a chain from a locked lid. The PVC pipe was secured to a metal fence post. The sonde sensors protruded from the bottom of the pipe approximately 6-12 inches from the stream bottom, ensuring they would stay submerged even if flow was low. The sonde was programmed to take readings every 30 minutes. Readings included pH, salinity, specific conductance, temperature, dissolved oxygen, and turbidity. The sonde was calibrated before each deployment.

The Hydrolab was deployed into the stream when a storm predicted to drop at least 0.5 inches of rain, and preferably greater, was approaching. Past grab sample monitoring had found that the greatest water quality problems occurred after

storms exceeding one inch. In some instances, water level was already high before the storm and remained high after the storm. At other times, predicted rain did not fall and we were monitoring baseflow conditions. In all instances, the Hydrolab was left in the field for several days.

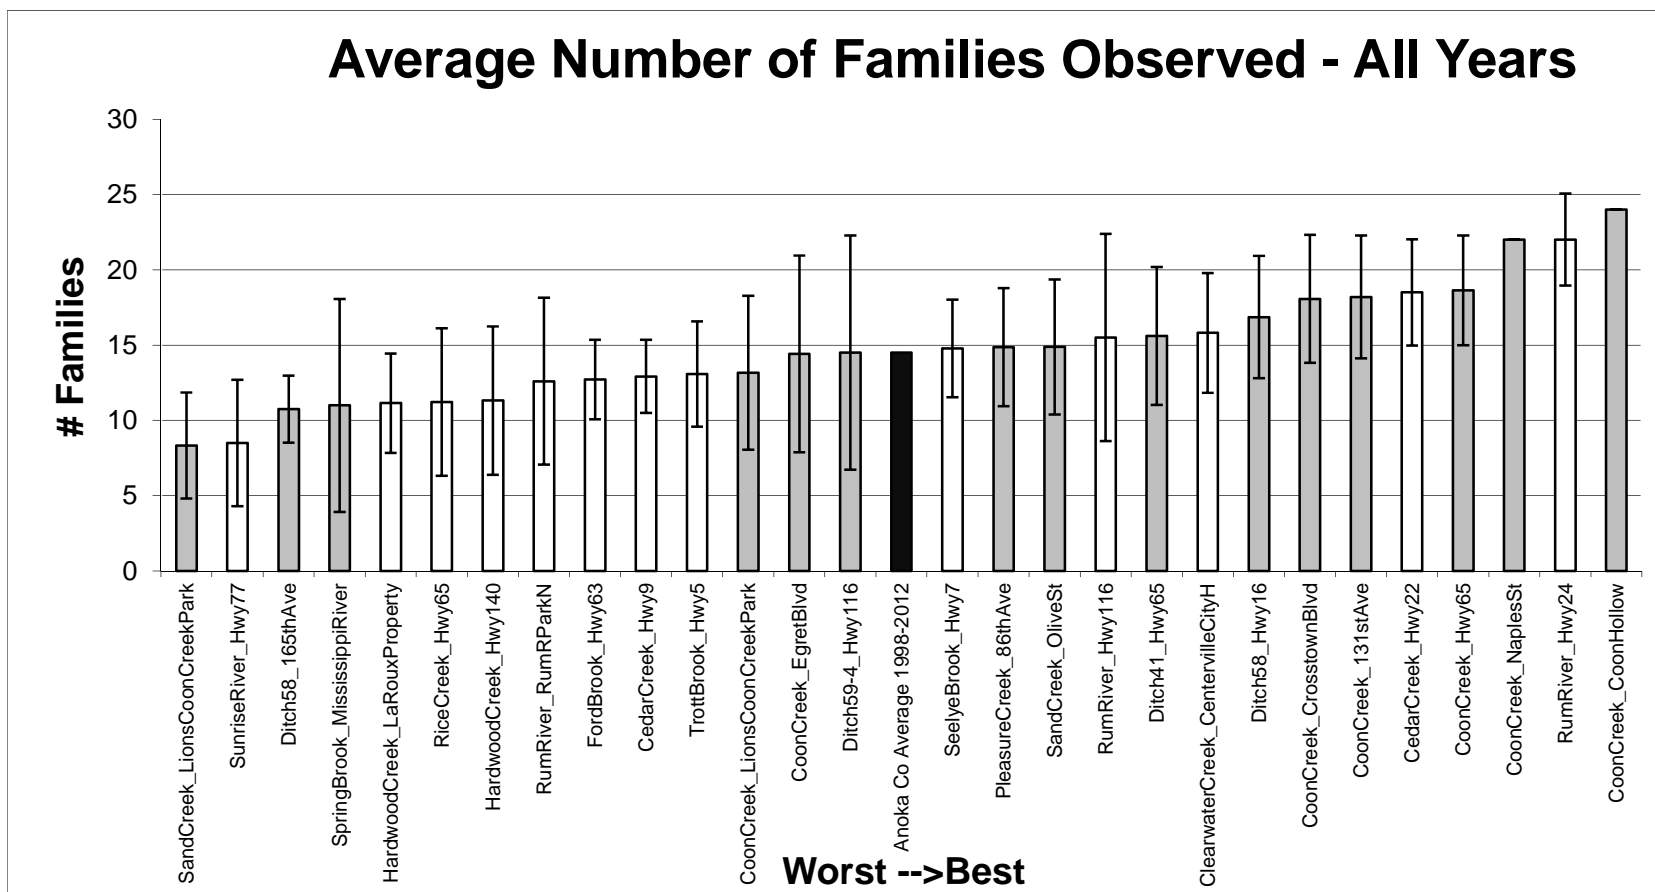
Figure 8. Average number of invertebrate families in the orders Ephemeroptera (mayflies), Plecoptera (stoneflies), and Trichoptera (caddisflies) observed at each monitored site in Anoka County. The EPT orders are generally pollution sensitive; higher numbers are generally reflective of better stream health. Sites with grey bars are within the Coon Creek watershed.

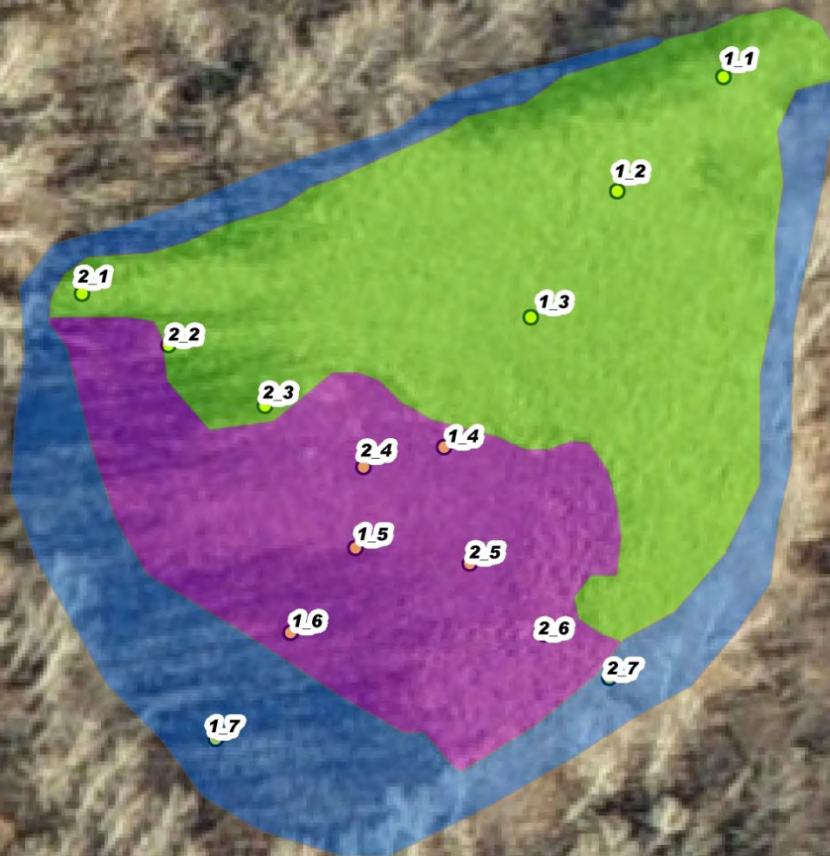
2010 Bunker Hills Reference Wetland Vegetation Inventory

2010 Plant Communities

-   **Diverse Native**
-   **Diverse Native/Non-Native**
-   **Monotypic Non-Native**
-   **Transects and Sample Points**

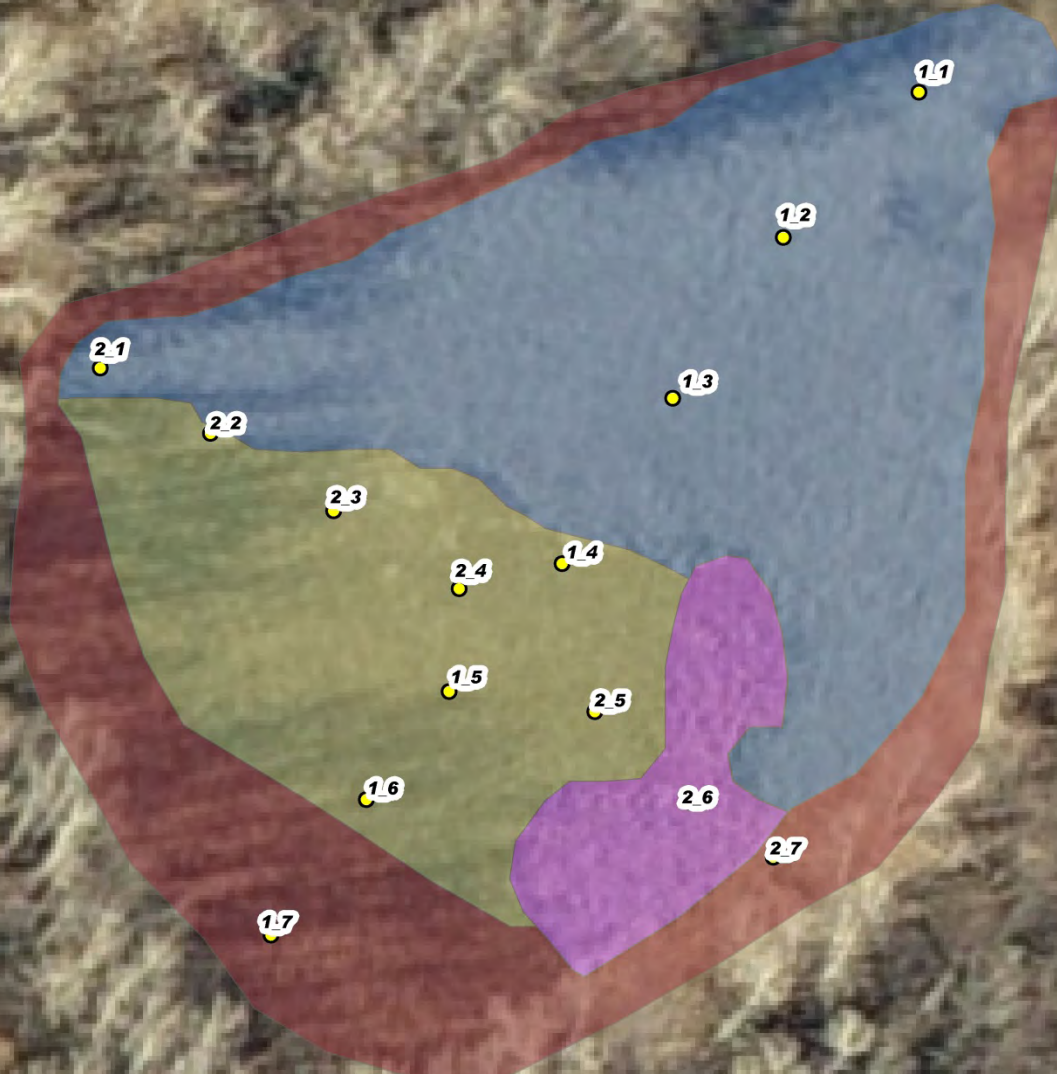
2009 Bunker Hills Reference Wetland Vegetation Inventory

2009 Plant Communities

-   **Diverse Native**
-   **Monotypic Native**
-   **Diverse Native/Non-Native Mix**
-   **Monotypic Non-Native**
-   **Transects and Sample Points**

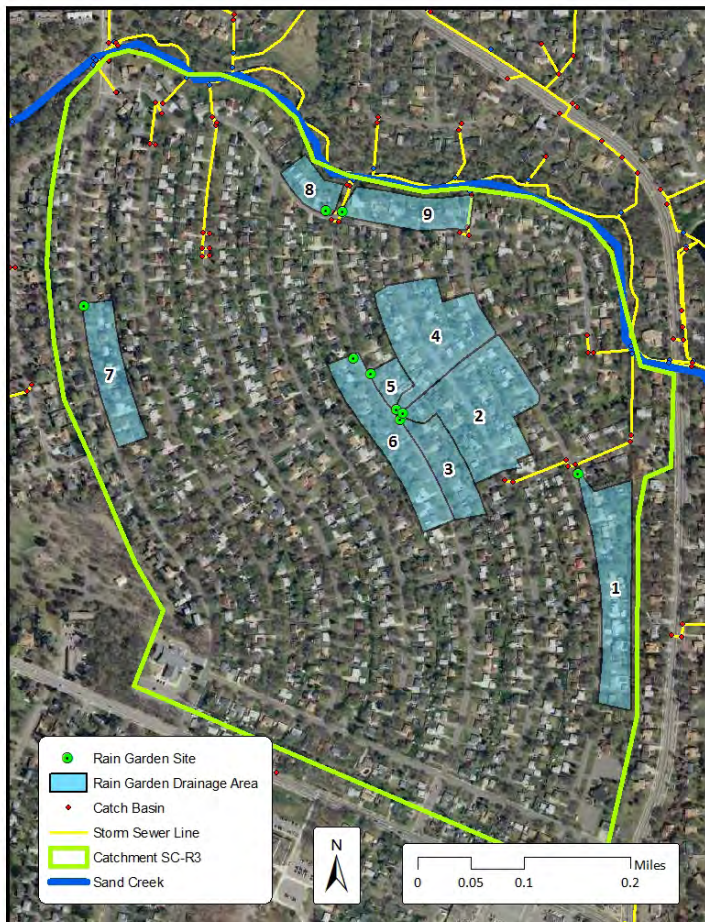
Installation sites of nine rain gardens installed in the Sand Creek subwatershed in 2012.

Results: In fall 2011, ACD staff approached over 30 properties in a residential neighborhood to the south of Sand Creek looking for landowners interested in participating in the rain garden program. Interested landowners attended educational meetings held by ACD and some eventually signed contracts for rain garden construction on their property. In 2012 ACD staff oversaw the construction process for nine rain gardens at strategic locations. Project designs were completed by Metro Landscape Restoration Program staff with project dollars provided by ACD and the Clean Water Fund (CWF) from the Clean Water, Land and Legacy Amendment. Long term maintenance will be conducted by the landowners under an agreement with the CCWD. Together, these nine rain gardens will reduce stormwater runoff volumes into Sand Creek by 1,620,594 gallons/yr, suspended solids by 2000 lbs/yr, and phosphorus by 8.76 lbs/yr.
