# 2014 Anoka Water Almanac

## Water Quality and Quantity Conditions of Anoka County, MN

A Report of Activities by  
Watershed Organizations and the  
Anoka Conservation District

Prepared by the Anoka Conservation District

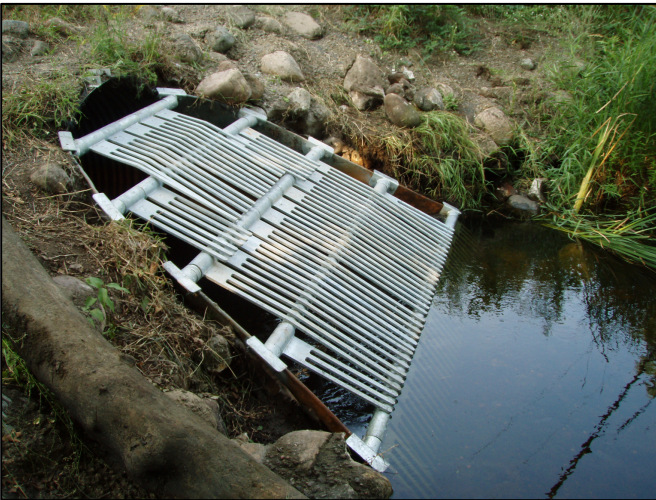
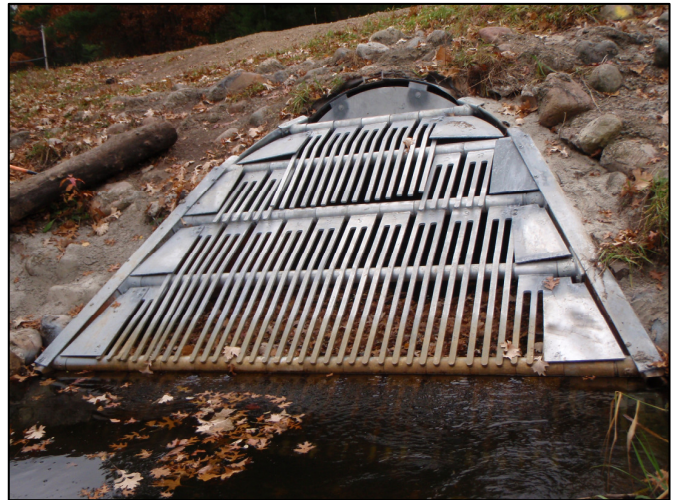
**Results:** In 2014 the SRWMO installed one carp barrier in the Martin and Typo Lake system with the approved financing and planning for three additional barriers to be installed in 2015.

During and completed installation of first barrier.

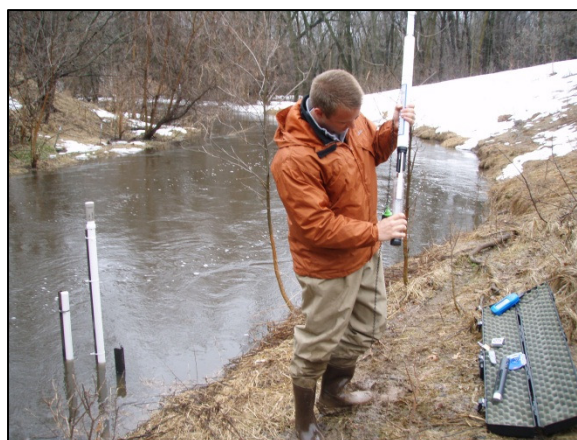
Staff deploying the Hydrolab MS5. In the background are the Hydrolab casing (shorter) and a Measura continuous water level monitoring device.

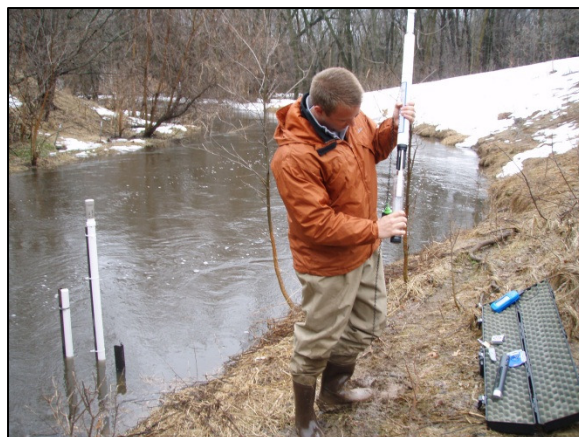
Staff deploying the Hydrolab MS5. In the background are the Hydrolab casing (shorter) and a Measura continuous water level monitoring device.

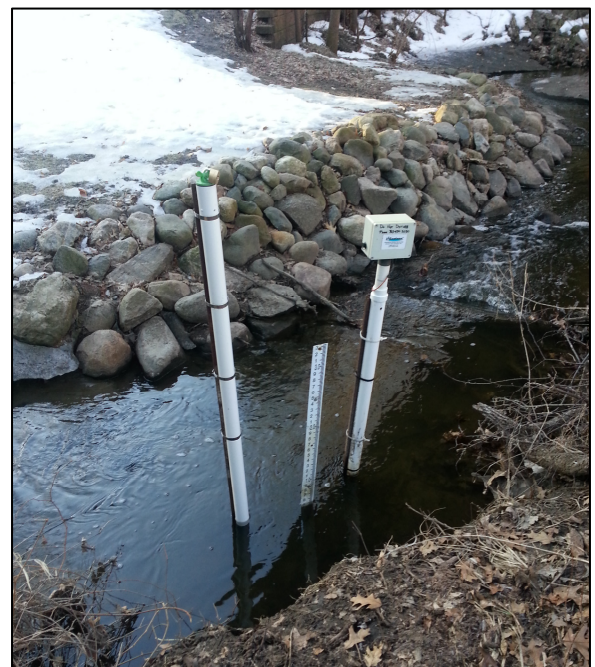
Hydrolab MS5 casing (taller) and a Measura continuous water level monitoring device in Pleasure Creek. A staff gauge is shown in the middle.

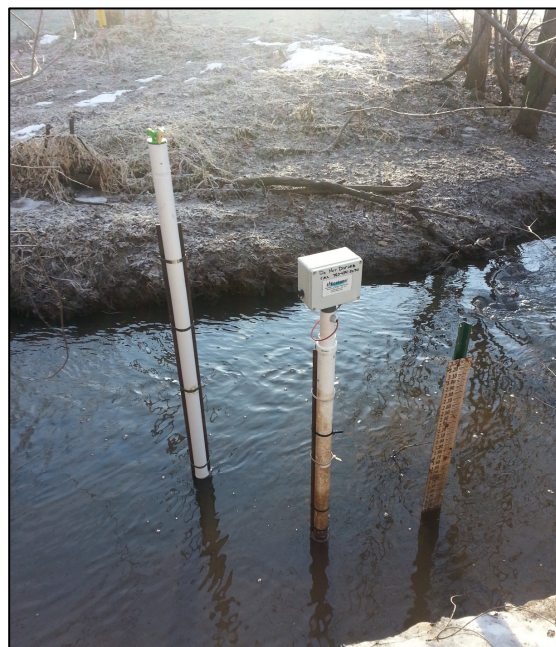
Hydrolab MS5 casing (taller) and a Measura continuous water level monitoring device I Springbrook Creek.

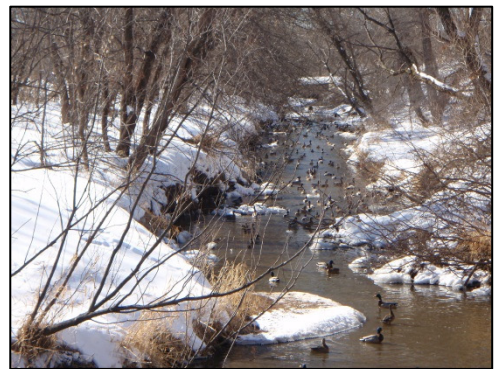
Waterfowl congregating on Pleasure Creek near Evergreen Blvd in Coon Rapids, February 2010. 250+ ducks were present in about 350 meters of creek.

Of particular interest are the 11 stormwater ponds that the creek flows through in its headwaters in the City of Blaine. These ponds and the developments around them were built post-1995. Some are small and shallow and serve as forebays to the larger, deeper ponds. The stormwater pond network in Blaine is likely a source of bacteria, collecting them from polluted runoff, harboring them, and releasing them (especially during

storm flushing). Smaller, shallower upper ponds are the most suitable for bacterial survival. The larger, deeper lower ponds are less suitable for bacteria and seem to remove them from the system during baseflow but not during storms. While these ponds do a good job removing suspended solids in all conditions, they do not regulate water rate and volume during storms well. These storm flushes can provide a means for transporting bacteria. The fact that suspended solids seem to be captured by the ponds during storms but not bacteria seems inconsistent and deserves more research.

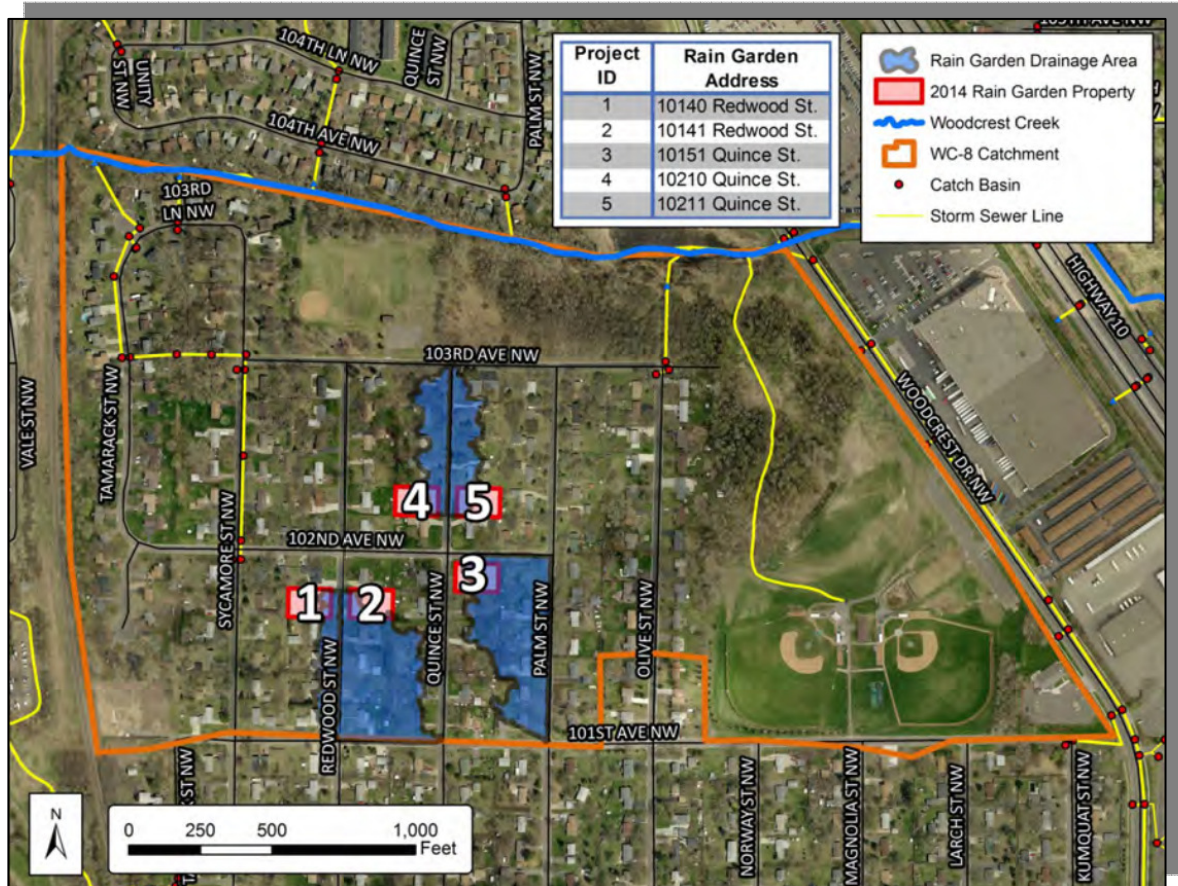
Sites of five rain gardens installed in the WC-8 catchment of the Woodcrest Creek subwatershed in 2014.

**Results:** ACD staff targeted priority properties in the residential neighborhoods located within the catchments to identify landowners interested in participating in the rain garden program. Interested landowners attended an educational meeting held by ACD. Those landowners with favorable rain garden sites and willingness to move forward with the program entered into contracts with the CCWD for rain garden construction. ACD staff provided design and construction management for the installation of five rain gardens throughout the WC-8 catchment and six rain gardens throughout the SC-R3 catchment. The rain gardens were installed at strategic locations to ensure sufficient contributing drainage areas and maximize treatment. Long-term maintenance will be provided by the landowners under an agreement with the CCWD. Cumulatively, the five rain gardens of the WC-8 catchment reduce stormwater runoff volumes into Woodcrest Creek by 3.1 acre-ft/yr, total suspended solids by 1,117 lbs/yr, and total phosphorus by 3.7 lbs/yr. The six rain gardens of the SC-R3 catchment reduce stormwater runoff volumes into Sand Creek by 7.2 acre-ft/yr, total suspended solids by 2,725 lbs/yr, and total phosphorus by 8.4 lbs/yr.

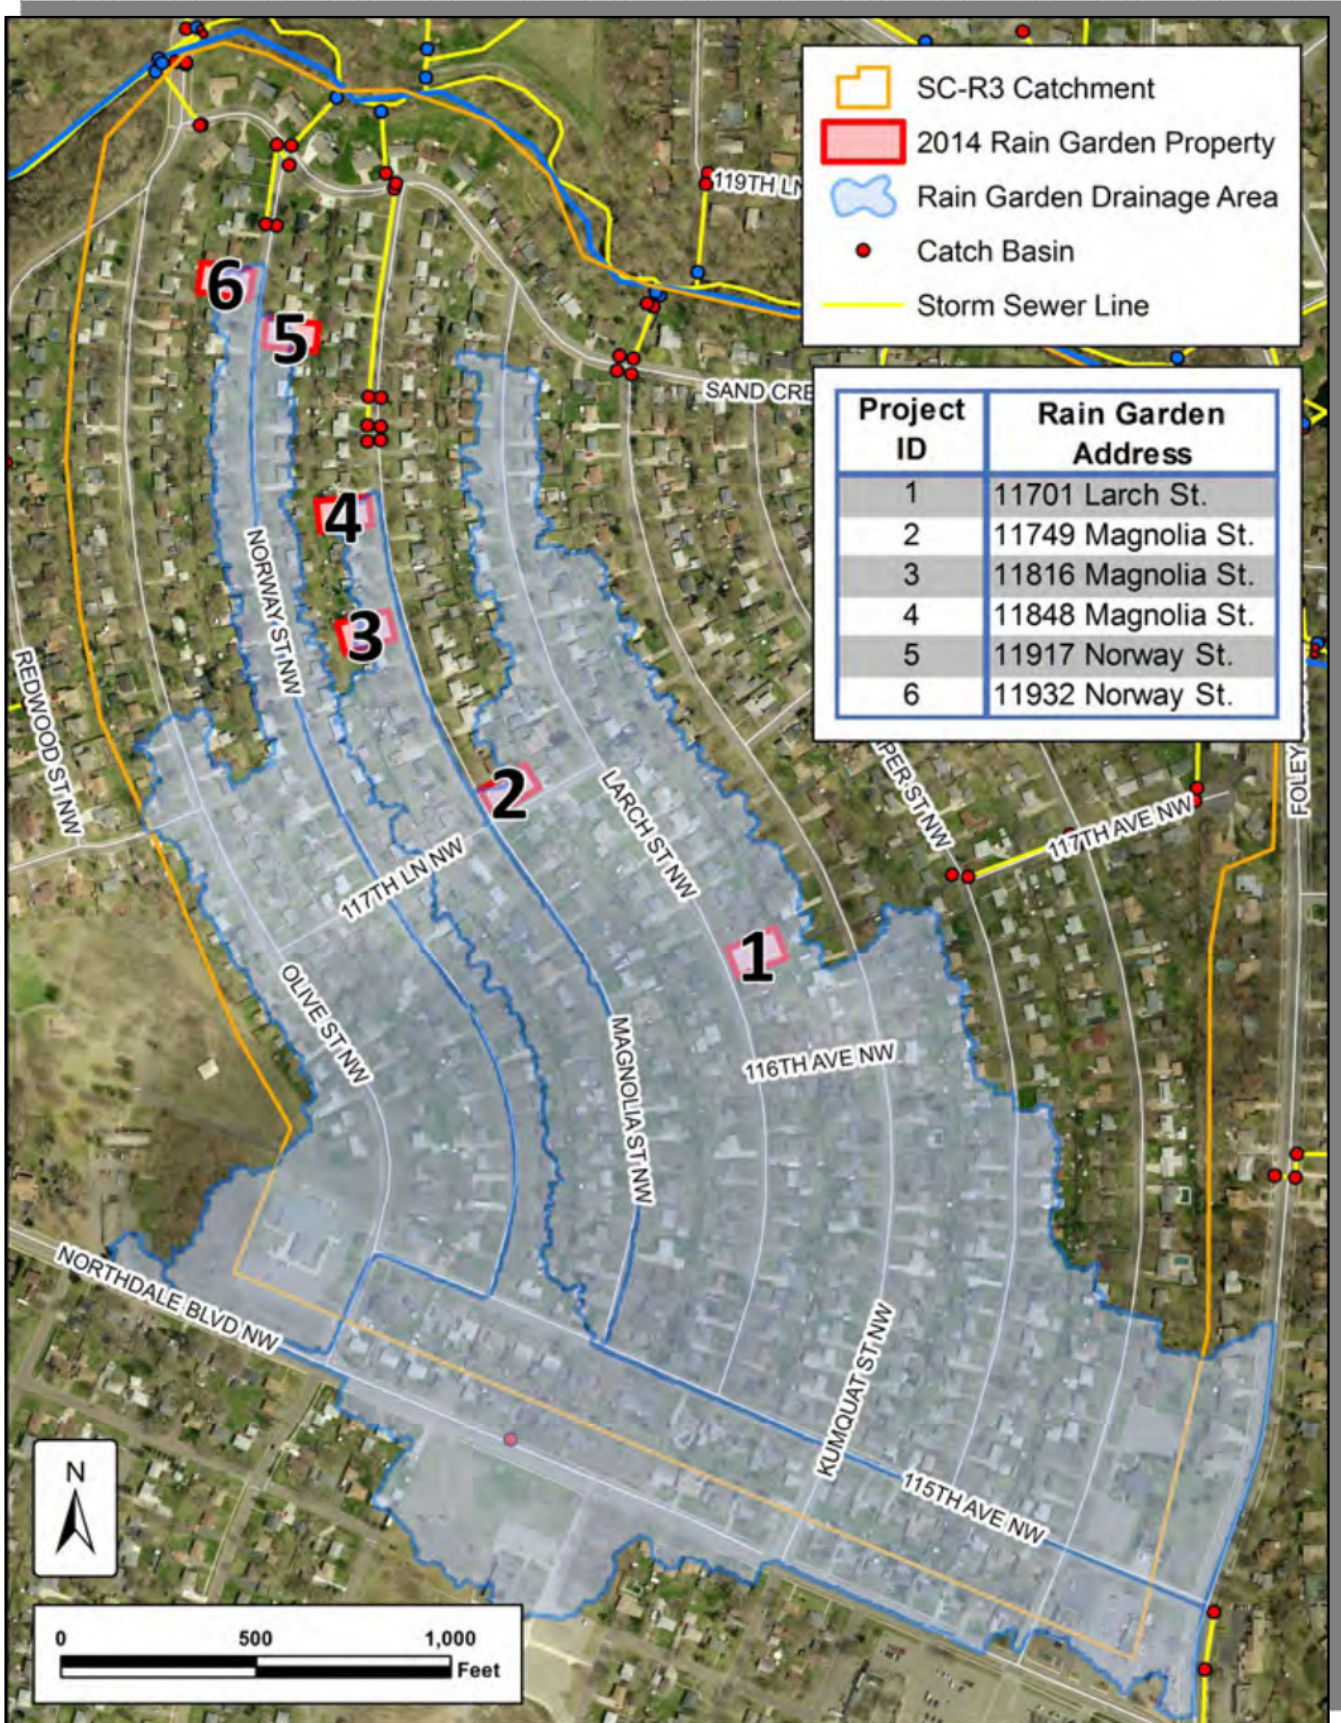
Sites of six rain gardens installed in the SC-R3 catchment of the Sand Creek subwatershed in 2014.
