2015 Anoka Water Almanac

Water Quality and Quantity Conditions of Anoka County, MN

A Report of Activities by
Watershed Organizations and the
Anoka Conservation District

Prepared by the Anoka Conservation District

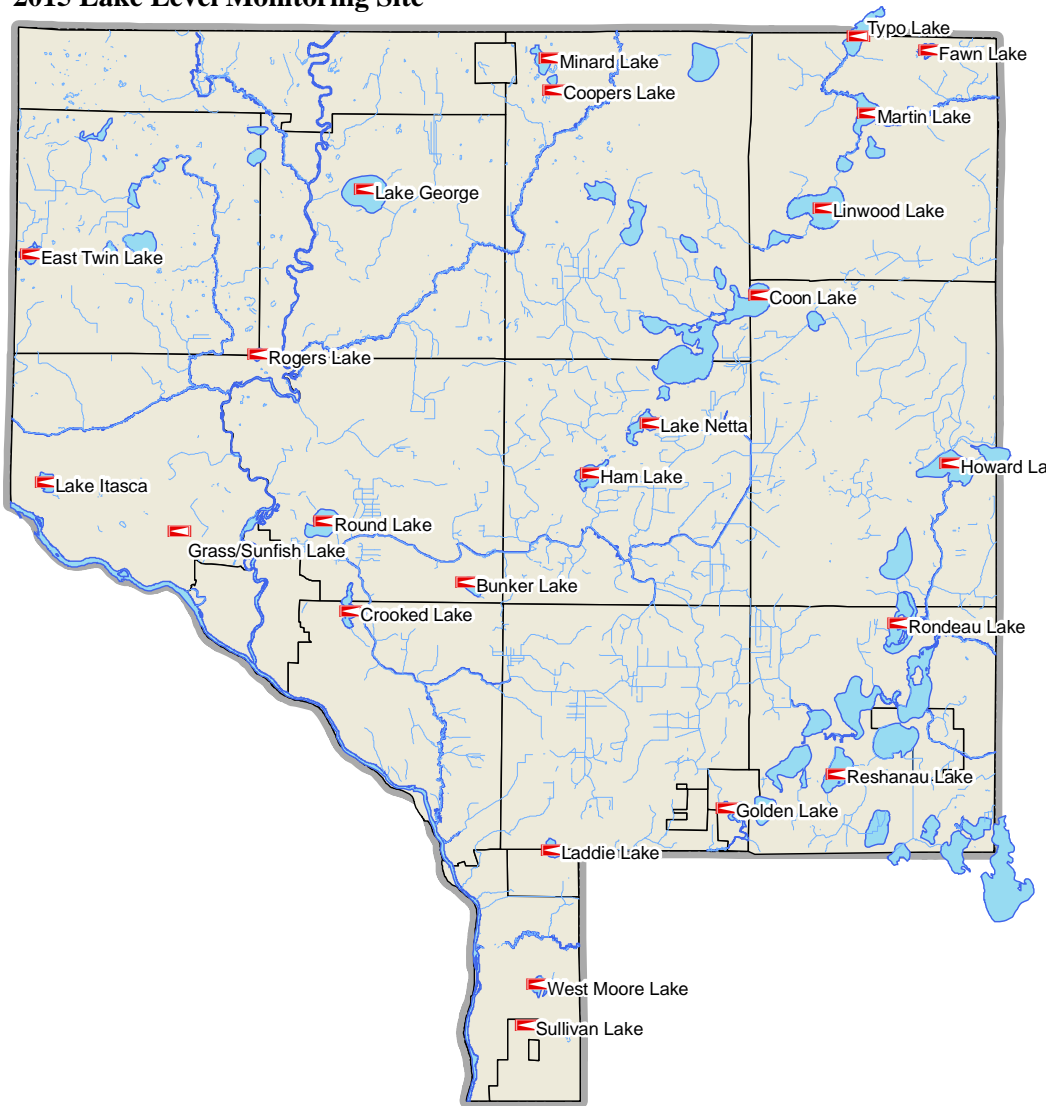
2015 Lake Level Monitoring Site

Results of lake level monitoring are separated by watershed in the following chapters.

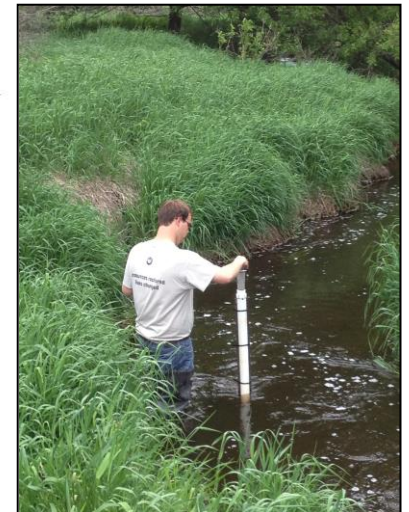
2015 Stream Hydrology Monitoring Sites

Results of stream hydrology monitoring are separated by watershed in the following chapters.

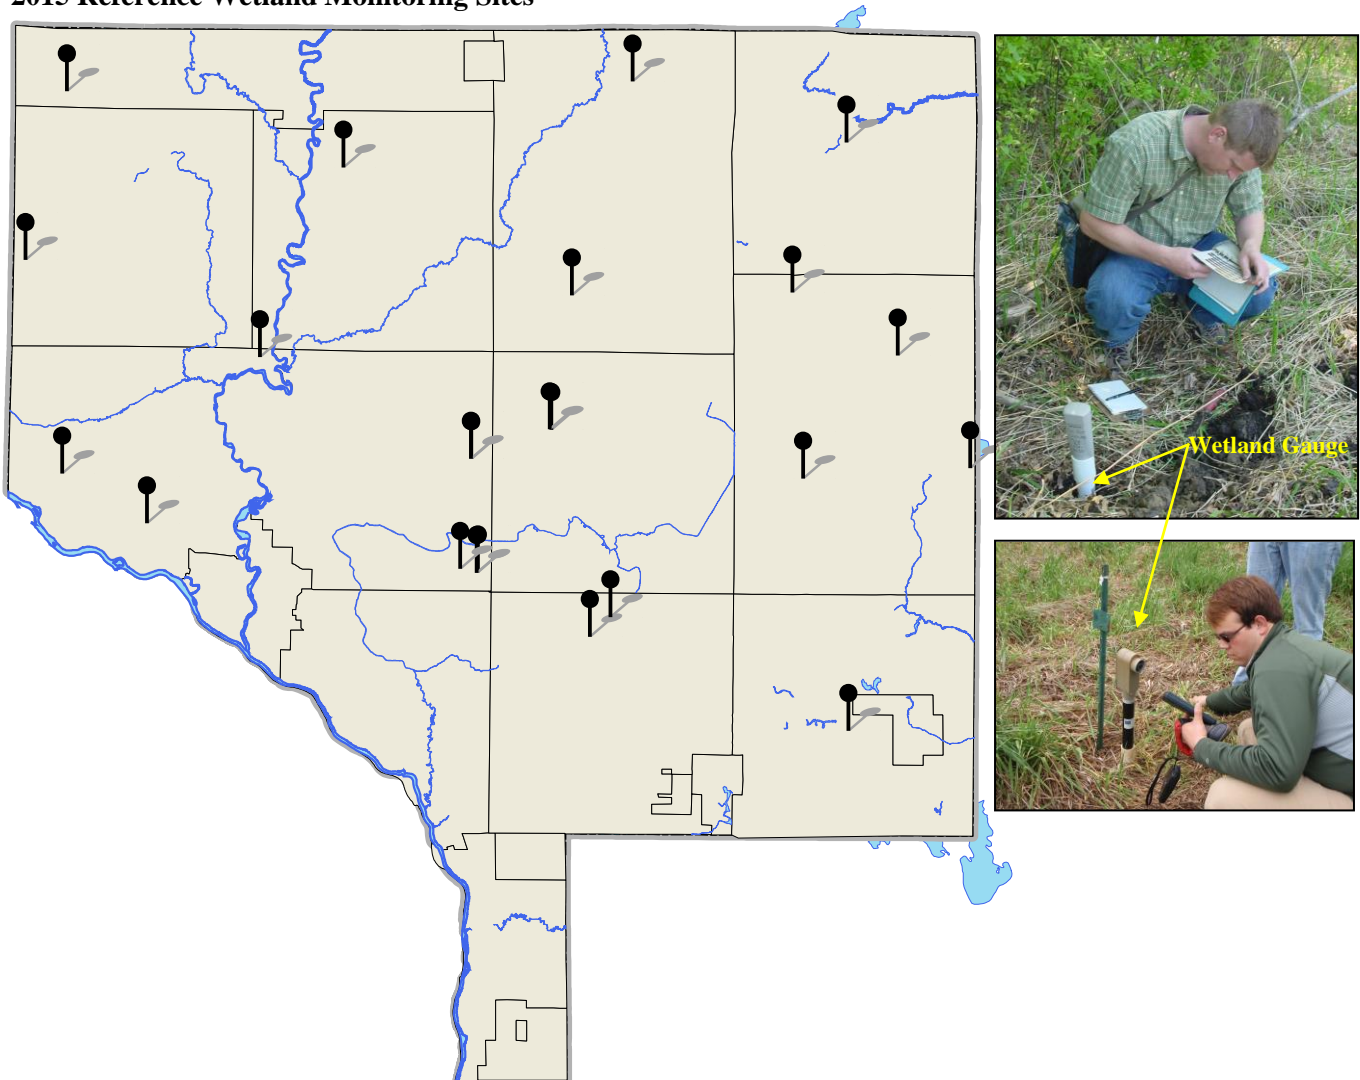
2015 Reference Wetland Monitoring Sites

Results of wetland hydrology monitoring are separated by watershed in the following chapters. The Coon Creek Watershed chapter includes a multi-year and most recent year analysis of all the wetlands.

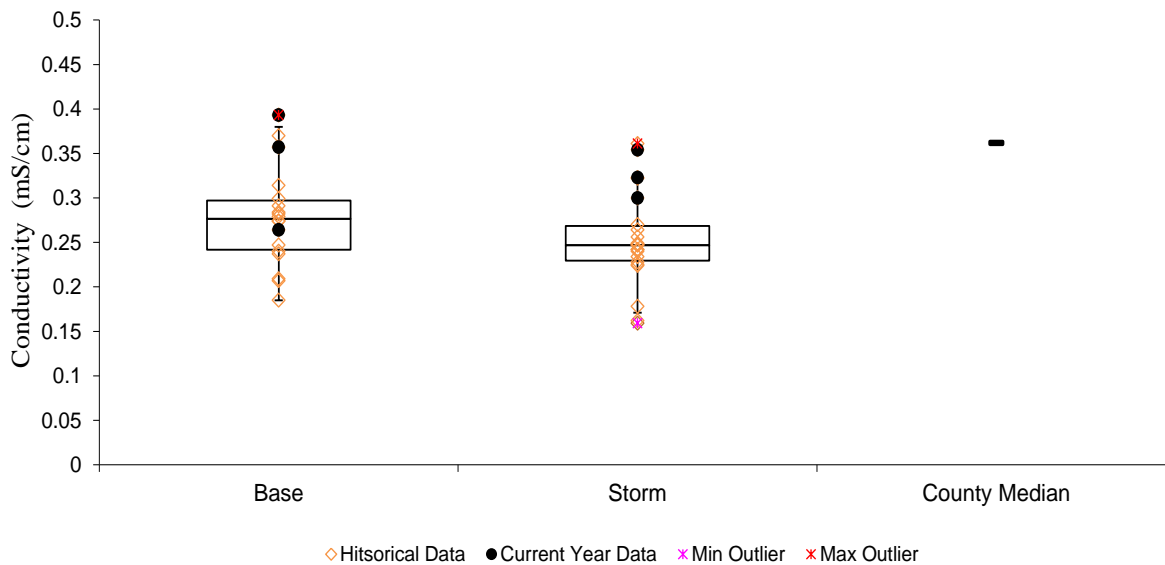
Conductivity during baseflow and storm conditions. Orange diamonds are historical data from previous years and black circles are 2015 readings. Box plots show the median (middle line), 25th and 75th percentile (ends of box), and 10th and 90th percentiles (floating outer lines).

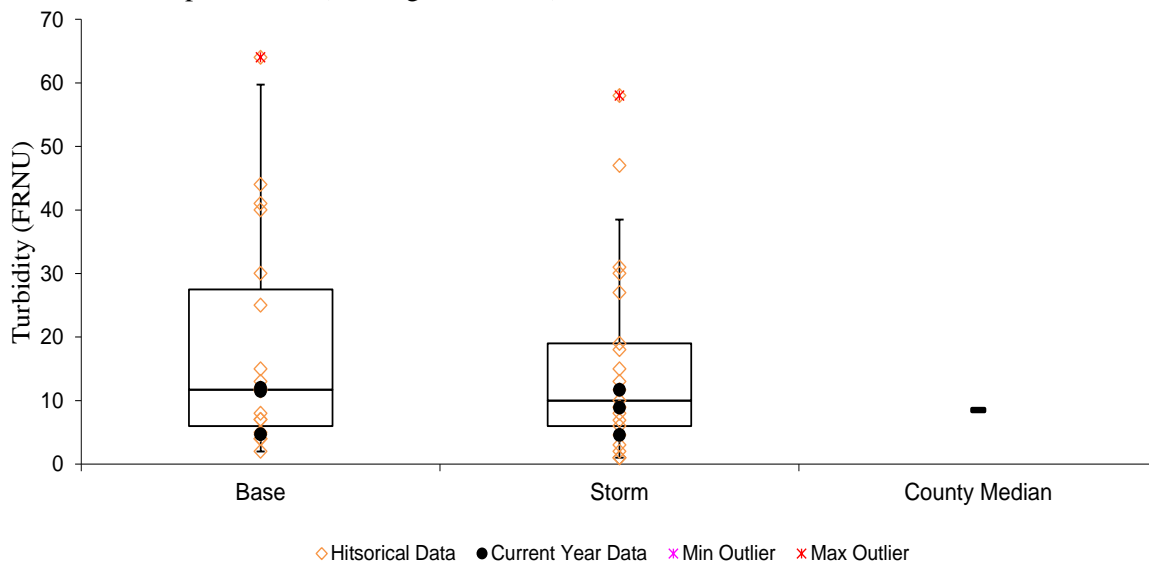
Turbidity during baseflow and storm conditions Orange diamonds are historical data from previous years and black circles are 2015 readings. Box plots show the median (middle line), 25th and 75th percentile (ends of box), and 10th and 90th percentiles (floating outer lines).

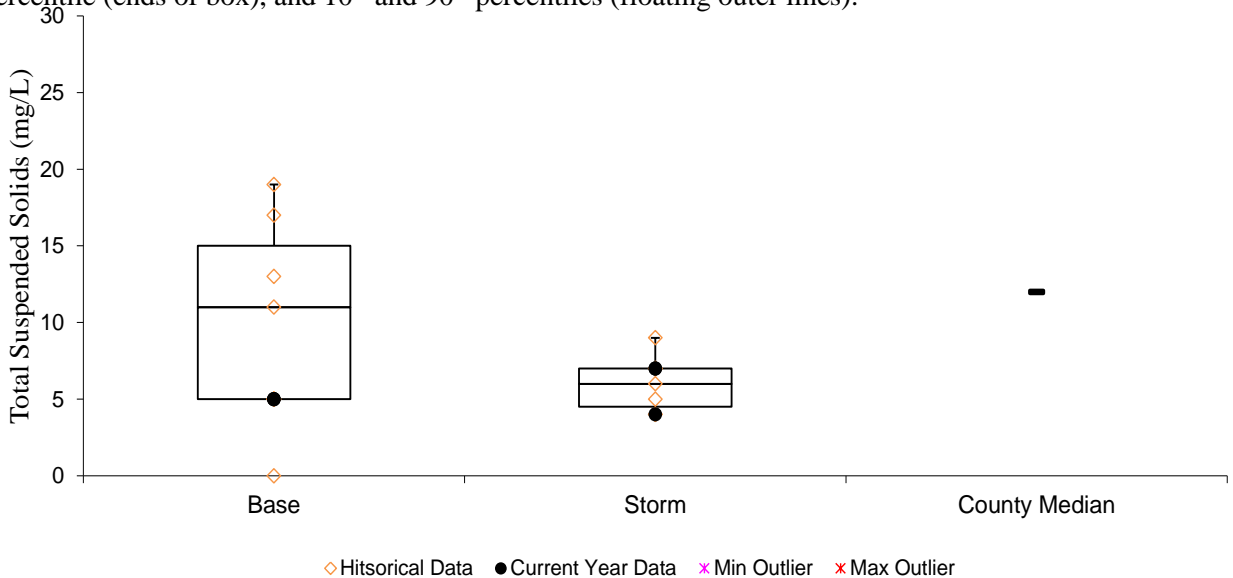
Total suspended solids during baseflow and storm conditions. Orange Diamonds are historical data from previous years and black circles are 2015 readings. Box plots show the median (middle line), 25th and 75th percentile (ends of box), and 10th and 90th percentiles (floating outer lines).

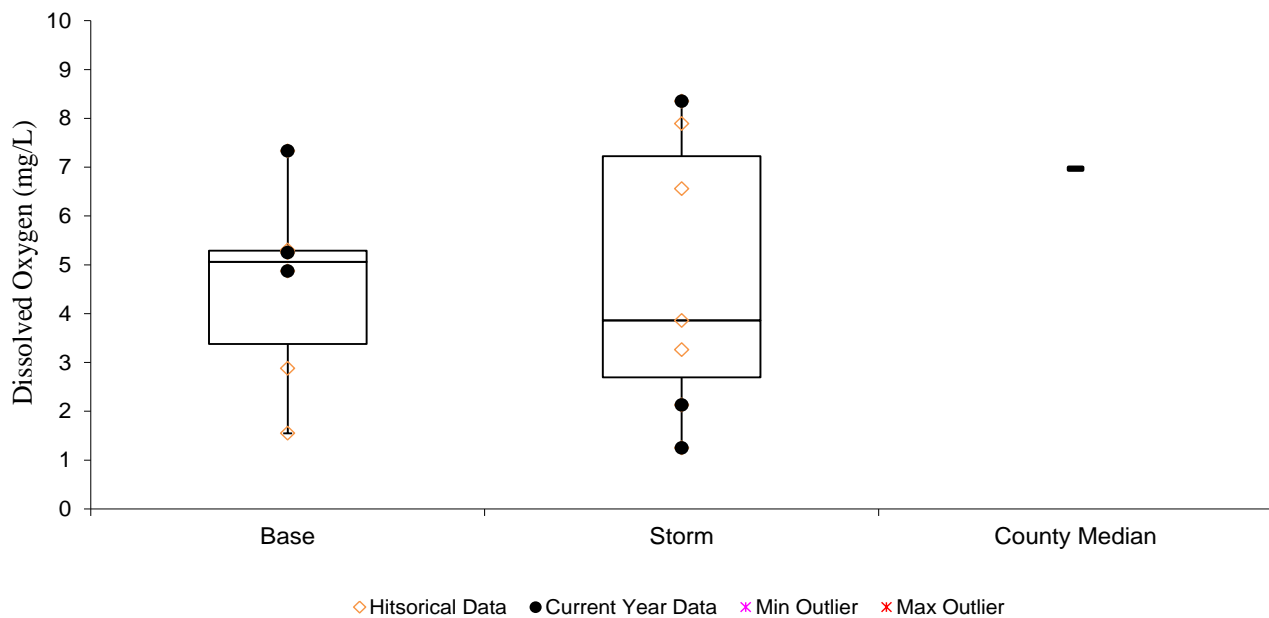
Dissolved oxygen results during baseflow and storm conditions. Orange diamonds are historical data from previous years and black circles are 2015 readings. Box plots show the median (middle line), 25th and 75th percentile (ends of box), and 10th and 90th percentiles (floating outer lines).

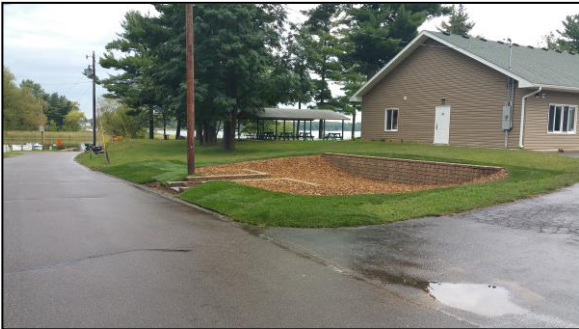
Coon Lake Beach Community Center rain garden

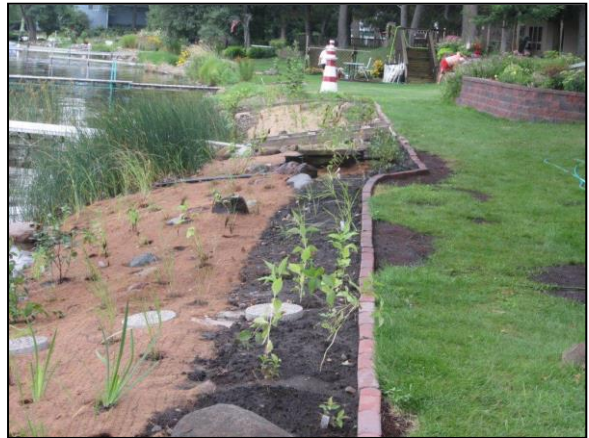
19511 East Tri Oak Circle NE lakeshore restoration

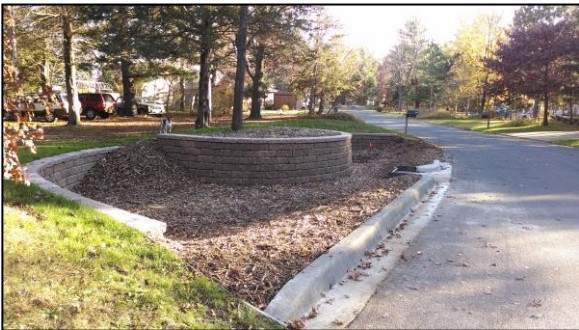
19303 East Front Blvd rain garden

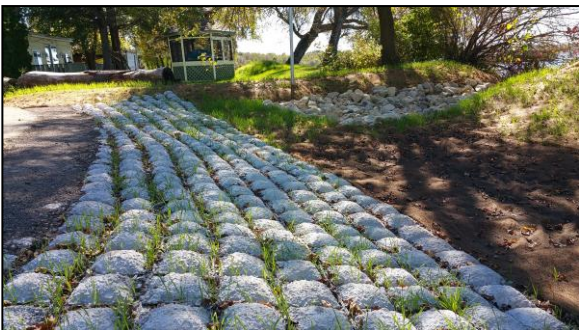
Lincoln Avenue stormwater stabilization.

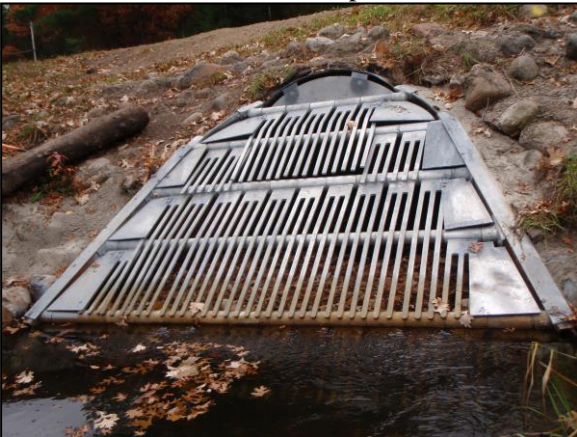
Typo Lake outlet (completion in early 2016)

Results: In 2014 the SRWMO installed one carp barrier at the south inlet of Martin Lake. In 2015 three additional barriers were installed at the following locations: Typo Lake outlet, Martin Lakes' north inlet, and Martin Lake outlet. Construction will conclude in early 2016.

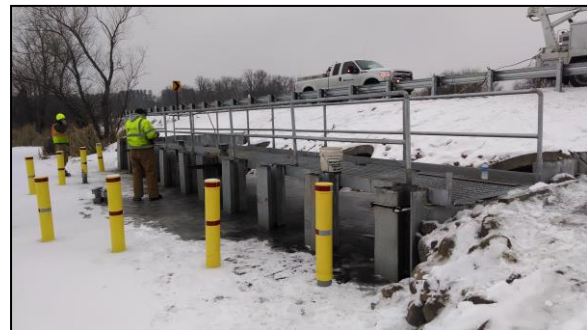
Martin Lake north inlet (completion in early 2016)

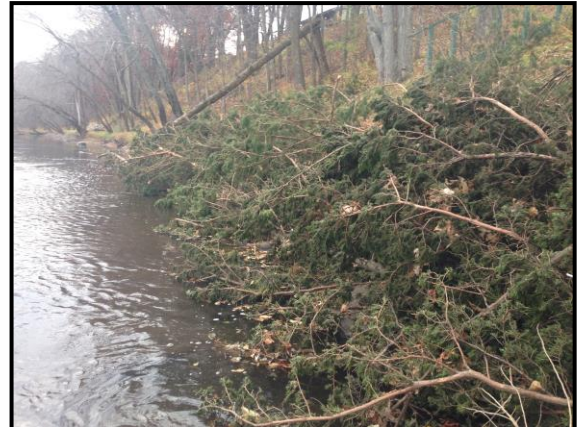
100 feet of undercut, eroding riverbank was stabilized using a cedar tree revetment. This was phase two of efforts on this property. In 2012, approximately 70 feet of riverbank were stabilized using a cedar tree revetment. A design was completed for the entire 170 feet of riverbank on the property, but a full installation in 2012 was cost prohibitive. The remaining 100 feet of riverbank was stabilized in 2015.

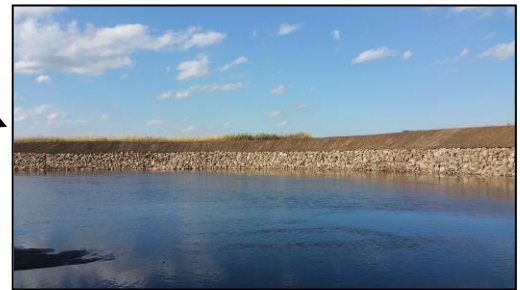
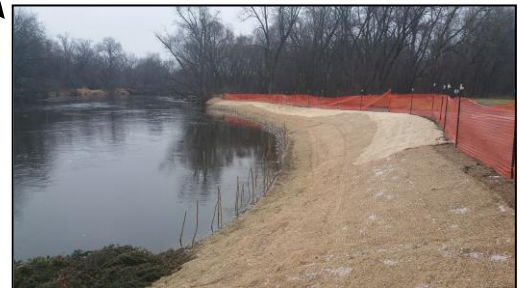
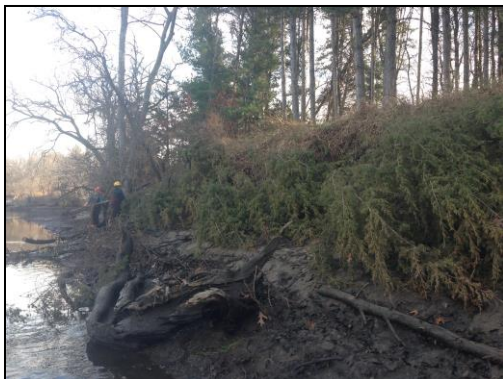
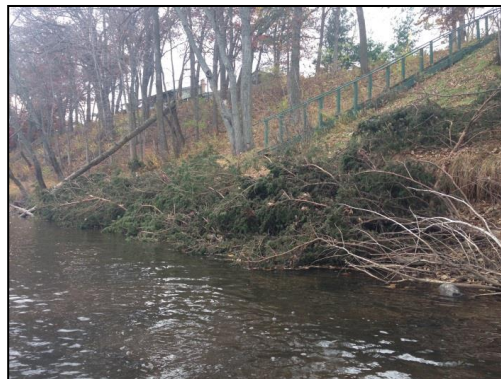
Results: Stabilized a total of 1,150 linear feet of riverbank on the Rum River.

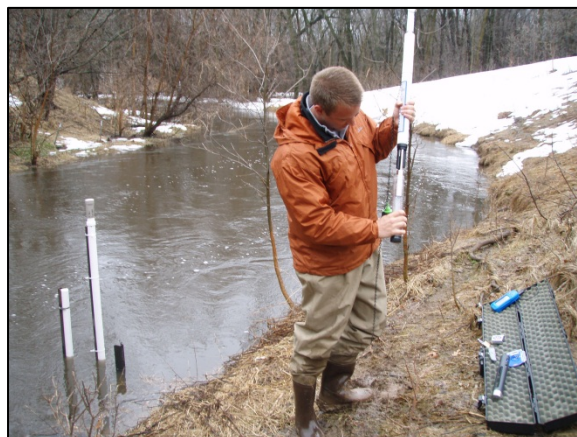
Staff deploying the Hydrolab MS5. In the background are the Hydrolab casing (shorter) and a Measura continuous water level monitoring device.

Coon Creek at 131st Street was monitored immediately before, during, and after storms with a YSI Exo water quality sonde. The sonde was suspended inside a PVC pipe by a chain from a locked lid. The PVC pipe was secured to a metal fence post. The sonde sensors protruded from the bottom of the pipe approximately 6-12 inches from the stream bottom, ensuring they would stay submerged even if flow was low. The sonde was programmed to take readings every 30 minutes. Readings included pH, salinity, specific conductance, temperature, dissolved oxygen, and turbidity. The sonde was calibrated before each deployment.

The Hydrolab was deployed into the stream when a storm predicted to drop at least 0.5 inches of rain, and preferably greater, was approaching. Past grab sample monitoring had found that the greatest water quality problems occurred after storms exceeding one inch. In some instances, water level

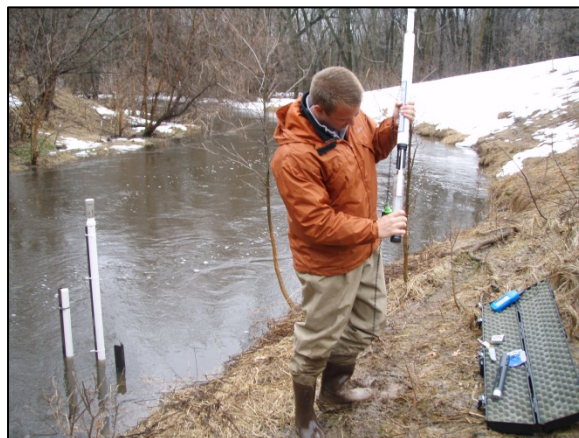
Staff deploying the Hydrolab MS5. In the background are the Hydrolab casing (shorter) and a Measura continuous water level monitoring device.

Coon Creek at Prairie Road was monitored immediately before, during, and after storms with a Hydrolab MS5 water quality sonde. The sonde was suspended inside a PVC pipe by a chain from a locked lid. The PVC pipe was secured to a metal fence post. The sonde sensors protruded from the bottom of the pipe approximately 6-12 inches from the stream bottom, ensuring they would stay submerged even if flow was low. The sonde was programmed to take readings every 30 minutes. Readings included pH, salinity, specific conductance, temperature, dissolved oxygen, and turbidity. The sonde was calibrated before each deployment.

The Hydrolab was deployed into the stream when a storm predicted to drop at least 0.5 inches of rain, and preferably greater, was approaching. Past grab sample monitoring had

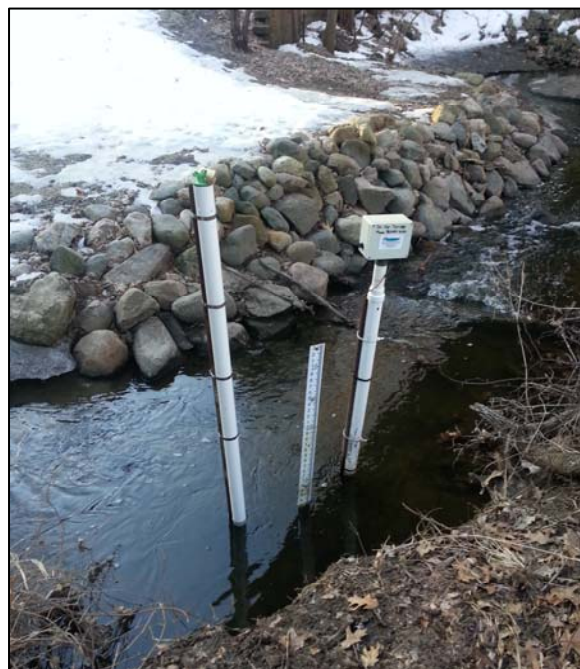
Hydrolab MS5 casing (taller) and a Measura continuous water level monitoring device in Pleasure Creek. A staff gauge is shown in the middle.

Pleasure Creek at 86th Street was monitored immediately before, during, and after storms with a Hydrolab MS5 water quality sonde. The sonde was suspended inside a PVC pipe by a chain from a locked lid. The PVC pipe was secured to a metal fence post. The sonde sensors protruded from the bottom of the pipe approximately 6-12 inches from the stream bottom, ensuring they would stay submerged even if flow was low. The sonde was programmed to take readings every 30 minutes. Readings included pH, salinity, specific conductance, temperature, dissolved oxygen, and turbidity. The sonde was calibrated before each deployment.

The Hydrolab was deployed into the stream when a storm predicted to drop at least 0.5 inches of rain, and preferably

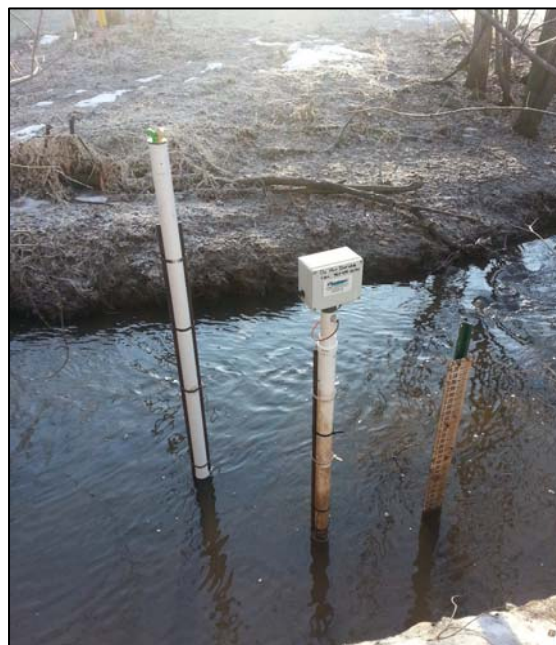
Hydrolab MS5 casing (taller) and a Measura continuous water level monitoring device I Springbrook Creek.

Springbrook at 79th Way was monitored immediately before, during, and after storms with a Hydrolab MS5 water quality sonde. The sonde was suspended inside a PVC pipe by a chain from a locked lid. The PVC pipe was secured to a metal fence post. The sonde sensors protruded from the bottom of the pipe approximately 6-12 inches from the stream bottom, ensuring they would stay submerged even if flow was low. The sonde was programmed to take readings every 30 minutes. Readings included pH, salinity, specific conductance, temperature, dissolved oxygen, and turbidity. The sonde was calibrated before each deployment.

The Hydrolab was deployed into the stream when a storm predicted to drop at least 0.5 inches of rain, and preferably

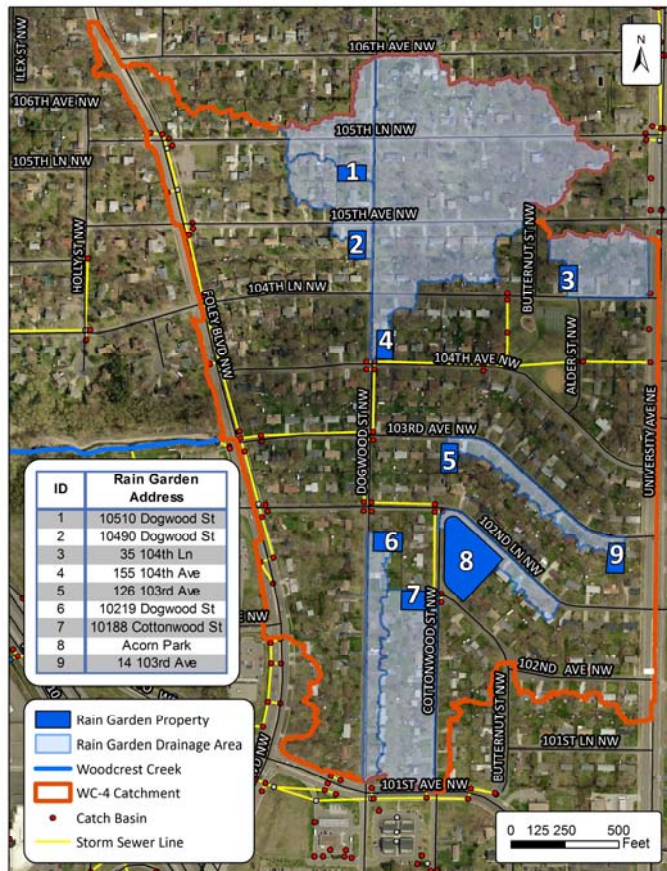
Sites of nine rain gardens installed in the SC-R3 catchment of the Sand Creek subwatershed in 2015.

Results: ACD staff targeted priority properties in the residential neighborhoods located within the catchments to identify landowners interested in participating in the rain garden program. Interested landowners attended an educational meeting held by ACD. Those landowners with favorable rain garden sites and willingness to move forward with the program entered into contracts with the CCWD for rain garden construction. ACD staff provided design and construction management for the installation of nine rain gardens throughout the WC-4 catchment and nine rain gardens throughout the SC-R3 catchment. The rain gardens were installed at strategic locations to ensure sufficient contributing drainage areas and maximize treatment. The planting of the gardens will take place in spring of 2016. Long-term maintenance will be provided by the landowners under an agreement with the CCWD. Cumulatively, the nine rain gardens of the WC-8 catchment reduce stormwater runoff volumes into Woodcrest Creek by 6.8 acre-ft/yr, total suspended solids by 3,225 lbs/yr, and total phosphorus by 9.9 lbs/yr. The nine rain gardens of the SC-R3 catchment reduce stormwater runoff volumes into Sand Creek by 9.7 acre-ft. /yr., total suspended solids by 4,629 lbs. /yr., and total phosphorus by 13.0 lbs. /yr.
