# 2017 Anoka Water Almanac

## Water Quality and Quantity Conditions of Anoka County, MN

A Report of Activities by  
Watershed Organizations and the  
Anoka Conservation District

March 2018

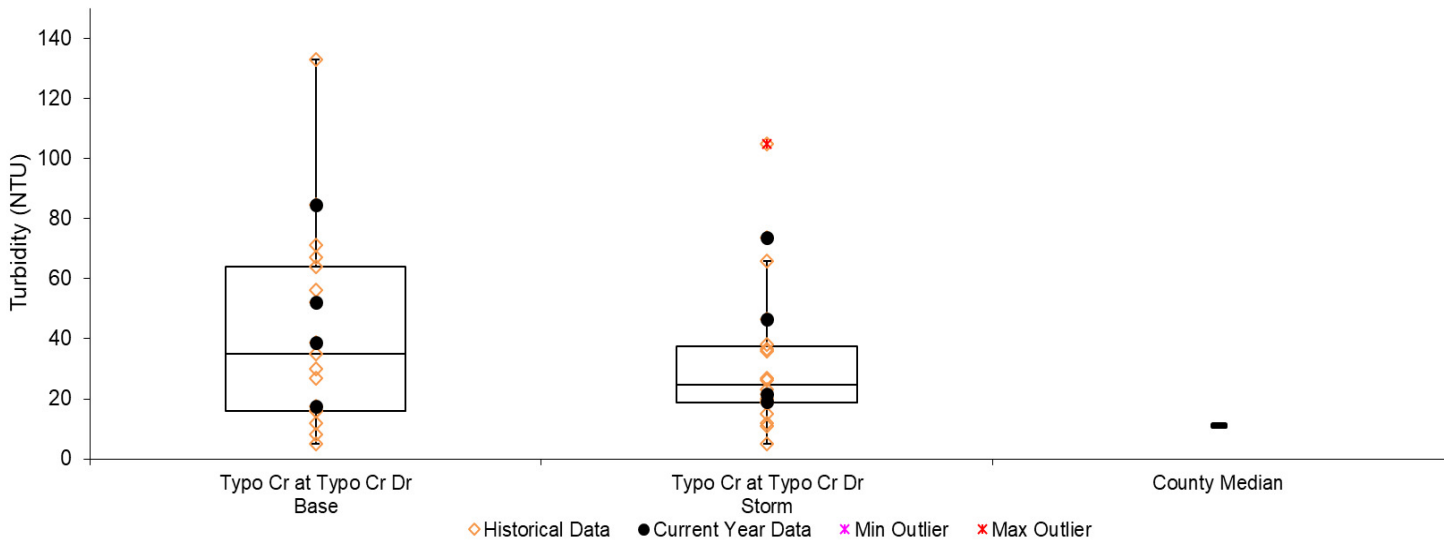
**Turbidity during baseflow and storm conditions** Orange diamonds are historical data from previous years and black circles are 2017 readings. Box plots show the median (middle line), 25<sup>th</sup> and 75<sup>th</sup> percentile (ends of box), and 10<sup>th</sup> and 90<sup>th</sup> percentiles (floating outer lines).

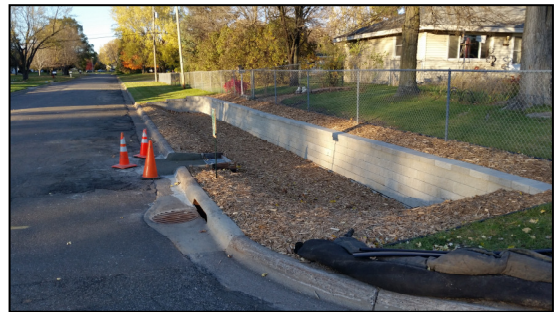
807 38<sup>th</sup> Lane, Anoka

**Results:** Two curb-cut rain residential gardens were constructed on 38<sup>th</sup> lane in Anoka.

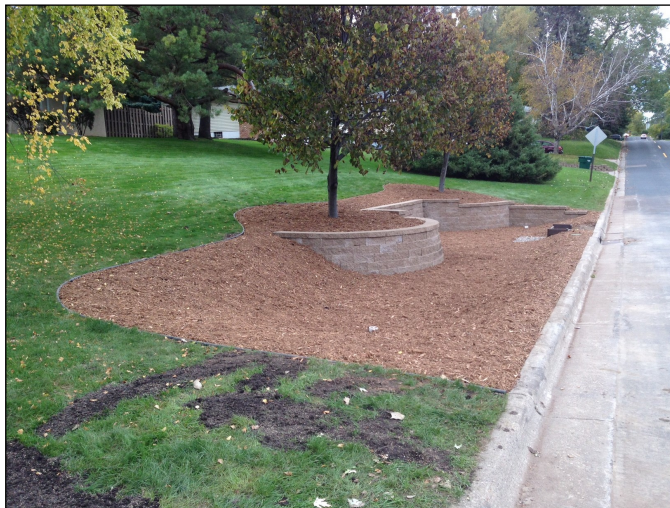
- 22 formal property reviews/site visits throughout the Rice Creek watershed in Anoka County (see overview map below). Projects included:
  - Rain Gardens
    - Design, cost-share coordination, and construction oversight for a residential curb-cut rain garden in Columbia Heights (Silver Lake).

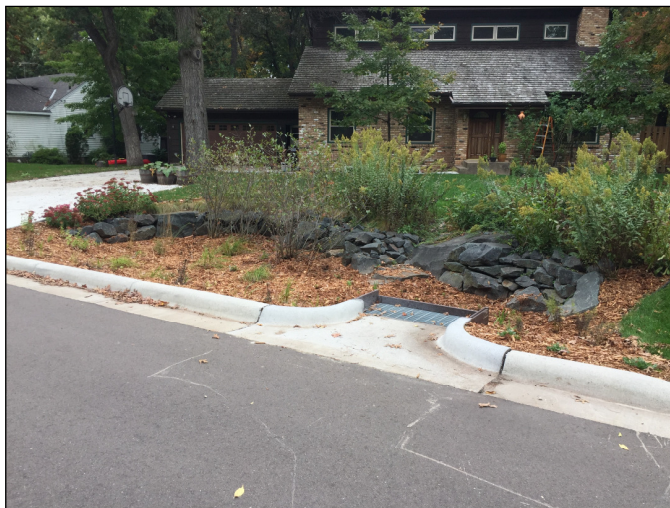
- Cost-share coordination and construction oversight for the retrofit of a curb-cut rain garden with a pretreatment chamber in Circle Pines (Golden Lake).

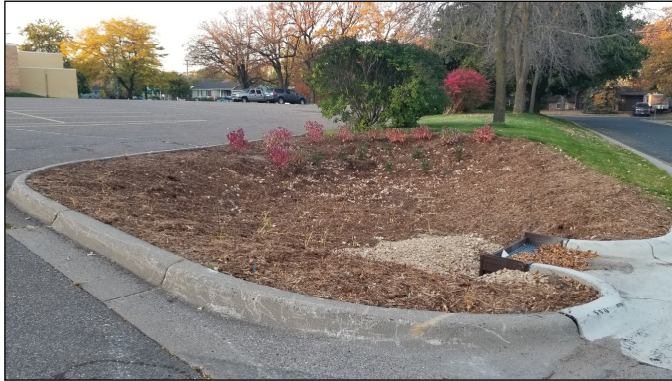
- Design, cost-share coordination, and construction oversight for a church campus curb-cut rain garden in Fridley (Rice Creek).

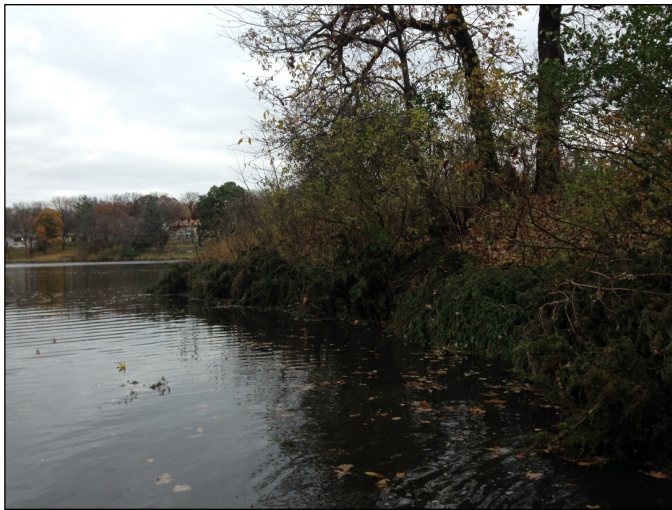
- Design, cost-share coordination, and construction oversight for a cedar tree revetment in Fridley (Locke Lake).

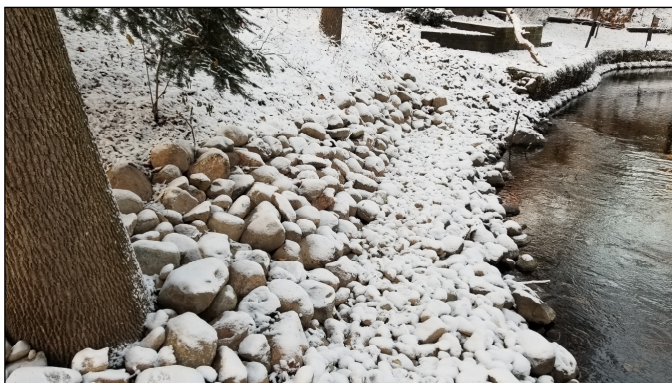
- Design, cost-share coordination, and construction oversight for a streambank stabilization in the City of Fridley (Rice Creek).

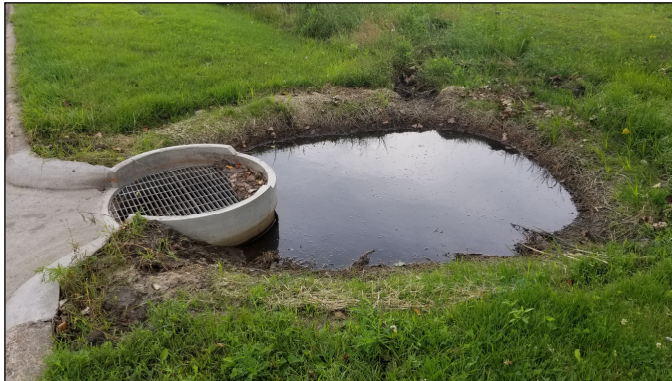
- Swales
  - Design, cost-share coordination, and construction oversight for the retrofit of a vegetated swale with a pretreatment chamber in Fridley (West Moore Lake).

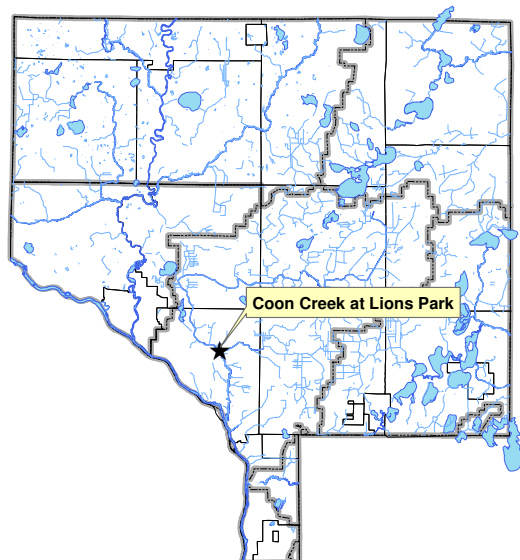
A rating curve developed in 2013 is available for this site and presented below.

Stream level was monitored for the first time at this site in 2012, and a rating curve was developed in 2012-2013. This site has a flashy hydrograph due to the urbanized watershed, similar to the Coon Creek at Coon Hollow site. Some of the data contains inaccurate “noise” during the second half of May and early June 2017 due to the meter getting wet (see hydrograph).

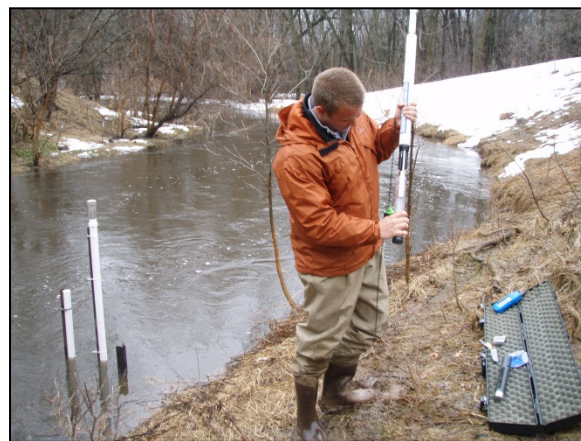
Staff deploying the Hydrolab MS5. In the background are the Hydrolab casing (shorter) and an RDS continuous water level monitoring device.

Water levels were continuously monitored throughout the open water season. An RDS Ecotone WM-40 water level monitoring device recorded water levels every two hours. This stream stage Data are presented with the

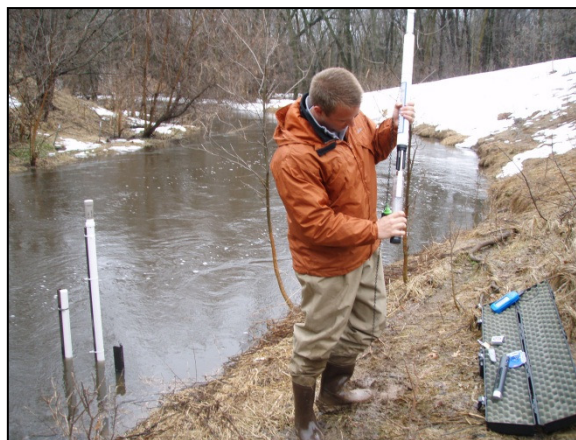
Staff deploying the Hydrolab MS5. In the background are the Hydrolab casing (shorter) and an RDS continuous water level monitoring device.

Water levels were continuously monitored throughout the open water season. An RDS Ecotone WM-40 water level monitoring device recorded water levels every two hours. This stream stage Data are presented with the water quality data. It would be preferable to present flow, but the existing rating curve is only valid to stage

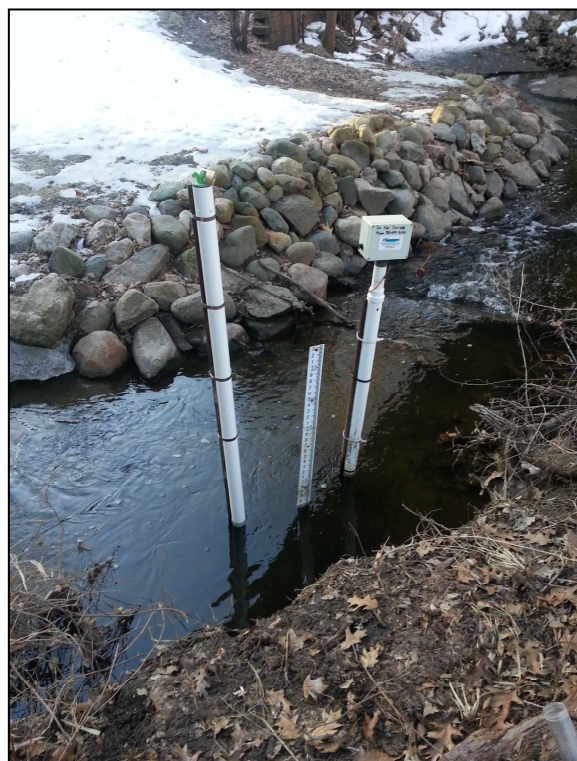
YSI EXO water quality sonde casing (taller) and an RDS continuous water level monitoring device in nearby Pleasure Creek. A staff gauge is shown in the middle.

The site was monitored immediately before, during, and after four storms with a YSI EXO data sonde. The sonde was suspended inside a PVC pipe with a locked lid. The PVC pipe was secured to a metal fence post. The sonde sensors protruded from the bottom of the pipe approximately 6-12 inches from the stream bottom, ensuring they would stay submerged even if flow was low. The sonde was programmed to take readings every 30 minutes. Readings included pH, salinity, specific conductance, temperature, dissolved oxygen, and turbidity. The sonde was calibrated before each deployment.

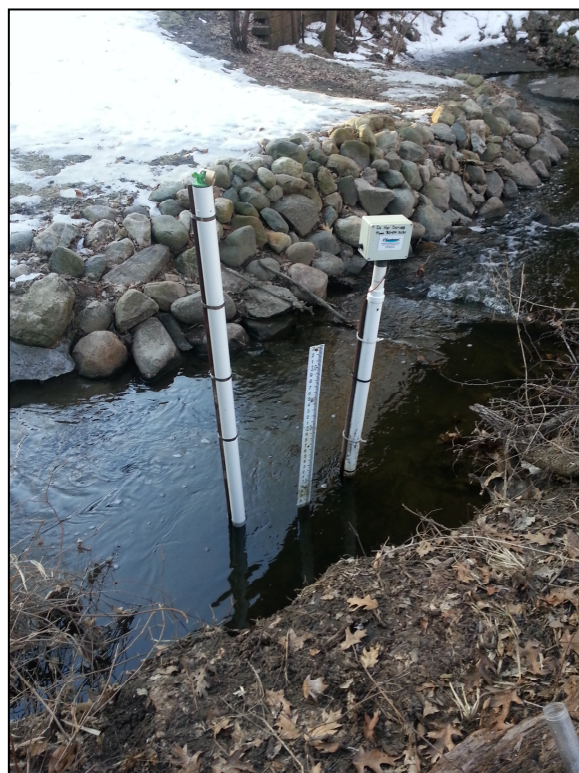
YSI EXO water quality sonde casing (taller) and an RDS continuous water level monitoring device in nearby Pleasure Creek. A staff gauge is shown in the middle.

The site was monitored immediately before, during, and after four storms with a YSI EXO data sonde. The sonde was suspended inside a PVC pipe with a locked lid. The PVC pipe was secured to a metal fence post. The sonde sensors protruded from the bottom of the pipe approximately 6-12 inches from the stream bottom, ensuring they would stay submerged even if flow was low. The sonde was programmed to take readings every 30 minutes. Readings included pH, salinity, specific conductance, temperature, dissolved oxygen, and turbidity. The sonde was calibrated before each deployment
