Excerpt from the 2021 Water Almanac

Chapter 3: Upper Rum River Watershed

Prepared by the Anoka Conservation District

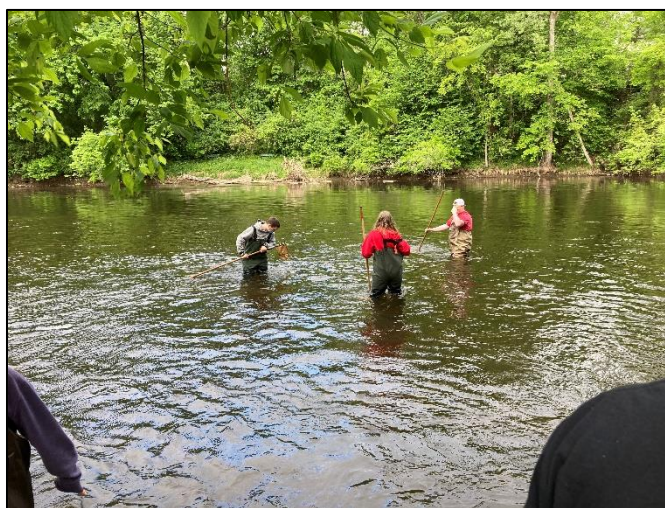
Summarized Biomonitoring Results for Rum River North County Park, St. Francis
(samplings by St. Francis High School and Crossroads Schools in 2002-2003 are averaged)

St. Francis High School classes monitored the Rum River in the spring of 2021, with ACD oversight and funding from the St. Francis American Legion. During 2021 fieldwork, general biology classes performed a rapid bio-assessment of the river, where they looked at types of organisms captured and determined a score based on general pollution sensitivity. The college biology class collected macroinvertebrate samples to identify in the lab. Many of the student groups captured numerous EPT taxa, which are indicators of good water quality.

In 2021, monitoring conditions were ideal for high school students, with lower, slower flows and good weather. Multiple years should cumulatively be considered when interpreting biomonitoring data. Water levels, weather, site conditions and differences in class sizes and student capabilities can all contribute to different results in any one year. Based on the multi-year dataset it appears that Rum River ecological health at this site is good.

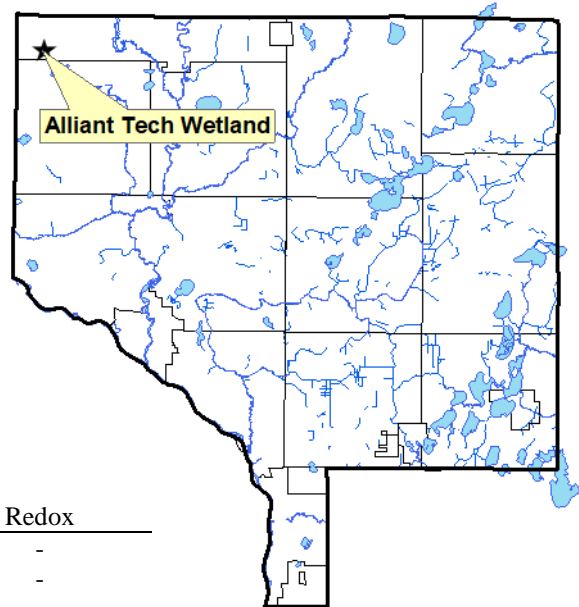
Surrounding Soils: Emmert

Horizon	Depth	Color	Texture	Redox
A	0-8	N2/0	Murky loam	-
Bg	8-35	5y5/1	Sandy Loam	-

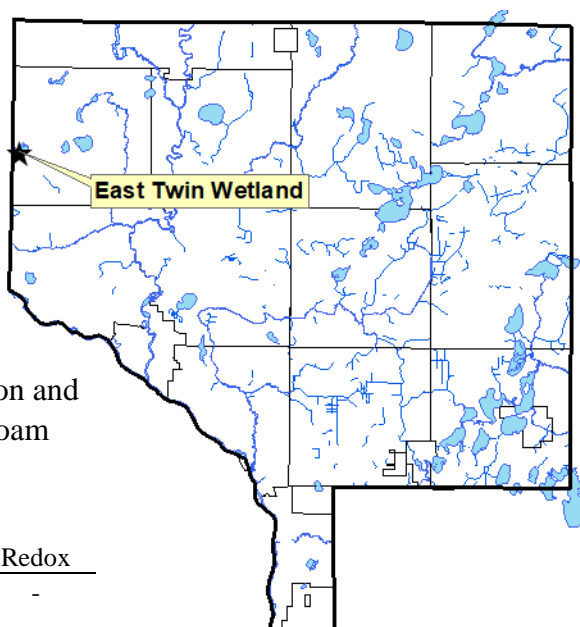
Monitored Since: 2001
Wetland Type: 5
Wetland Size: ~5.9 acres
Isolated Basin: Yes
Connected to a Ditch: No
Surrounding Soils: Lake Beach, Growton and Heyder fine sandy loam

Horizon	Depth	Color	Texture	Redox
A	0-8	10yr 2/1	Mucky Loam	-
Oa	Aug-40	N2/0	Organic	-

Other Notes: This wetland is located within Twin Lakes City Park, and is only 180 feet from East Twin Lake. The lake levels influence water levels in the wetland, and since Anoka County was in a state of drought beginning in June 2021, with most of the growing season spent in a severe drought condition, the well was dry for most of the year. Dry wells can cause slight miscalculations in equipment readings.

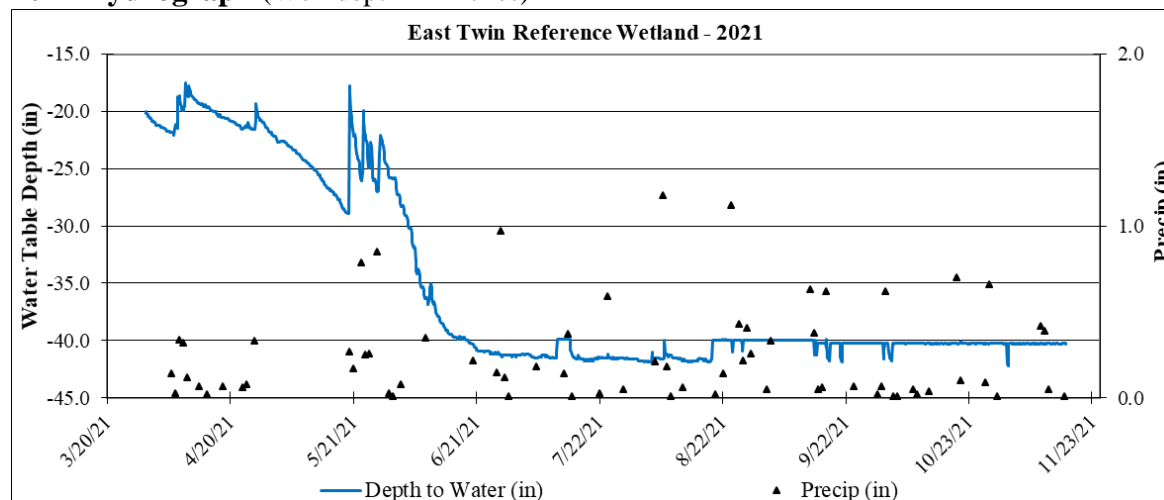
2021 Hydrograph (Well depth 41 inches)

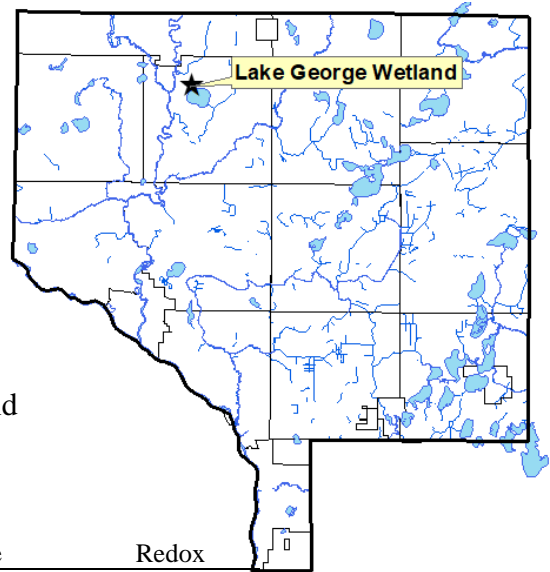
Surrounding Soils: Lino loamy fine sand and Zimmerman fine sand

Horizon	Depth	Color	Texture	Redox
A	0-8	10yr2/1	Sandy Loam	-
Bg	8-24	2.5y5/2	Sandy Loam	20% 10yr5/6
2Bg	24-35	10gy 6/1	Silty Clay Loam	10% 10yr 5/6

Other Notes: This wetland is located within Lake George County Park, and is only about 600 feet from the lake itself. Much of the vegetation within the wetland is cattails. Anoka County was in a state of drought beginning in June 2021, with most of the growing season spent in a severe drought condition. This well was dry for most of the year.

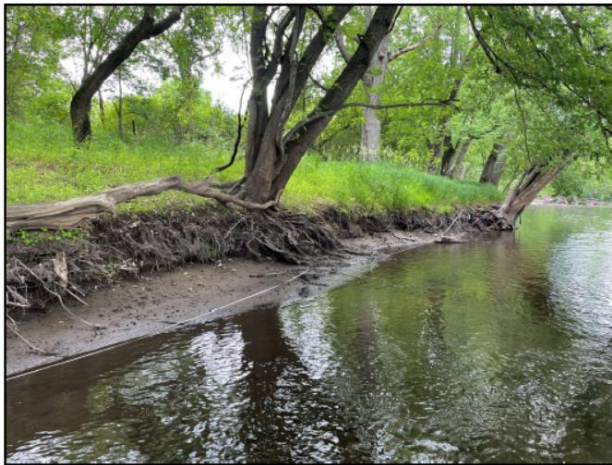
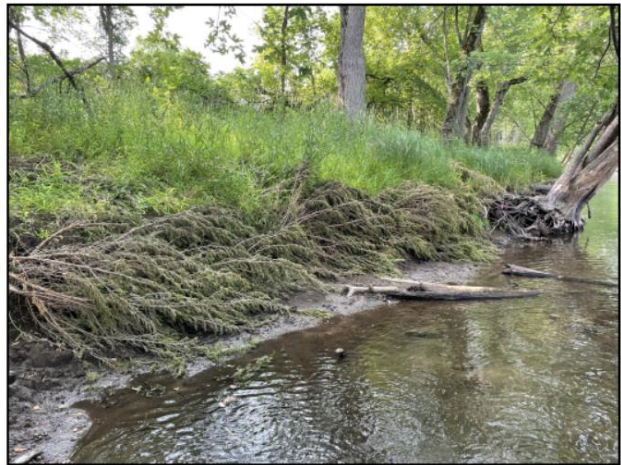
- 3,845 linear feet of cedar tree revetments installed at minor erosion sites. An additional 1,282 are planned for 2022.

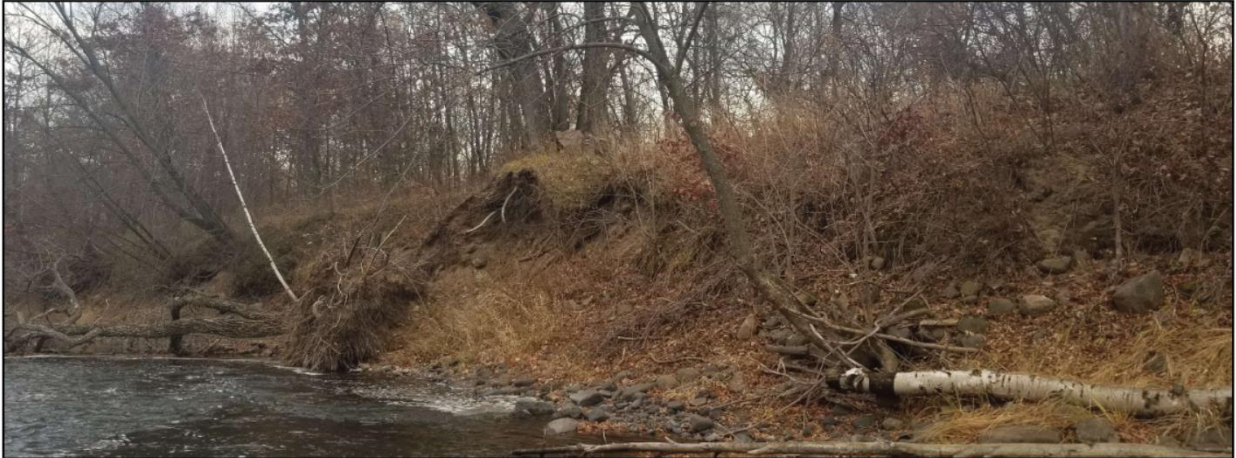
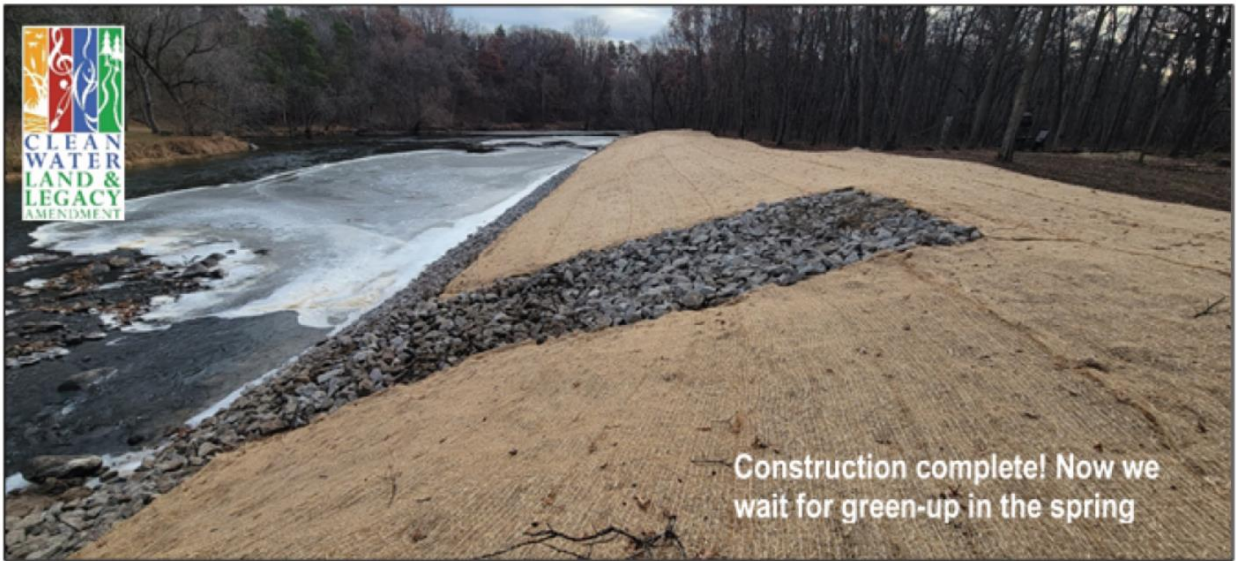
- 400 linear feet of regrading and rock rip rap at a site just south of the Viking Blvd Bridge.

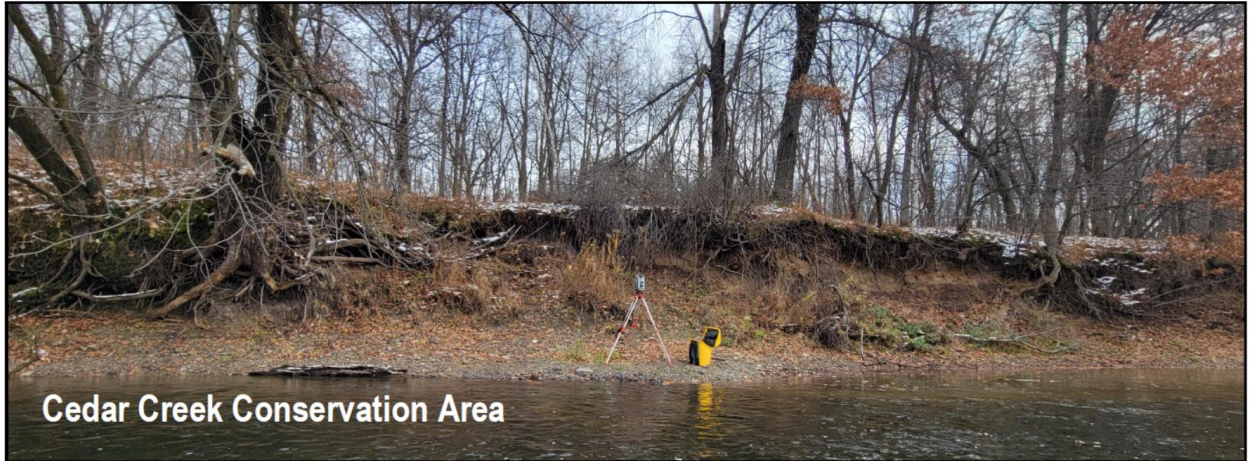
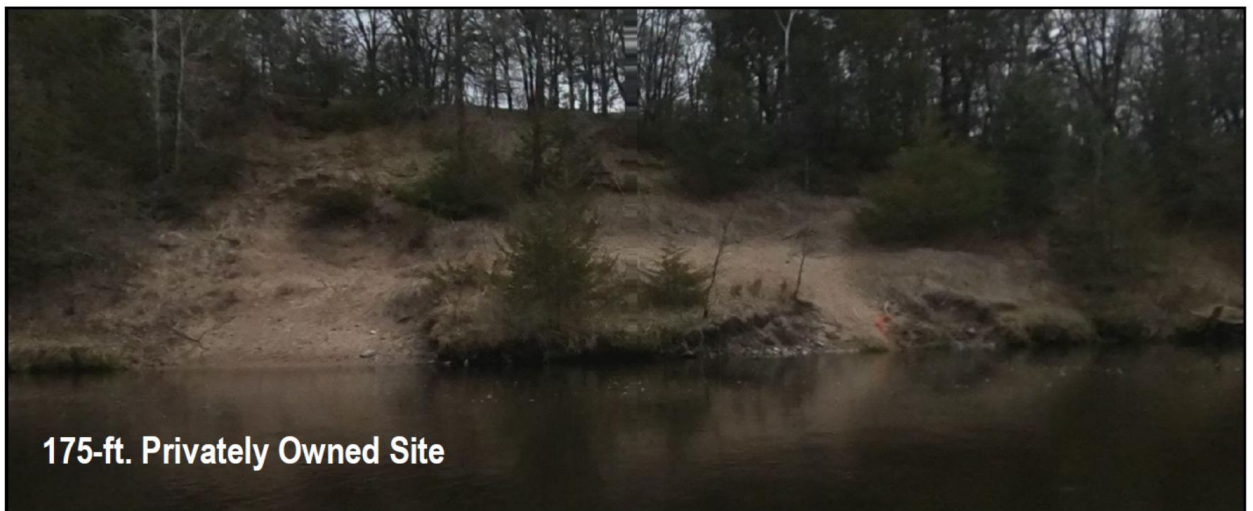
Map of identified Rum Riverbank sites

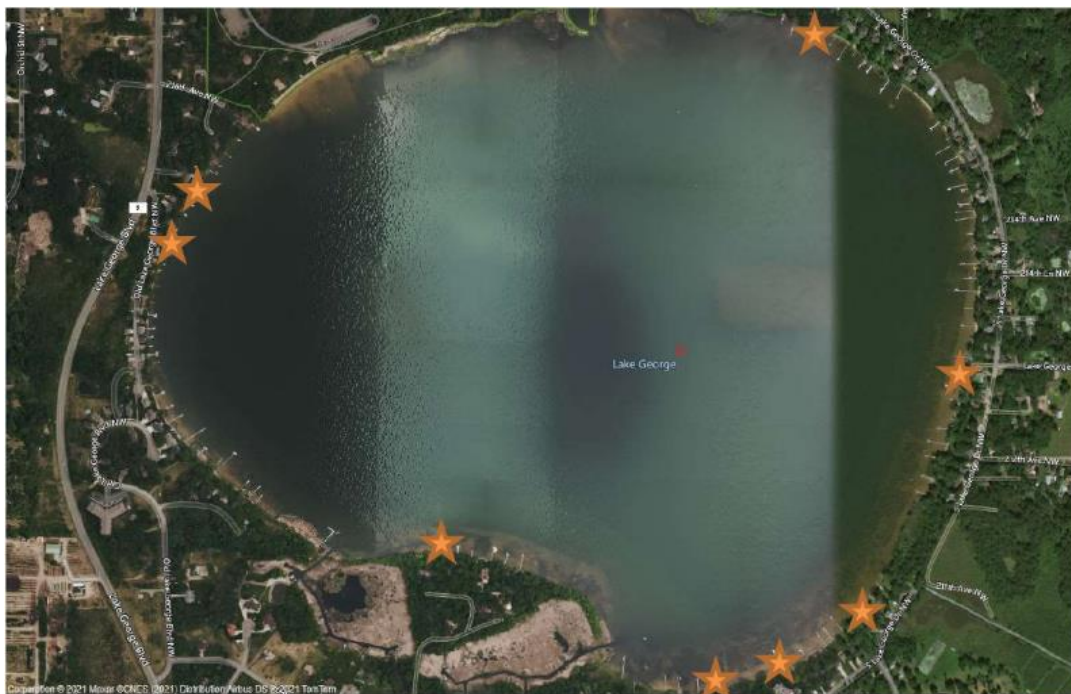
Project sites

In 2022, designs and installations of seven sites will be completed.
