Excerpt from the 2021 Water Almanac

Chapter 6: Coon Creek Watershed

Prepared by the Anoka Conservation District

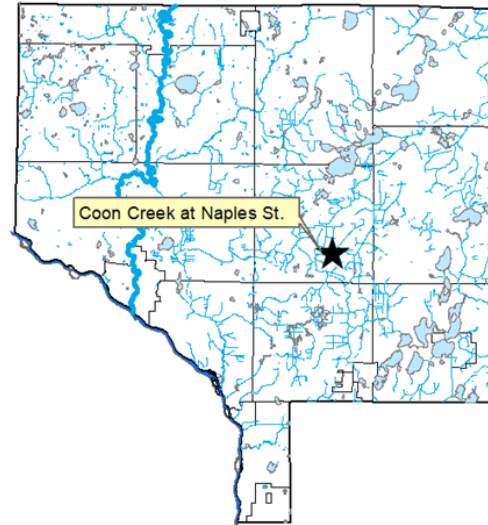
A rating curve was first established for this site in 2013 and was redeveloped in 2020.

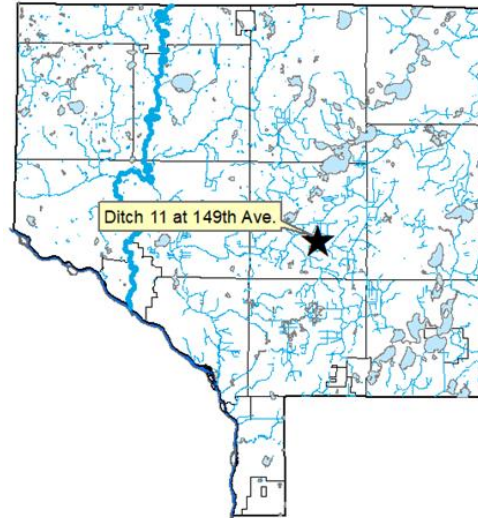
A rating curve was established for this site in 2020 and is displayed below. Additional flow measurements were collected during each water quality monitoring visit.

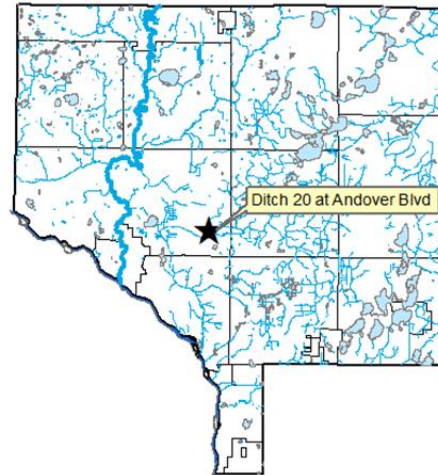
A rating curve was developed for this site in 2020 and is displayed below. In 2021, additional flow measurements were collected during each water quality monitoring visit.

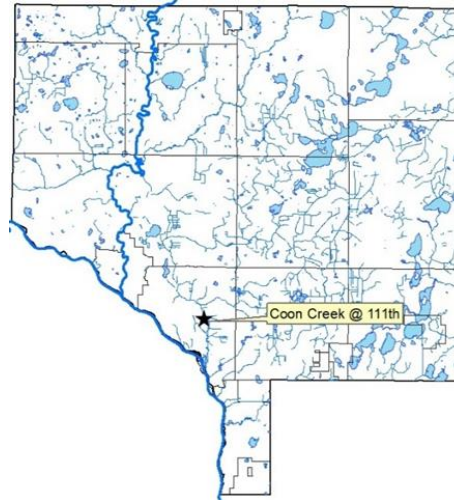
In 2021, flow measurements were taken during each water quality monitoring visit. A rating curve was developed for this site in 2018 and is displayed below.

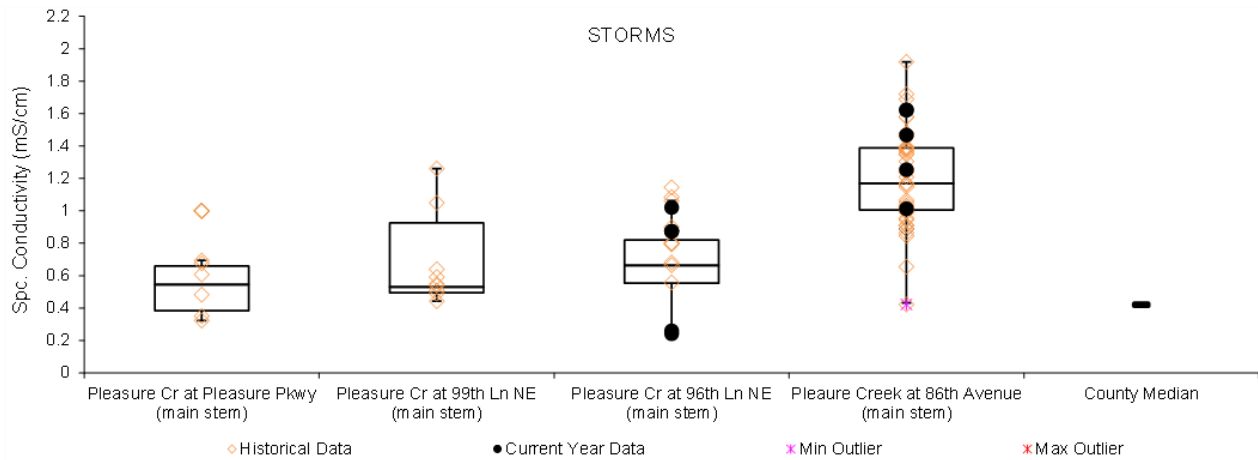
Specific conductance at Pleasure Creek. Orange diamonds are historical data from previous years and black circles are 2021 readings. Box plots show the median (middle line), 25th and 75th percentile (ends of box), and 10th and 90th percentiles (floating outer lines) for all data collected at these sites.

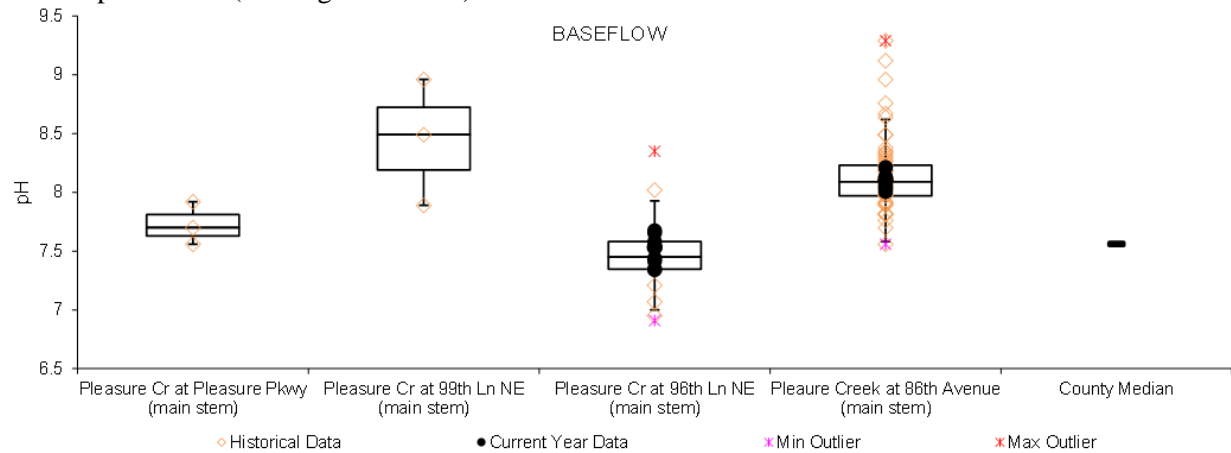
pH at Pleasure Creek. Orange diamonds are historical data from previous years and black circles are 2021 readings. Box plots show the median (middle line), 25th and 75th percentile (ends of box), and 10th and 90th percentiles (floating outer lines) for all data collected at these sites.

Pleasure Creek pH levels have generally remained within the state water quality standard range of 6.5-8.5, but median and average values are at the higher end of that range and higher than the long-term median for all Anoka County streams (7.56). Eight exceedances of the healthy range have occurred in all samples collected since 2007 at 86th Ave. Seven of these twelve exceedances occurred during baseflow conditions. This is not surprising given that rain is typically more acidic than water on the landscape and often reduces pH during storms.
