Excerpt from the 2022 Water Almanac

Chapter 5: Rice Creek Watershed

Prepared by the Anoka Conservation District

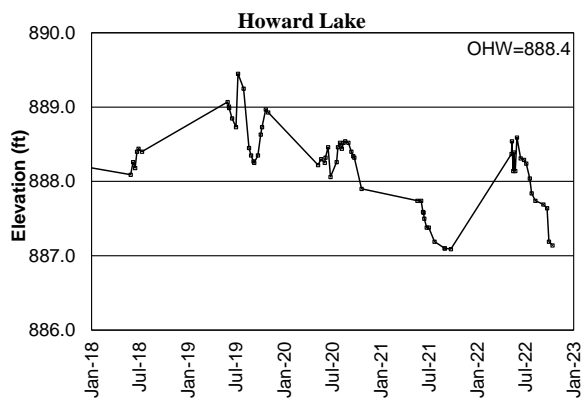
Howard Lake Levels – last 5 years

Results: In 2022, lake levels started near average and declined throughout the season. Anoka County experienced drought from June through the fall. Howard Lake reached its lowest level since 2015, Reshanau its lowest since 2013, and Moore Lake had its lowest water levels on record. Golden Lake water levels were the second lowest ever recorded, behind 1989. A long-time volunteer suffered a medical emergency and no readings were taken on Rondeau Lake in 2022. Outreach will be completed in the spring to find a replacement volunteer for 2023.

The Ordinary High Water Level (OHW) is listed for each lake on the corresponding graphs below. Any work performed below this elevation requires a DNR permit.

Lake	Year	Average	Min	Max
Howard	2018	888.30	888.09	888.44
	2019	888.77	888.25	889.45
	2020	888.34	887.90	888.54
	2021	887.40	887.09	887.74
	2022	888.02	887.14	888.59

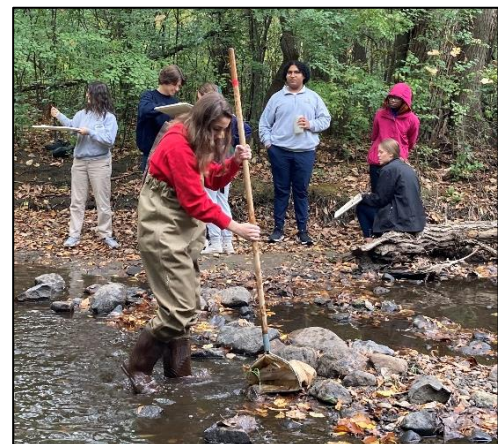
The poor macroinvertebrate community in Rice Creek is likely due to poor water quality and the flashy flows observed during storm events, not poor habitat conditions. Habitat at the sampling site and the surrounding area is good, in part because of habitat improvement projects implemented in the past. The creek has diverse characteristics, containing runs, riffles, and pools. The area immediately surrounding the stream is predominately a buckthorn forest, with paved walking trails. However, outside of this wooded corridor, the watershed is urbanized and storm water inputs are likely influencing the degraded water quality. During storms events, water levels in the creek can rise quickly. This portion of Rice Creek is impaired for both fish and invertebrate biota.
