Lake George Water Quality Improvement Assessment Phase 1: Lakeshed Analysis

LAKE GEORGE IMPROVEMENT DISTRICT (LGID) AND

December 2018

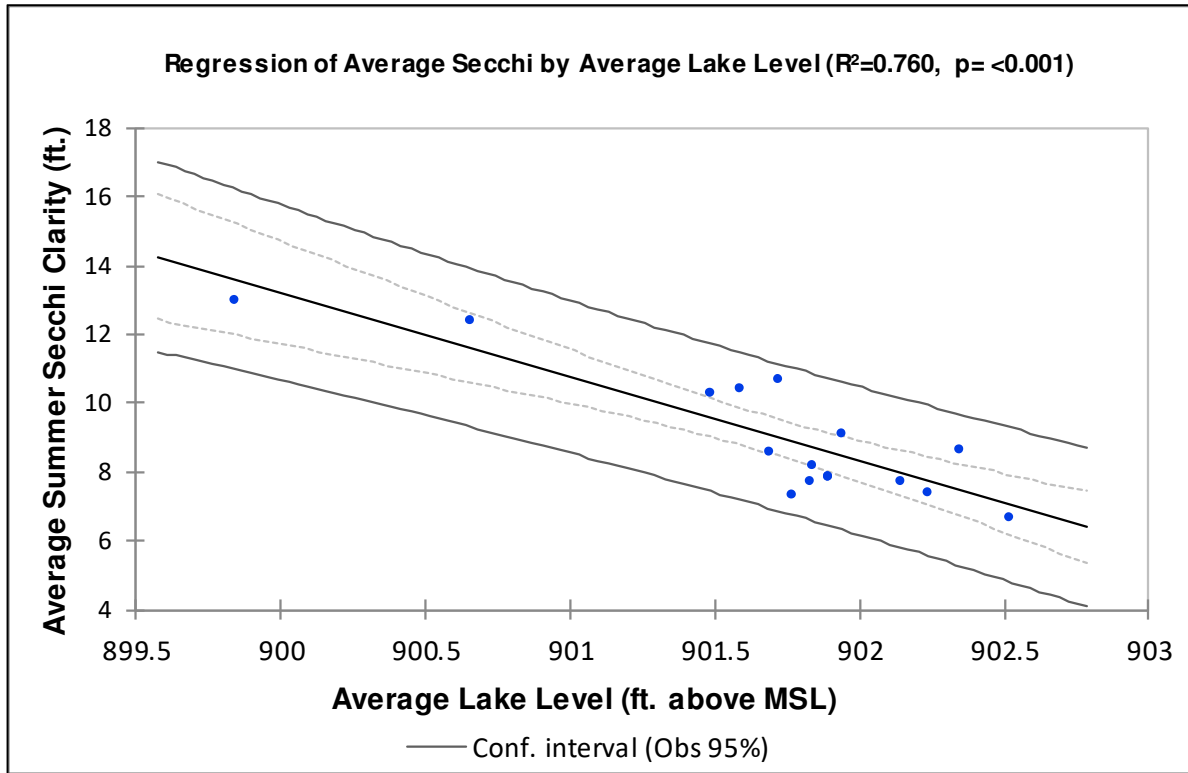
Figure 20 Regression of Average Summer Secchi vs. Average Lake Level, Lake George

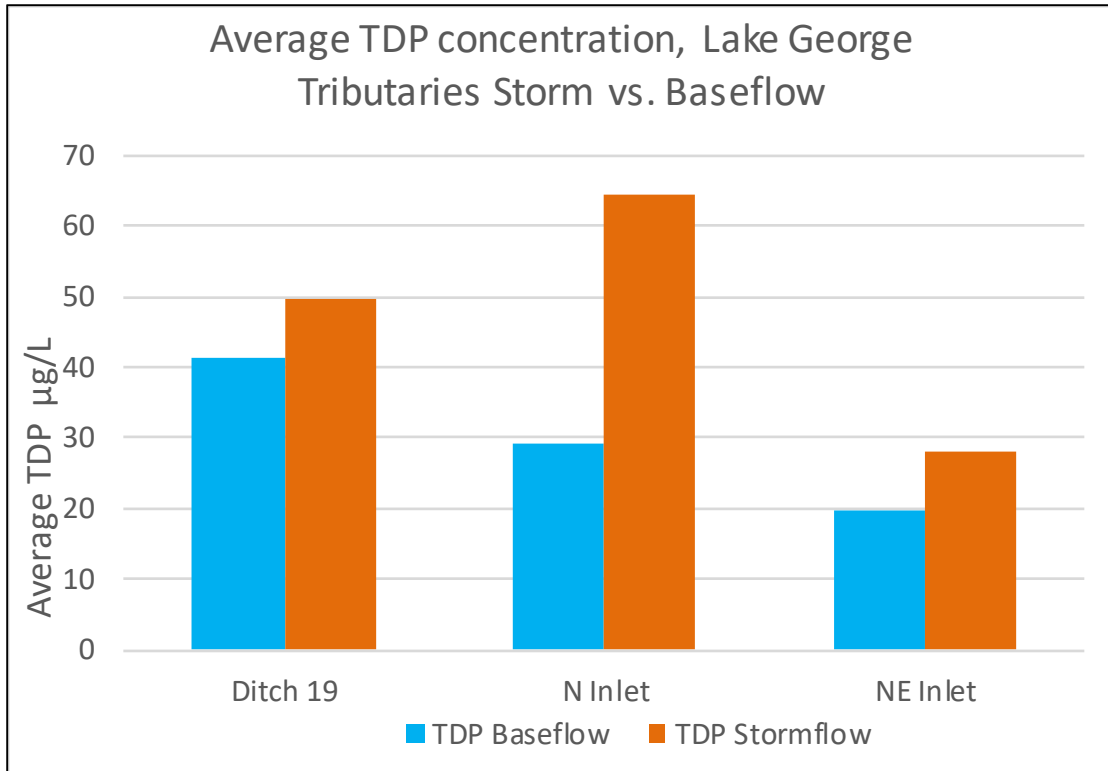
Figure 23 Lake George tributary TDP concentrations, baseflow vs. storm flow

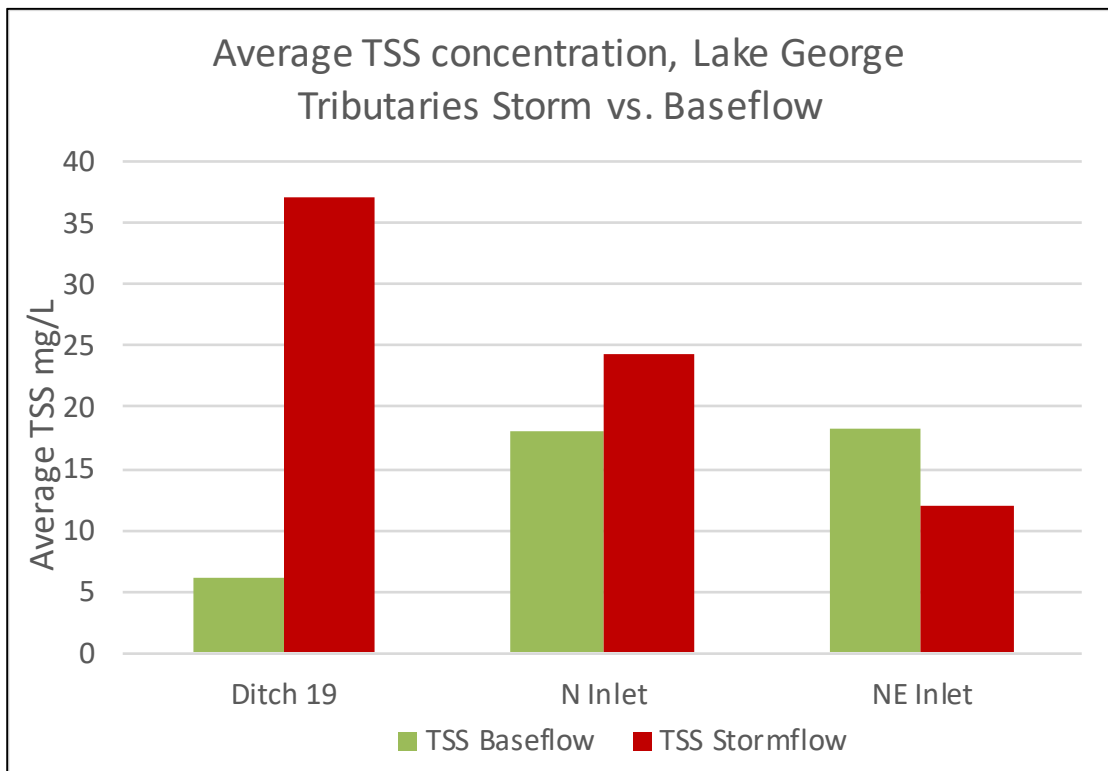
Figure 24 Lake George tributary TSS concentrations, baseflow vs. storm flow

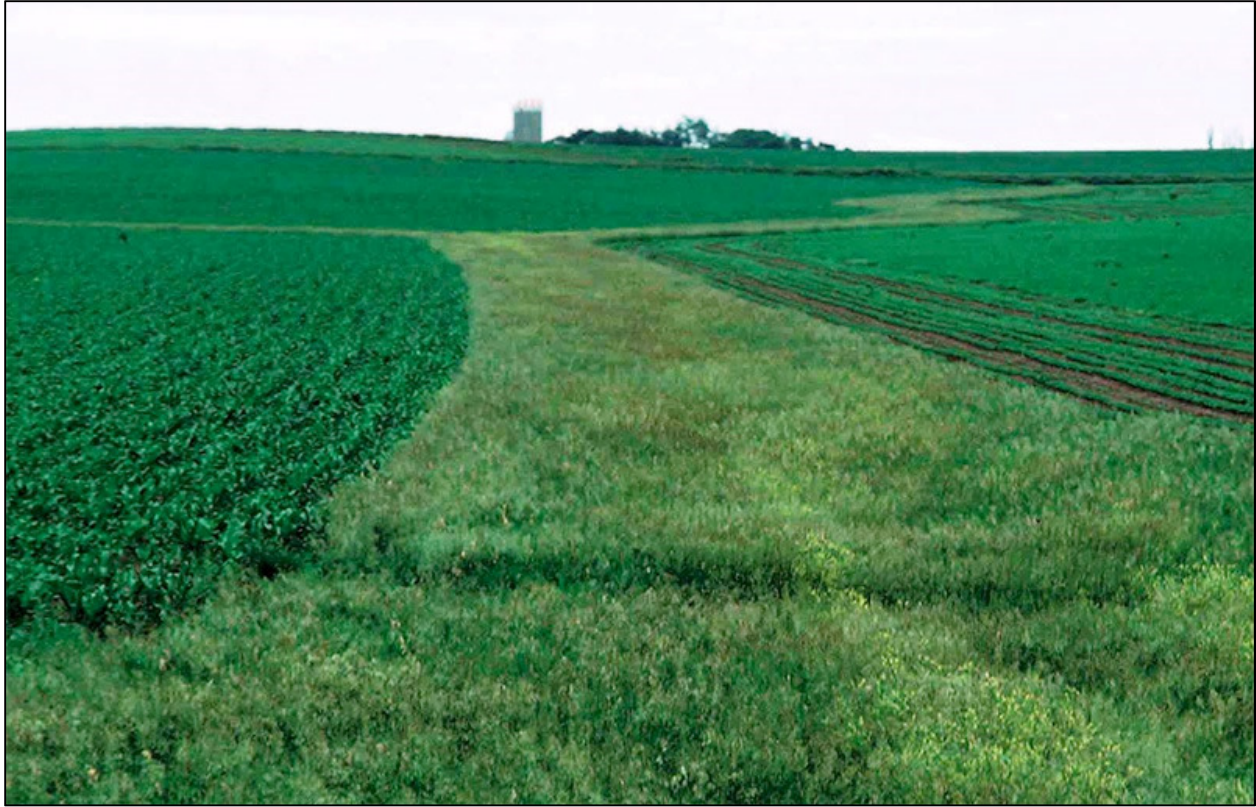
Figure 35 A grassed waterway installed by the Chisago SWCD, MN (Chisago SWCD n.d.)

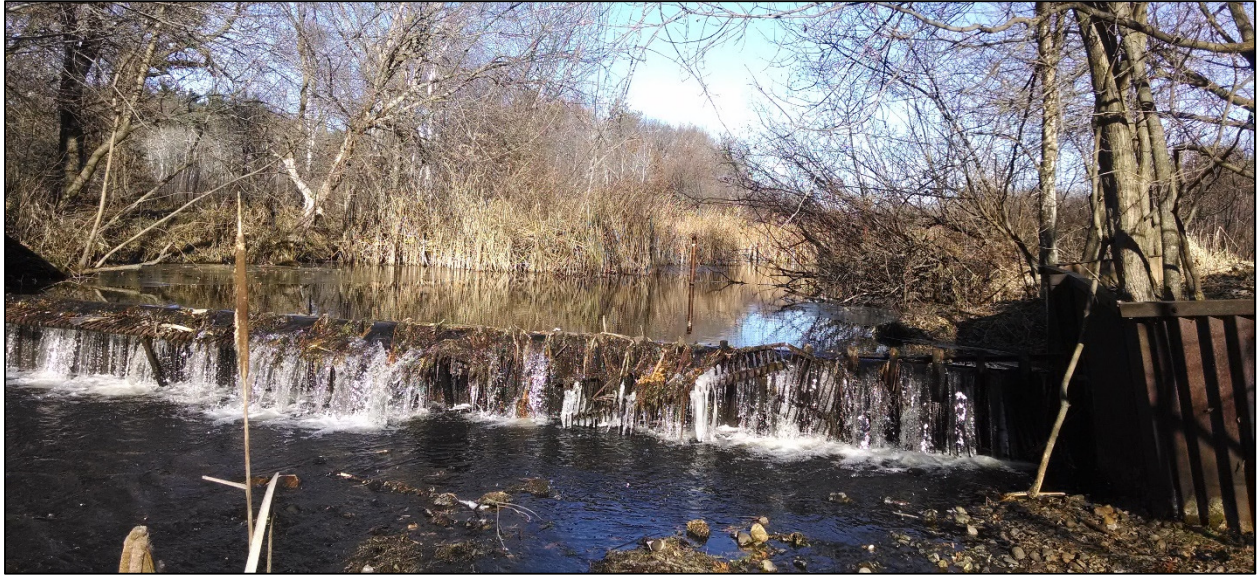
Figure 37 Deteriorating weir structure, November 2017

The effects of this weir reconstruction project go far beyond the pollutant removals analyzed for the other projects in this report, so cost benefit analysis does not paint a true picture of the project's effects. This weir reconstruction will likely have a noticeable impact on average lake level by restoring the original hydrology of the lake dating back to the early 1900's. The new weir structure will also facilitate fish passage to and from the lake from downstream, a function the current weir design prevents. This will likely have an impact on fish communities in Lake George by aiding the spawning of gamefish species.

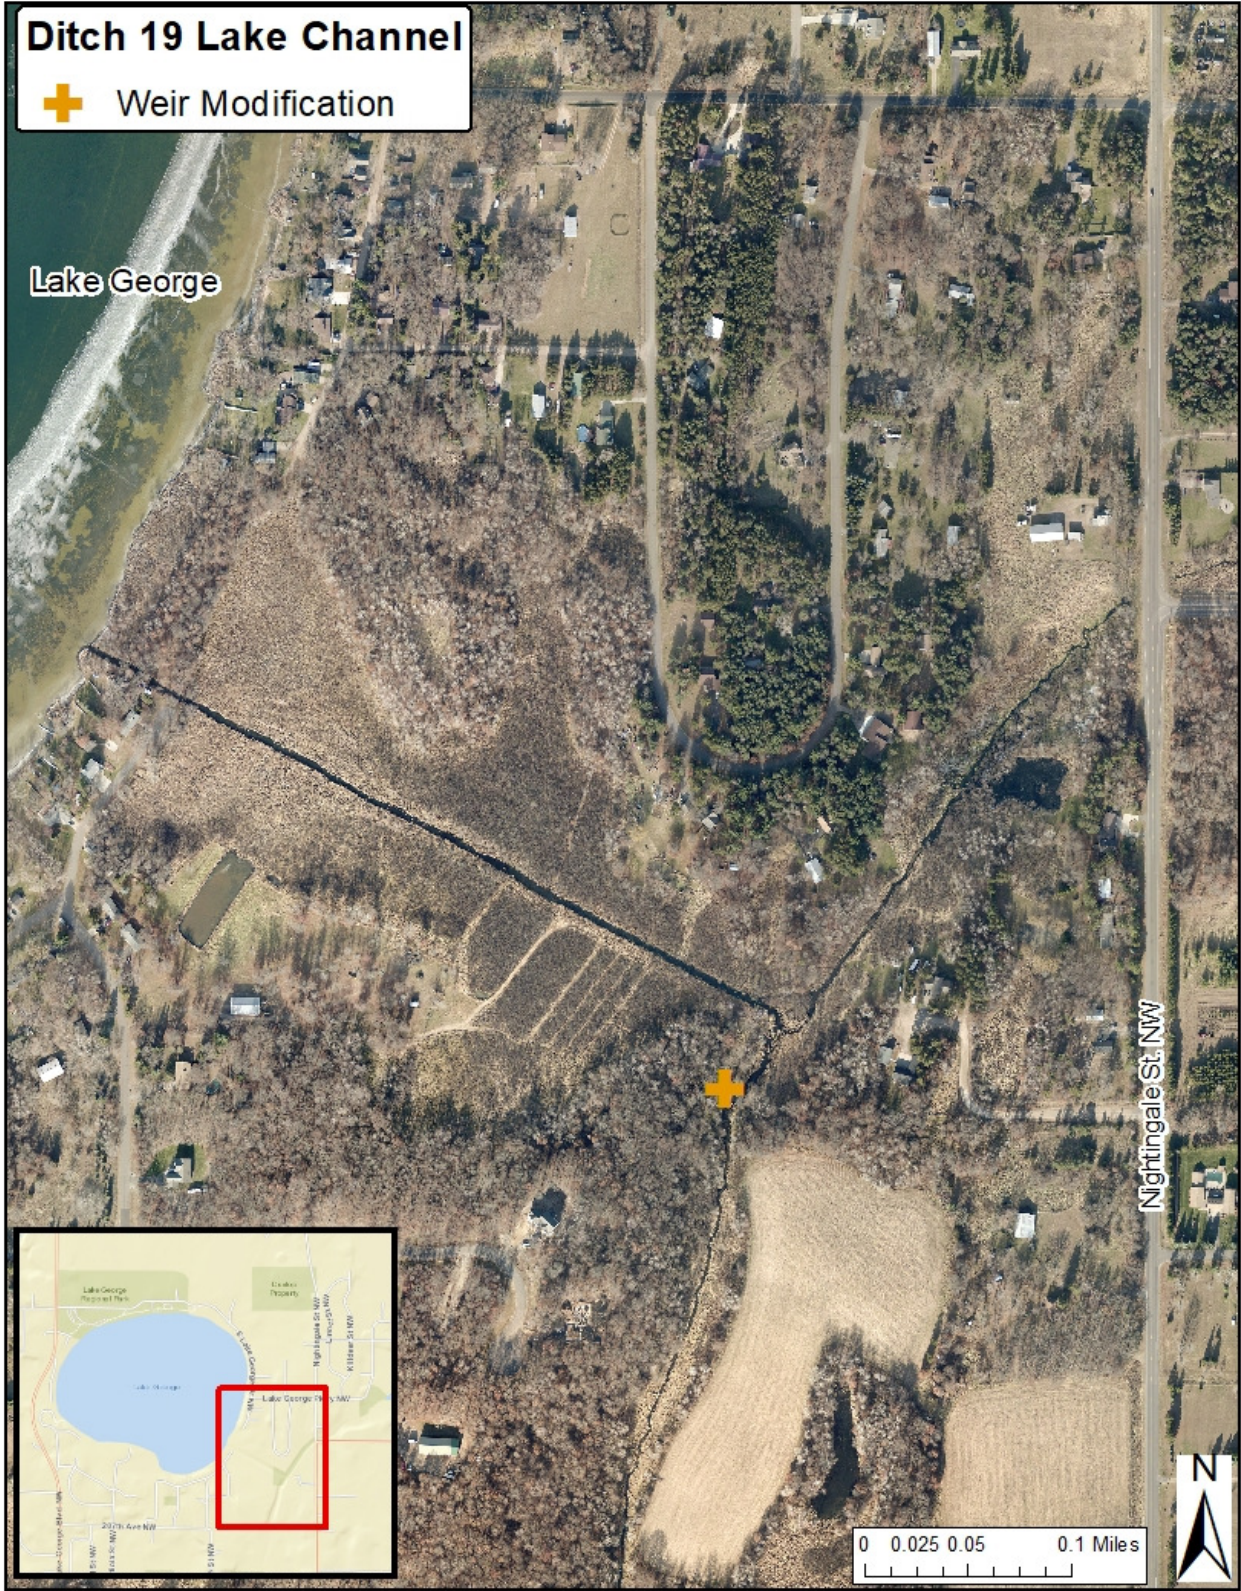
Figure 38 Map of the Ditch 19 weir structure location

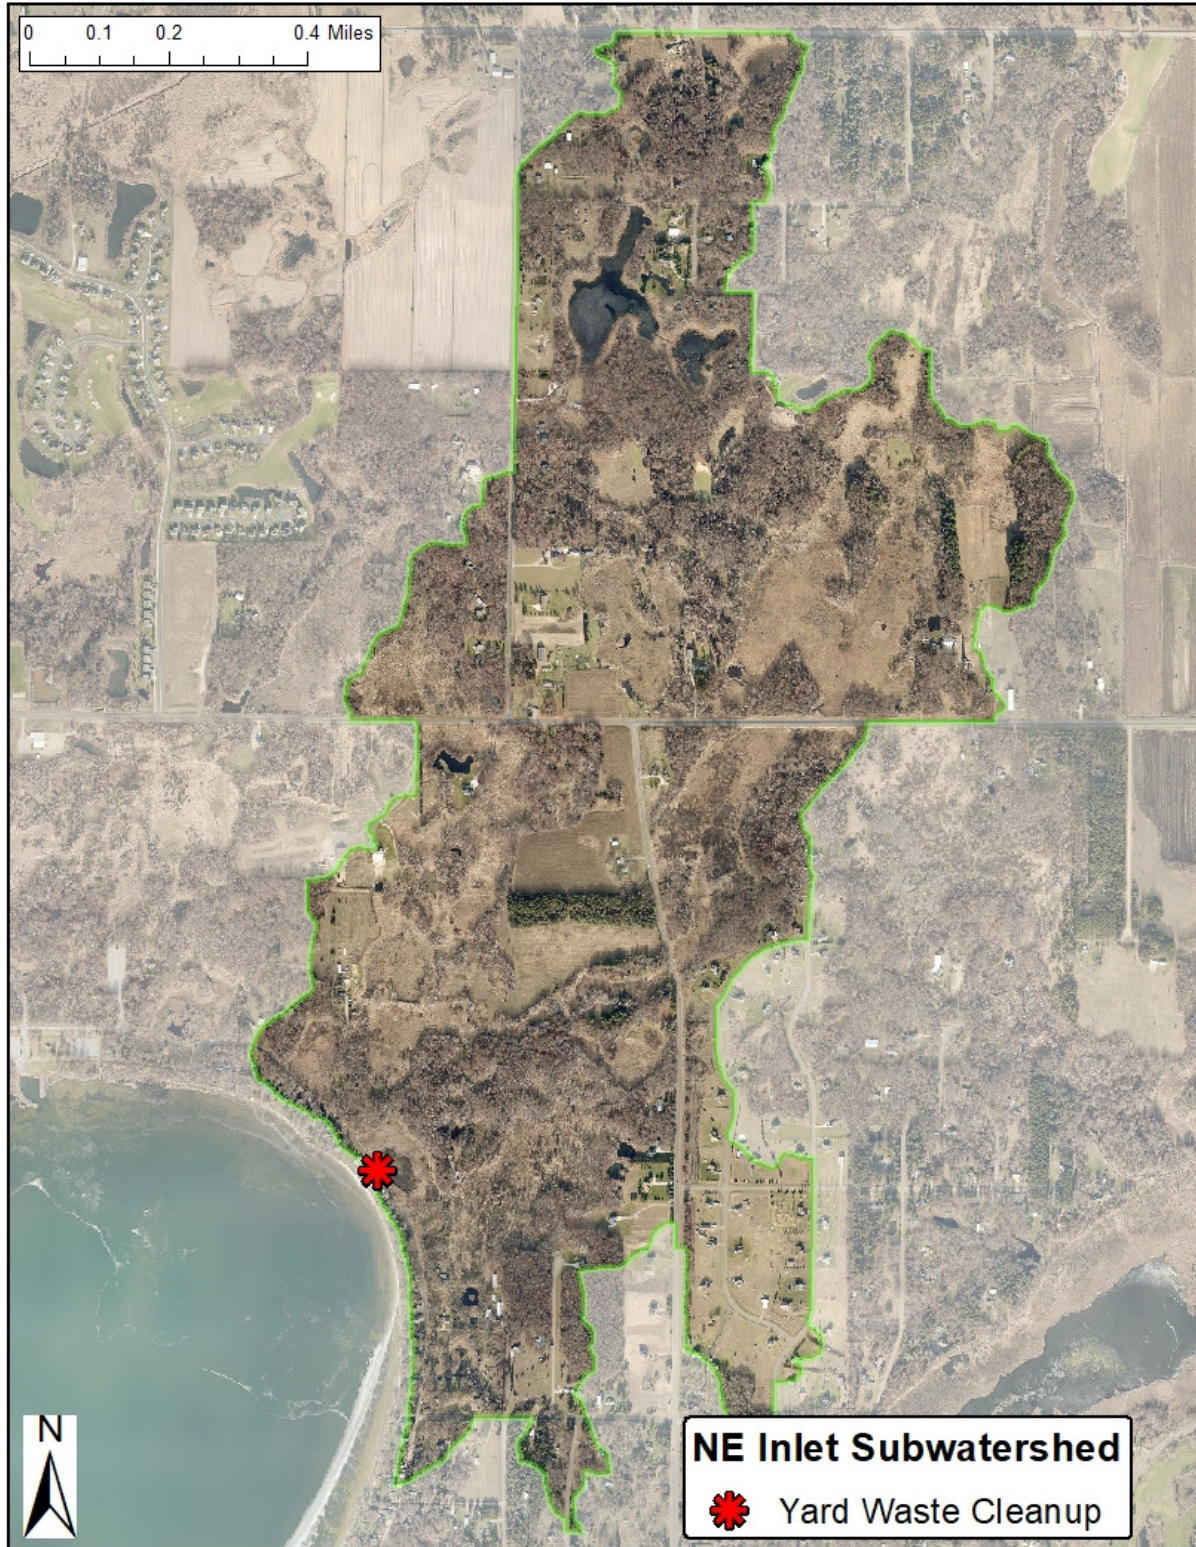
Figure 39 NE Inlet Subwatershed BMP Retrofit Recommendations

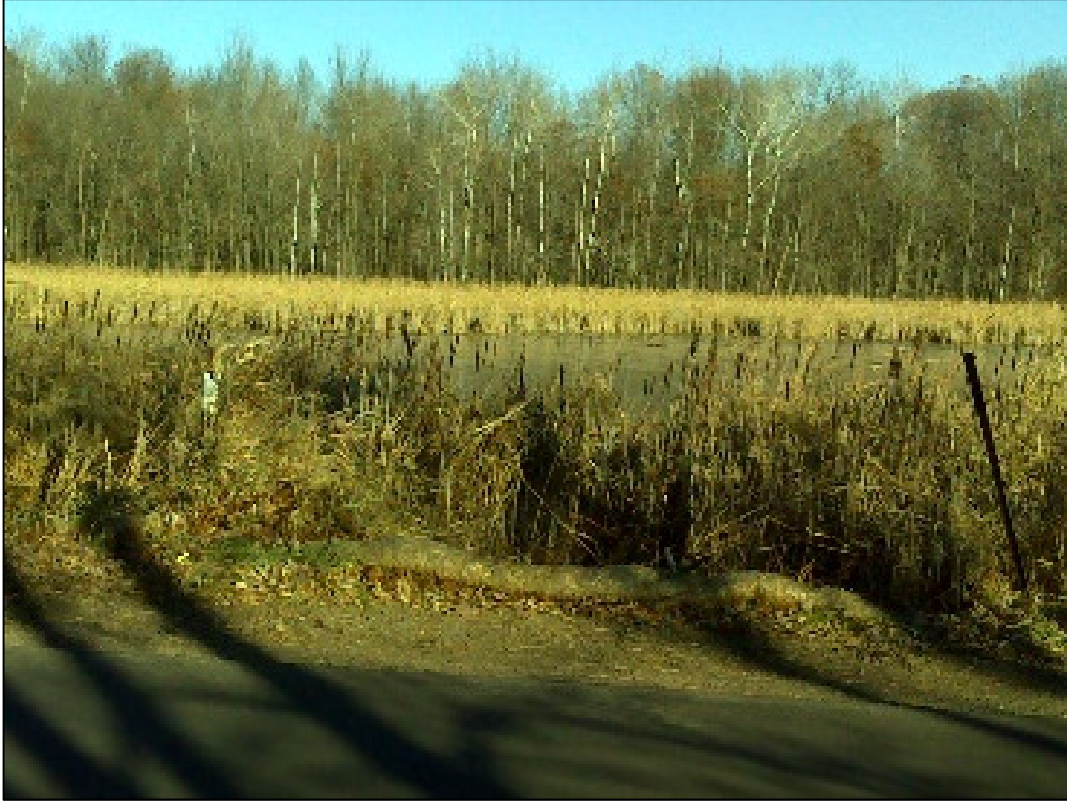
Figure 41 Wetland near outlet of NE lake inlet.

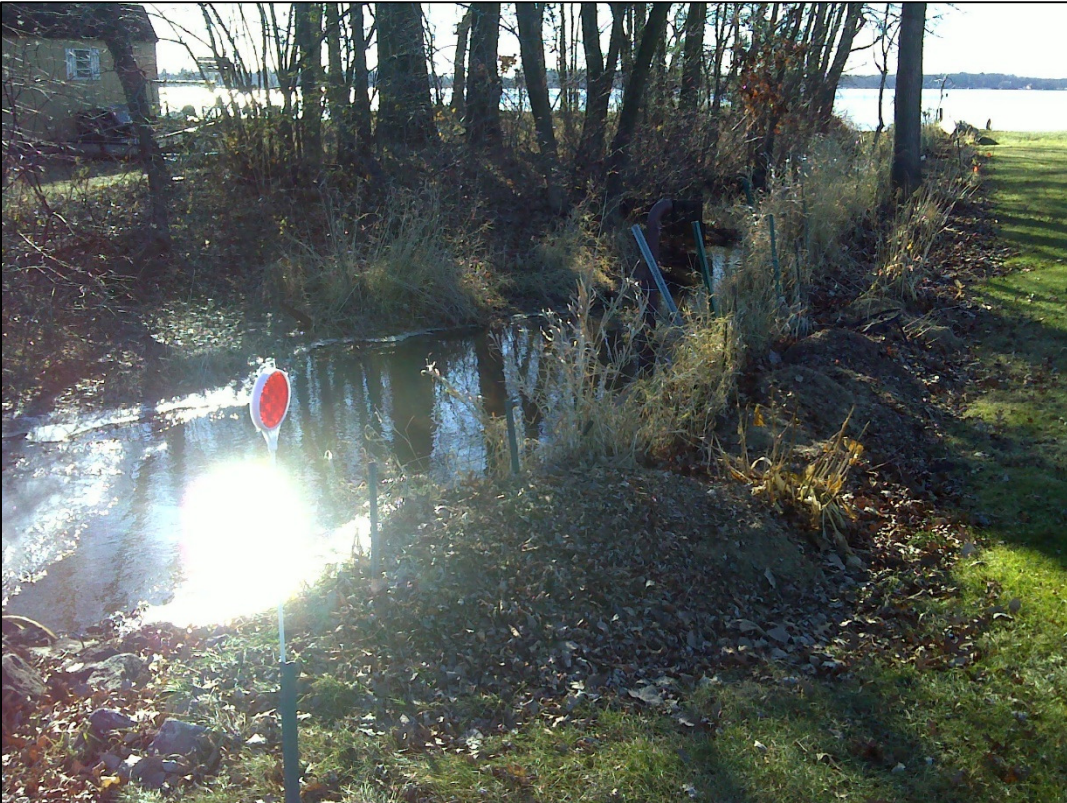
Figure 42 Debris piled along north side of NE inlet channel, 2017

A cost benefit analysis cannot be provided for this type of "good housekeeping" practice like for the installation of specific BMPs without further studying the types and amounts of debris contributed to this site annually. Additionally, costs associated with cleaning up the existing debris and changing habits would be up to the private landowner. However, advocating for this cleanup and behavioral change through mailings or signage could have important benefits for lake water quality at a relatively low cost.

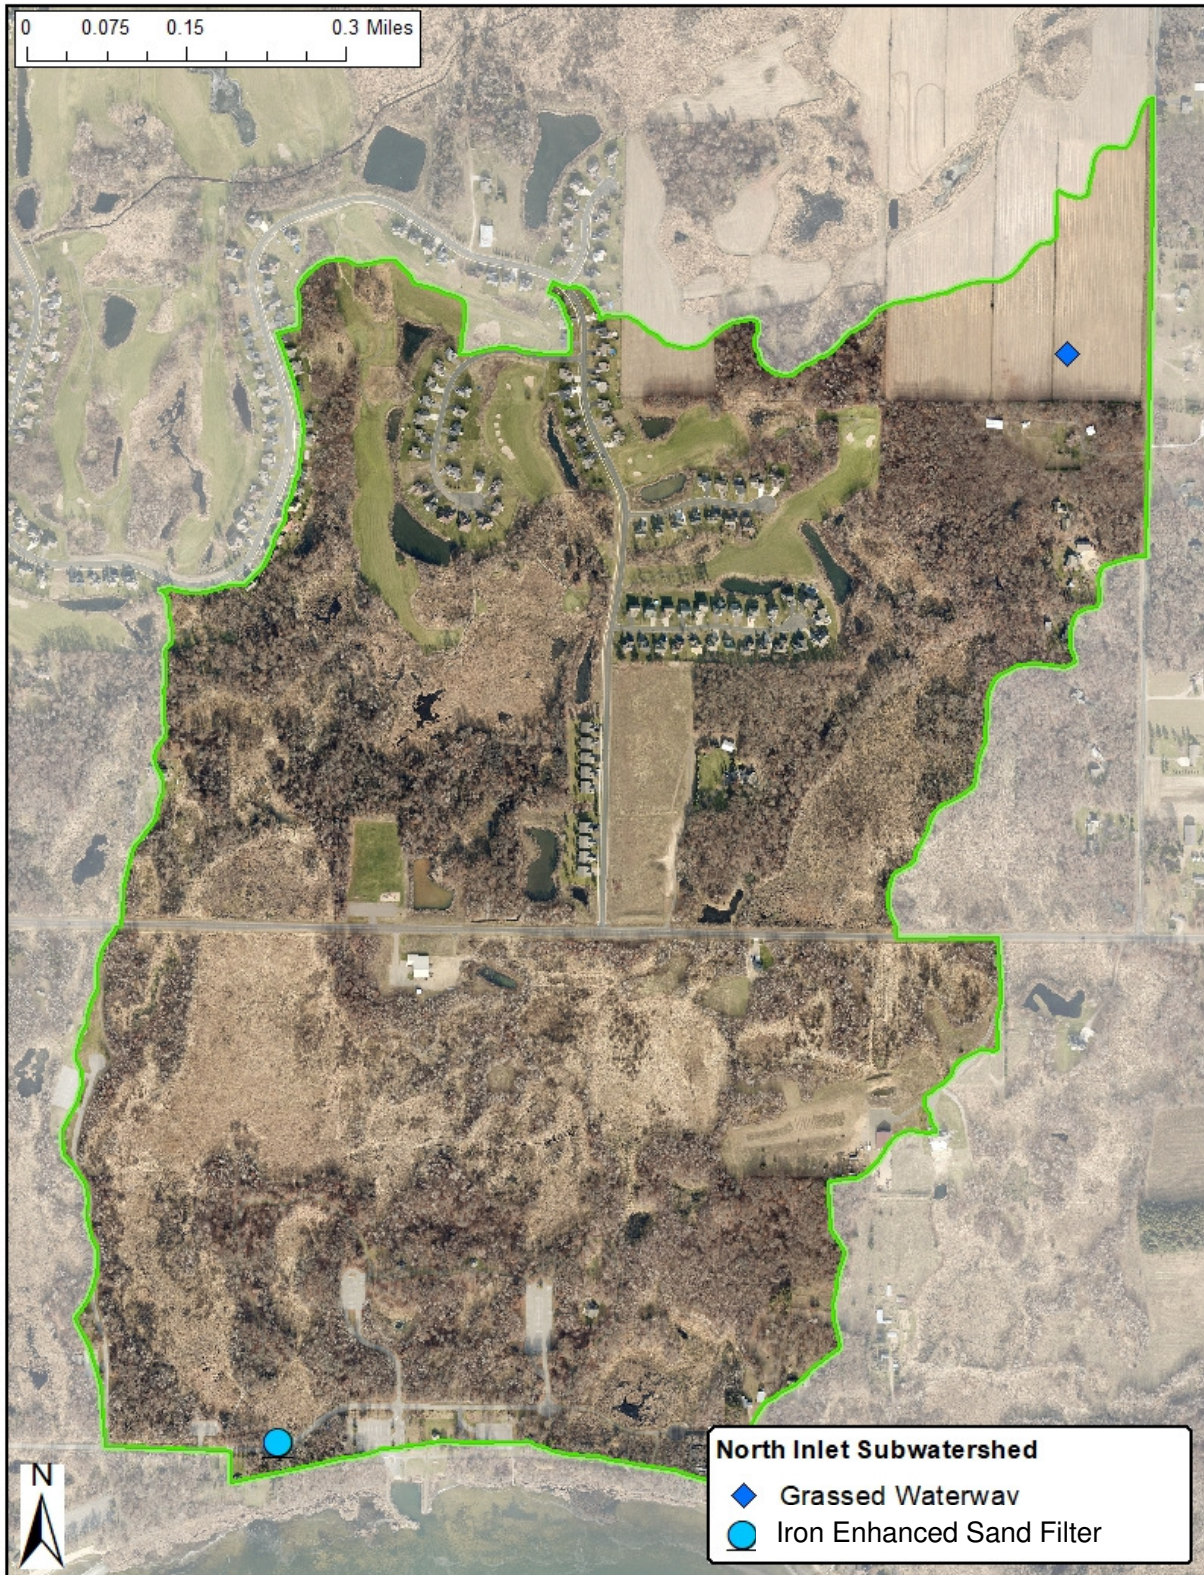
Figure 43 North Inlet Subwatershed BMP Retrofit Recommendations

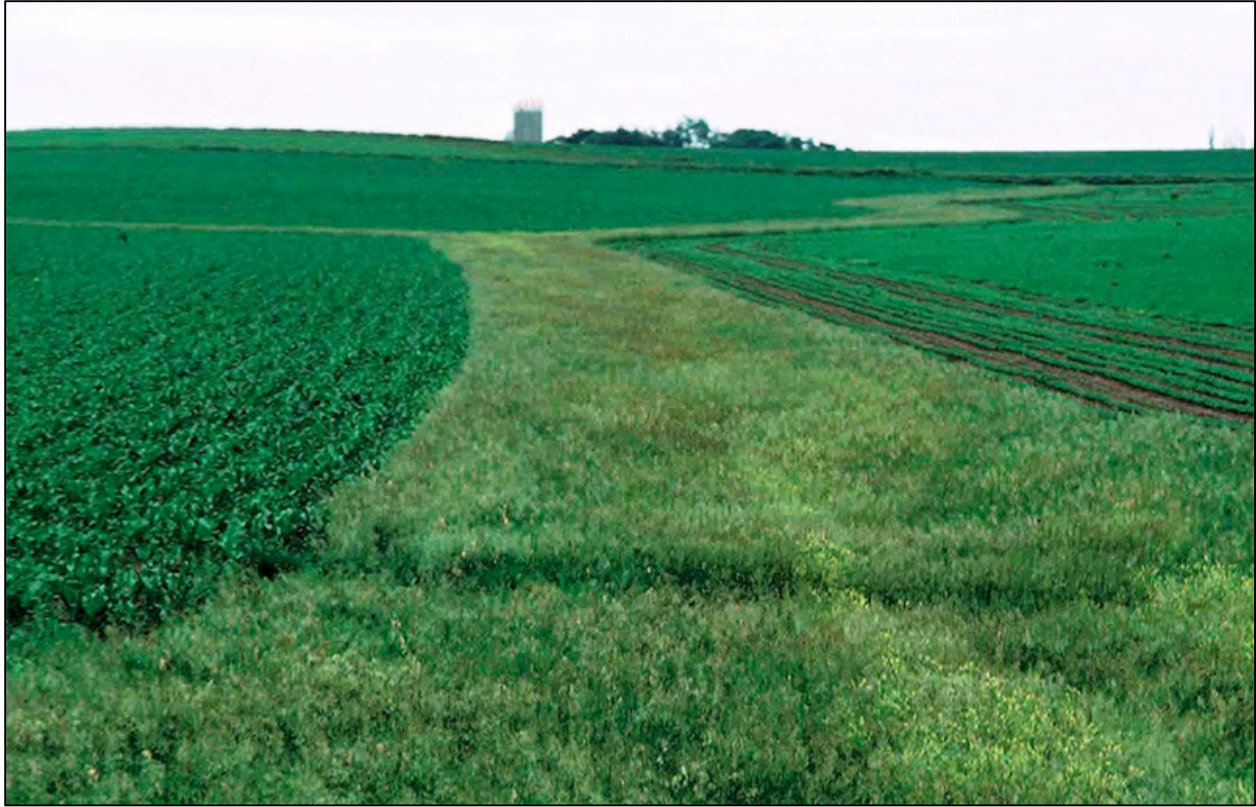
Figure 47 A grassed waterway installed by the Chisago SWCD, MN (Chisago SWCD n.d.)

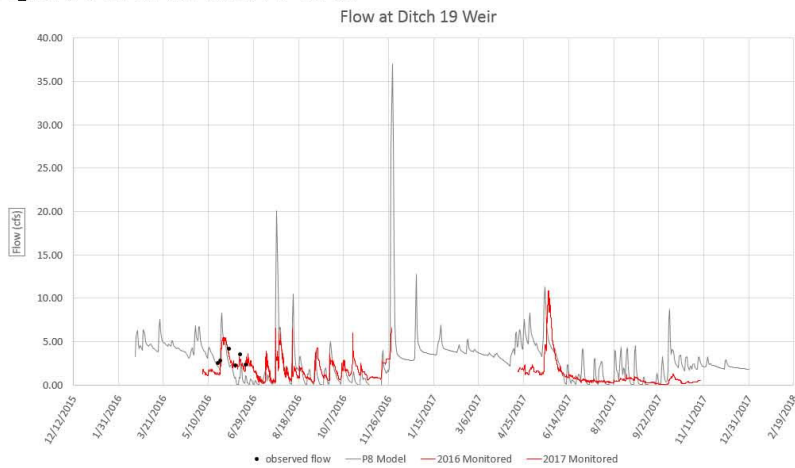
Figure 2. Flow at Ditch 19 Weir.

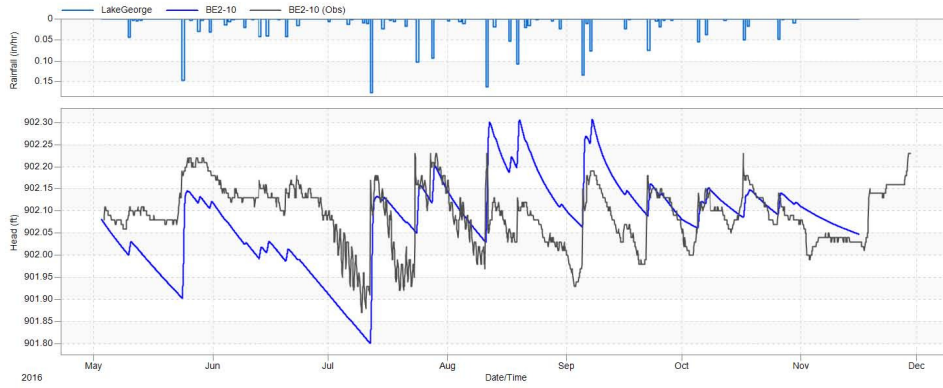
Figure 2. Lake George water surface elevation modeled versus monitored.
