# EARLY RESIDENCE

Rain Garden

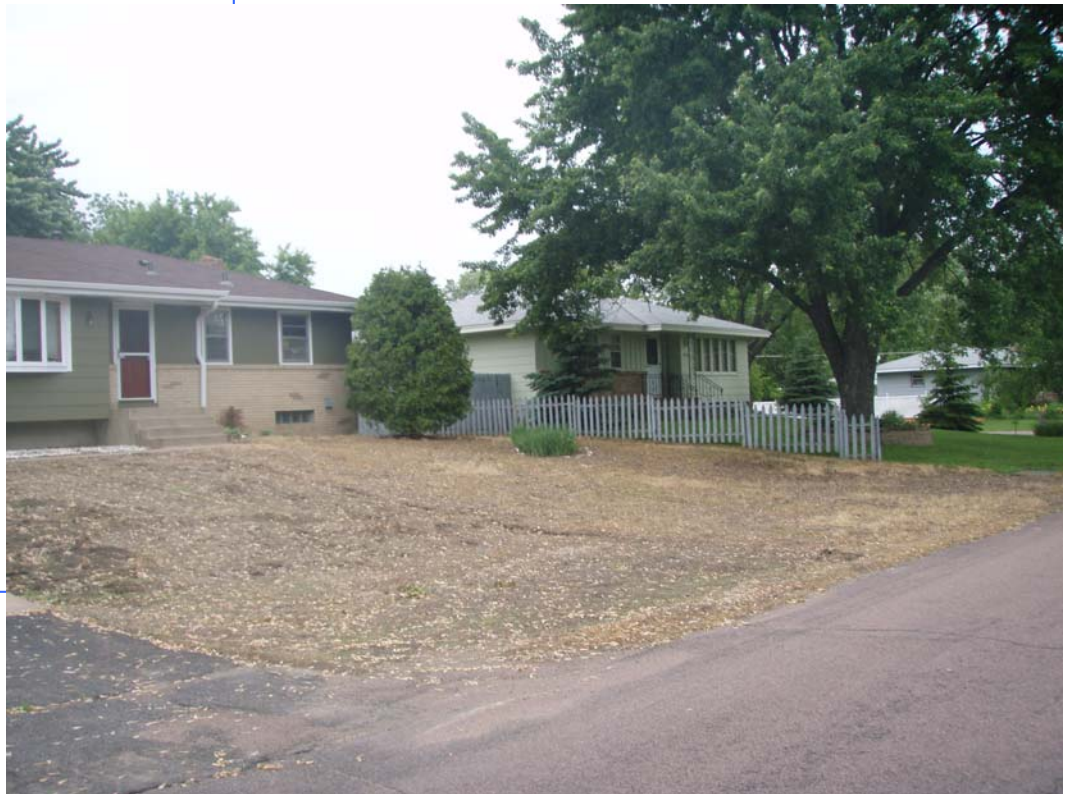
June 2008

Existing turf grass was destroyed with herbicide. After herbicide treatment, the soil was tilled under providing a base for native plantings and no mow grass seed mix.

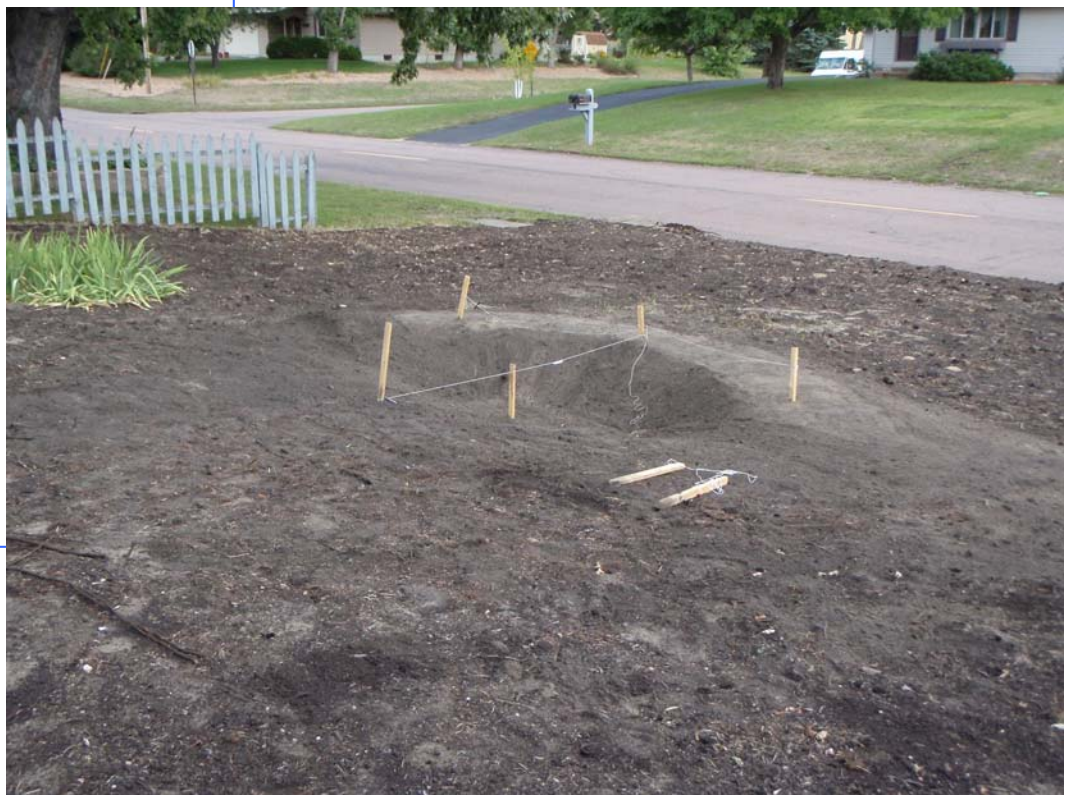
June 2008

A rain garden was constructed in the middle of the new native landscape area. The rain garden was oriented to capture storm water coming from the gutter downspout. The rain garden was sized to capture and treat storm water from a 1" rain event.

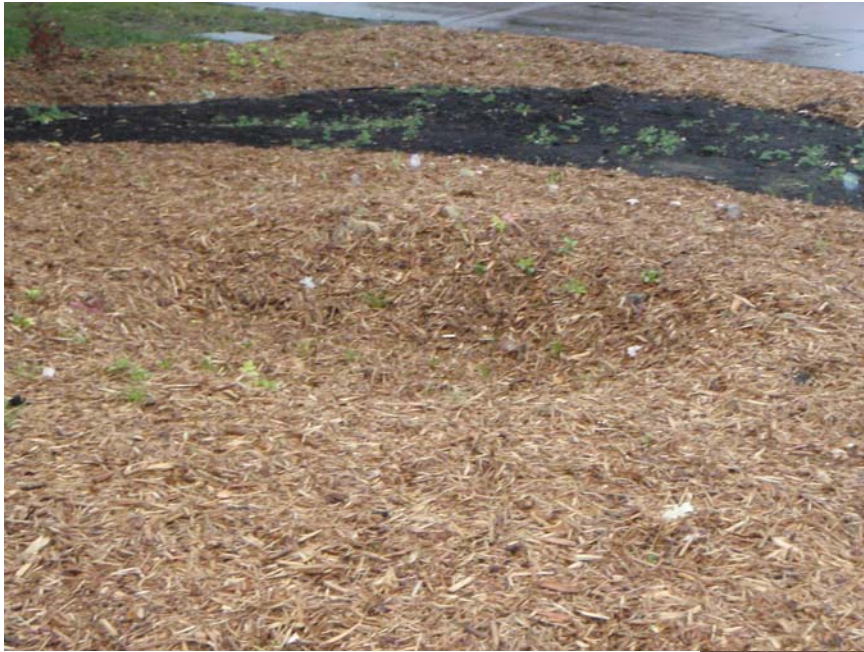
July 2008

The rain garden is mulched and planted with native plants to capture and treat storm water.

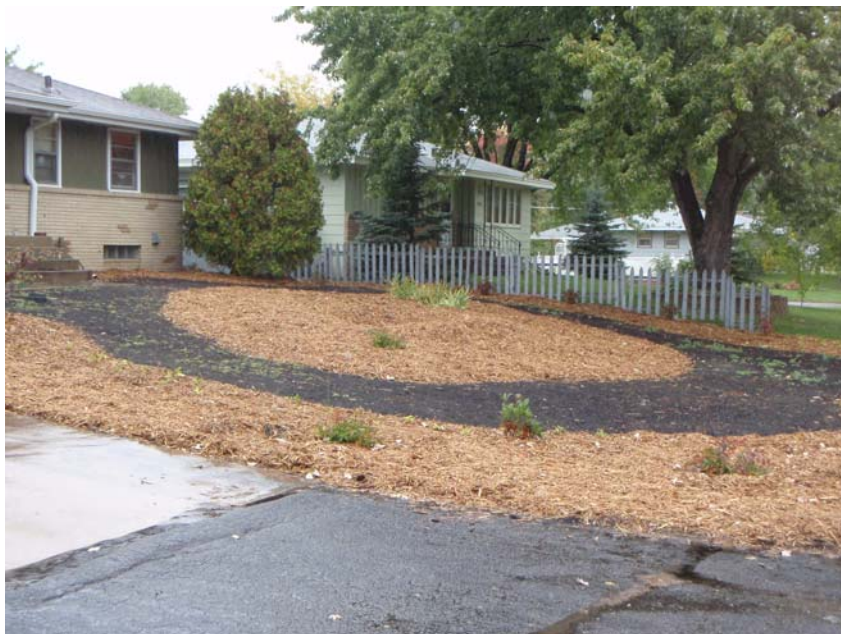
July 2008

A variety of native plant plugs were planted throughout the mulched area. A no mow grass seed was spread in the dirt area.
