PROJECT PROFILE

FRIDLEY CHURCH

Rain Garden

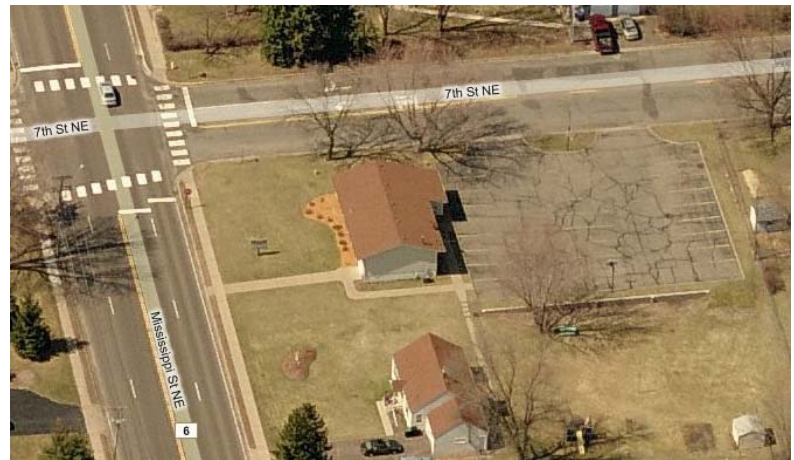
Fridley Church site prior to rain garden installation.

Rain falling on the roof of the Church was directed by downspouts, unfiltered, into the street, eventually making its way to the Mississippi River. This excess runoff from impervious surfaces can cause:

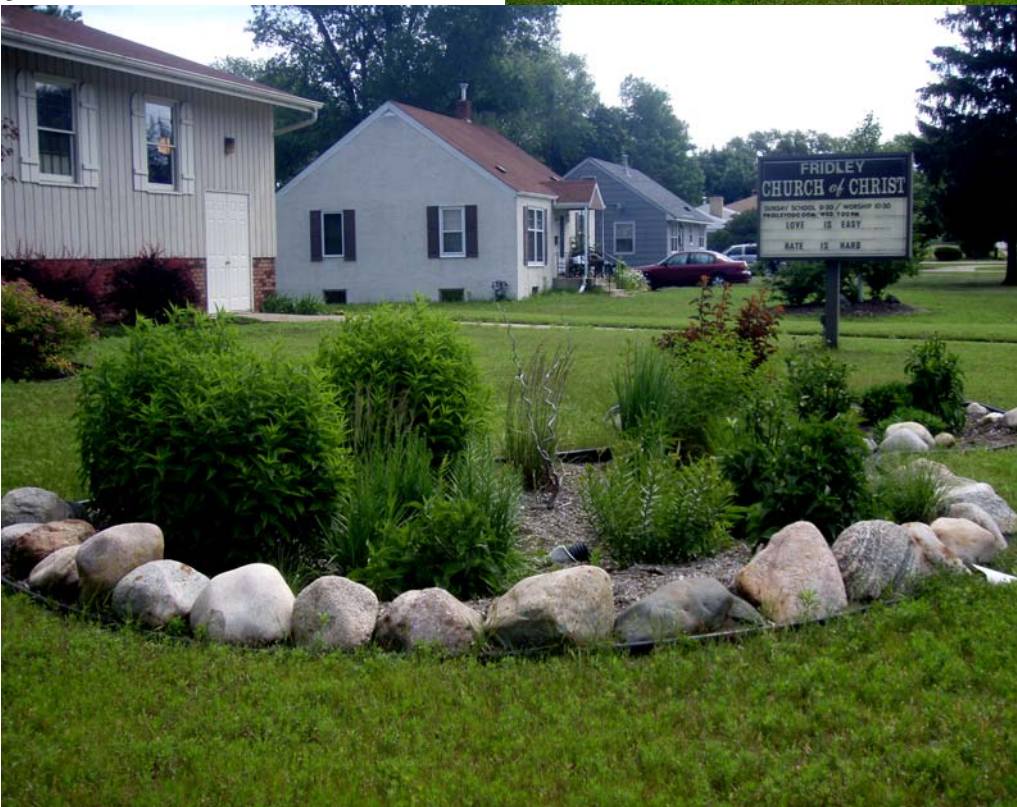
June 2008

- Rain falling on the roof is directed to the rain garden where it is treated to remove nutrients and pollutants.
- Up to 97 ft³ of water can be treated by the rain garden.
- In all, the rain garden detains, or slows down, up to 165 ft³ of rain water allowing the removal of sediment and solid particulate matter.
- By slowing the flow of water into the river, the rain garden helps to reduce flooding and erosion.
