# MUELLER RESIDENCE

Rain Garden

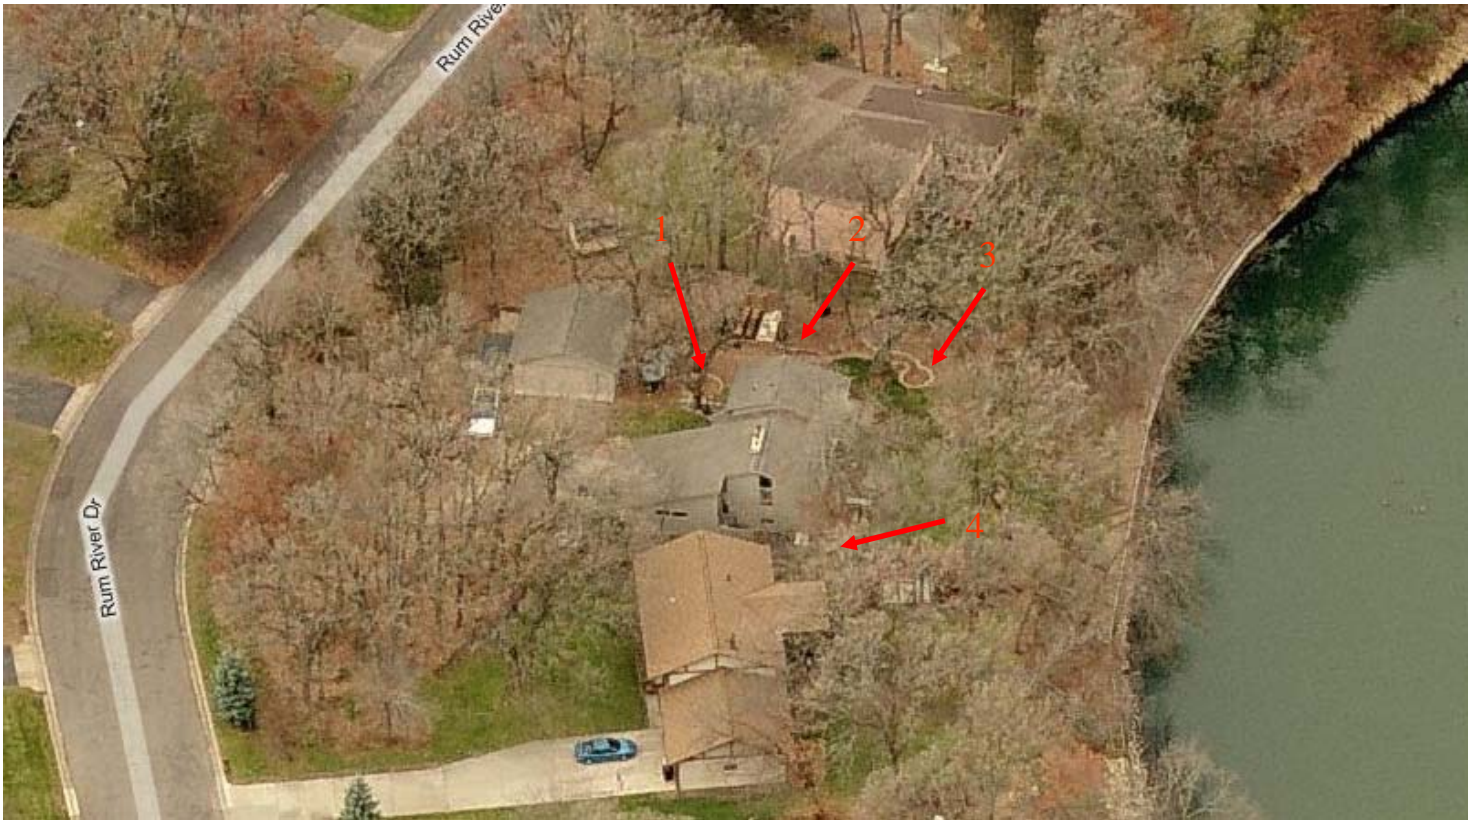
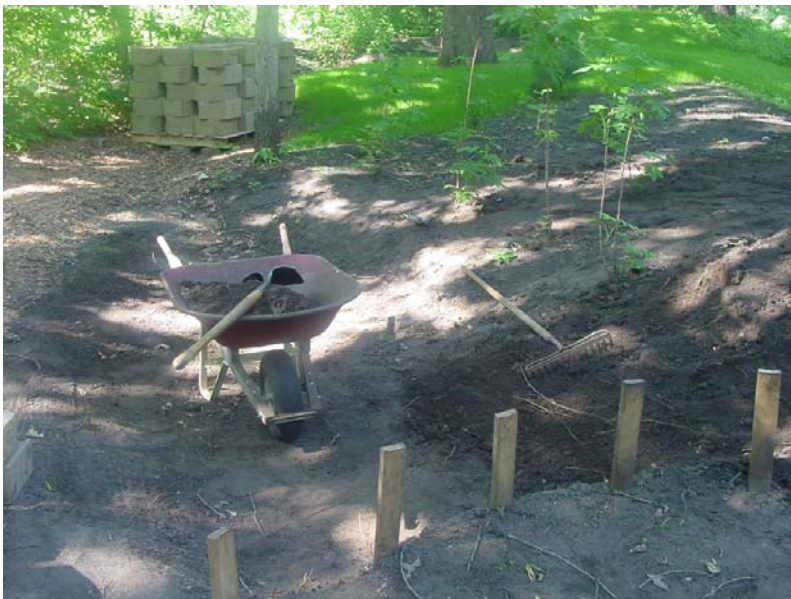
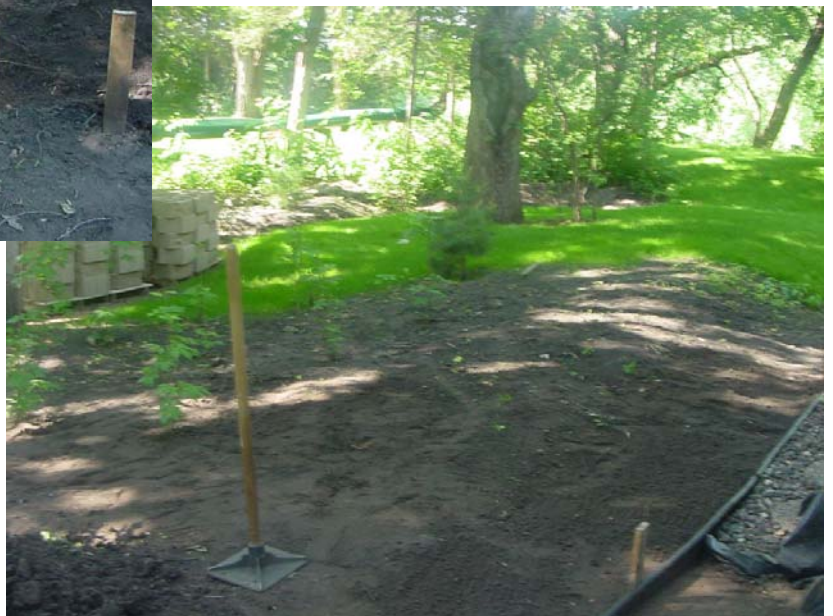
June 2006

A total of four rain gardens were designed for the Mueller residence. To help defray their portion of the project cost, the homeowners provided the labor for the project.

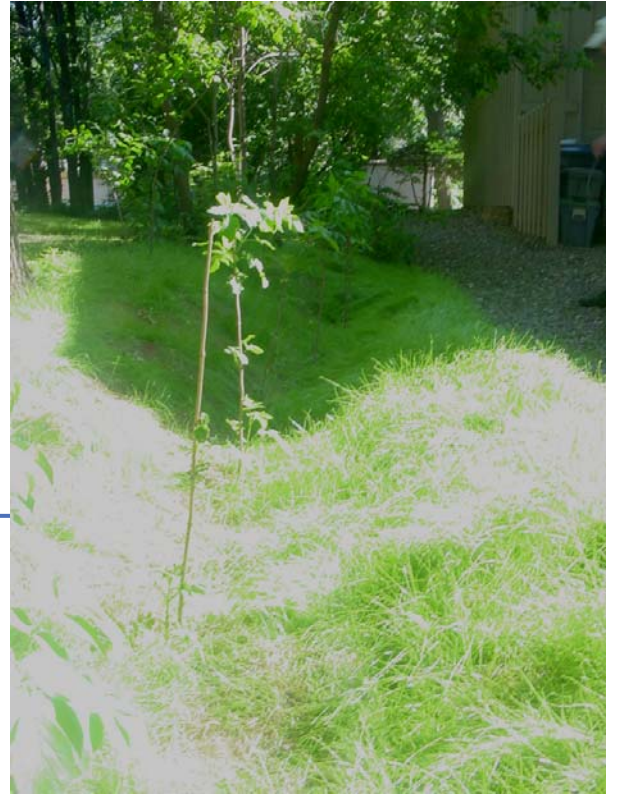
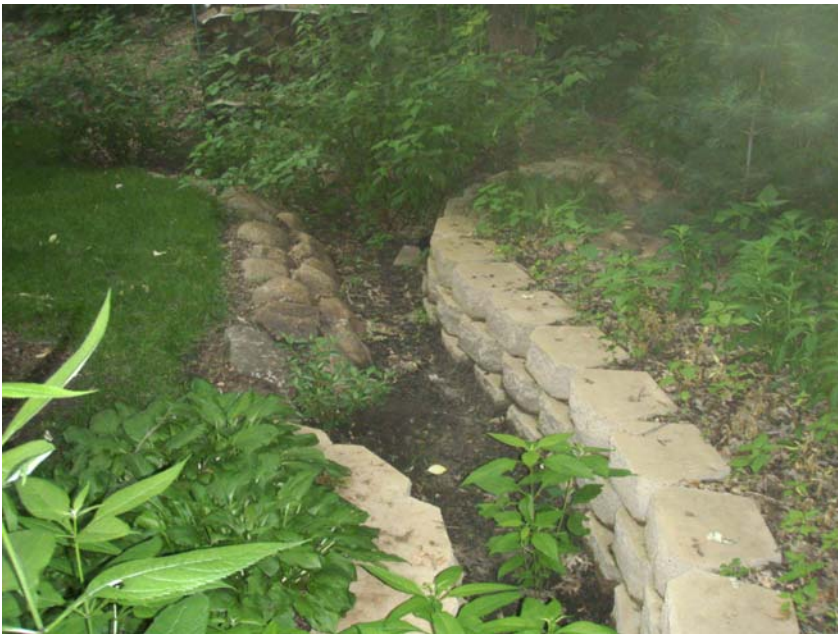
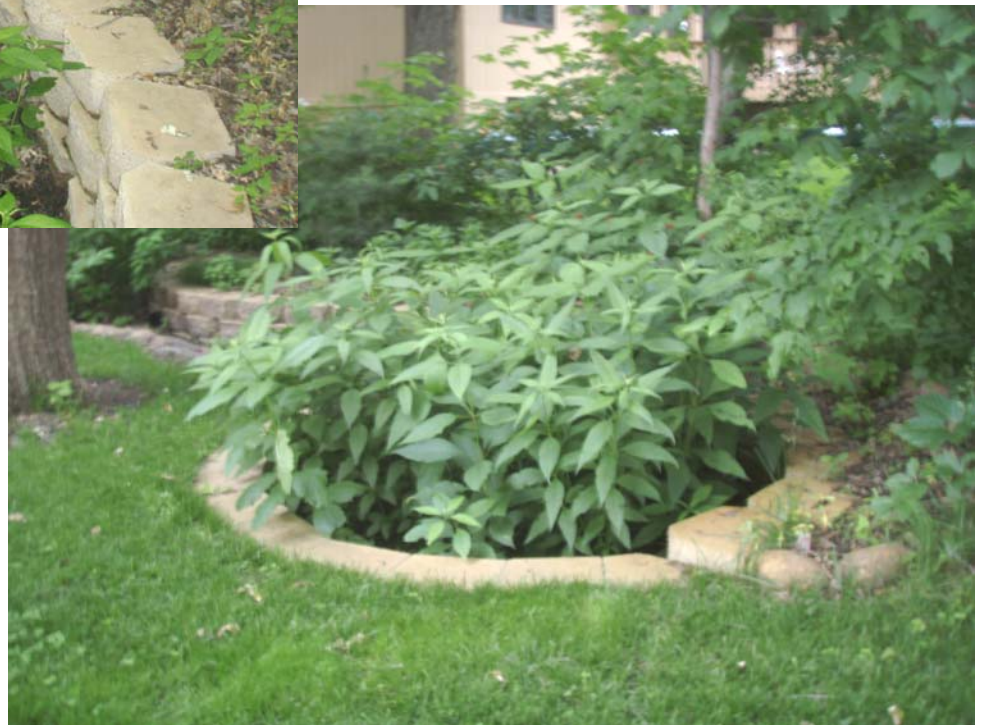
June 2008

- Rain falling on the roof is directed by drain tile to the rain gardens where it is treated to remove nutrients and pollutants.
- Rain gardens are placed to intercept and treat overland flow.
- Up to 189 ft<sup>3</sup> of water can be treated by the rain gardens to remove pollutants.
- In all, the rain gardens detain, or slows down, up to 212 ft<sup>3</sup> of rain water allowing the removal of sediment and solid particulate matter.
- By slowing the flow of water into the river, the rain gardens help to reduce flooding and erosion.
