OCHOCKI RESIDENCE

Pre-Rain Garden Conditions

PROJECT SPECS

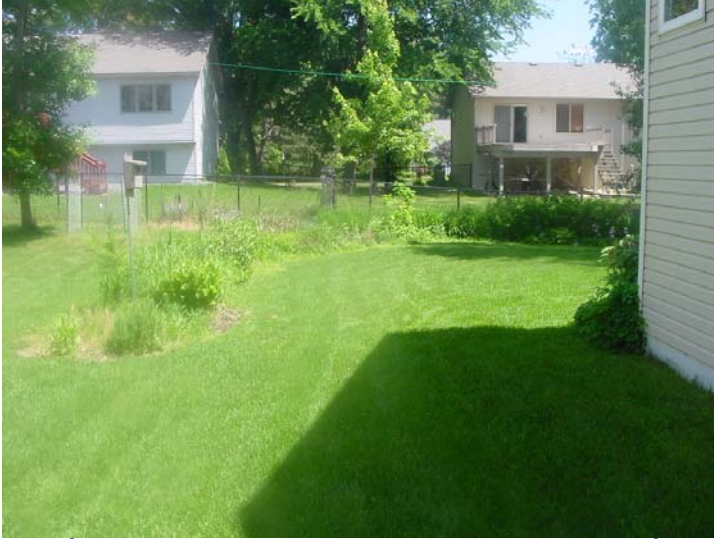
Before Rain Garden Installation

Areas landscaped with non-native plants requiring large quantities of water.

Future rain garden site.

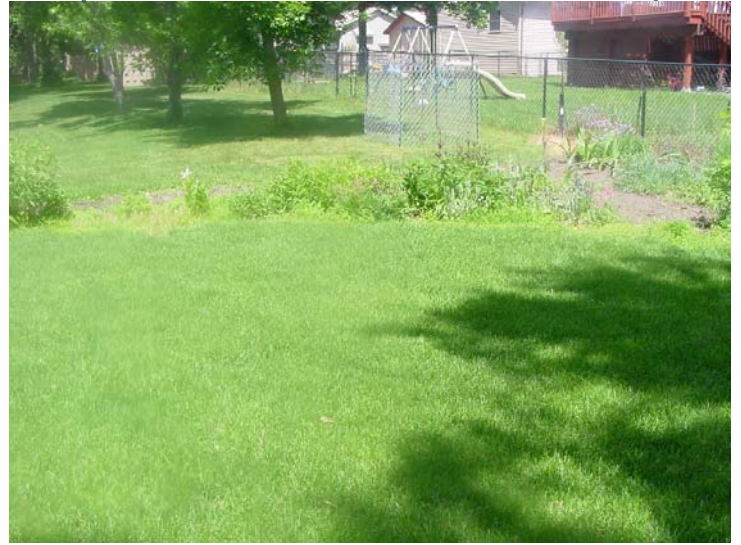
September 2006

After Rain Garden Installation

- Rain falling on the roof is directed by gutters and drain tile to the rain gardens where it is treated to remove nutrients and pollutants.
- Up to 125 ft³ of water can be treated by the rain garden.
- In all, the rain garden detains, or slows down, up to 130 ft³ of rain water allowing the removal of sediment and solid particulate matter.
- By slowing the flow of water into the river, the rain garden helps to reduce flooding and erosion.
