PHAM RESIDENCE

Pre-Rain Garden Conditions

Rain Garden Installation

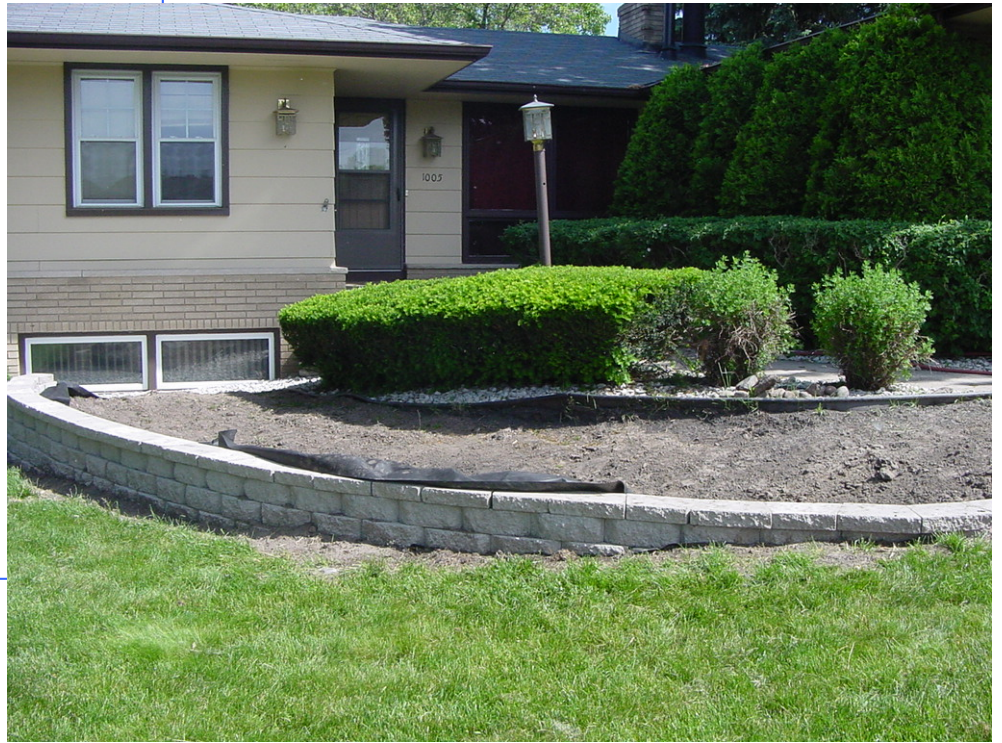
This rain garden was designed to tie in with existing landscaping. The homeowners joined the two areas and eventually re-planted the original area. Because homeowner labor was estimated at \$1,287.50—greater than half the total project cost—their cash contribution was \$0.00. The cost share program funded by the Met Council covered the remaining \$1,233.14 of the

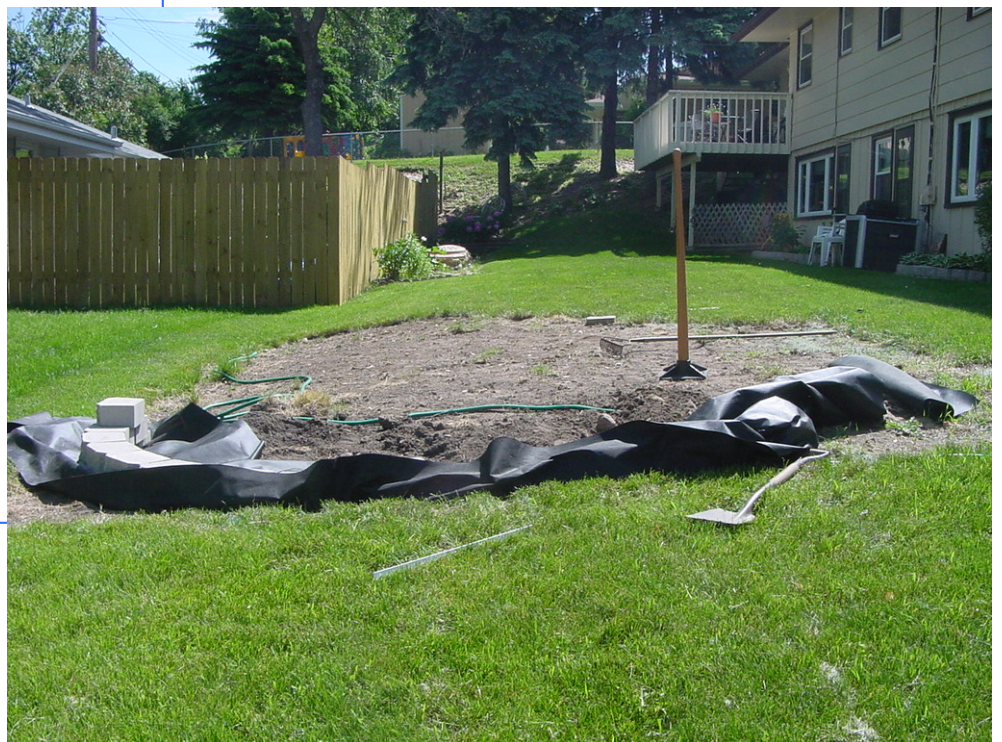
The rain gardens were designed to capture stormwater falling onto the roof of the Pham residence. Drainage tile was laid underground to direct water from the existing downspouts to each of the rain gardens. In all, the rain gardens are capable of treating up to 79 ft³ of stormwater, reducing pollution and nutrient input to the Mississippi River.

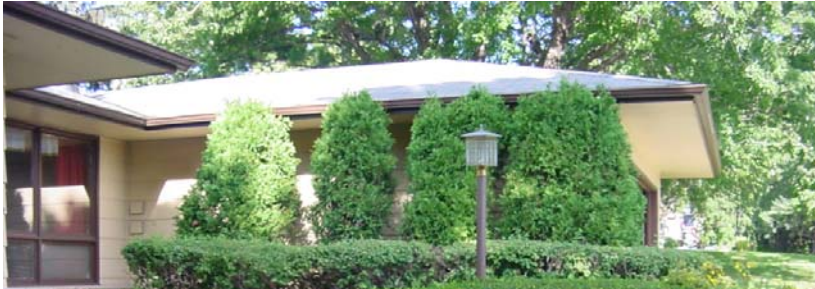
August 2006

Rain falling on the roof is directed by drain tile to the rain gardens for treatment.

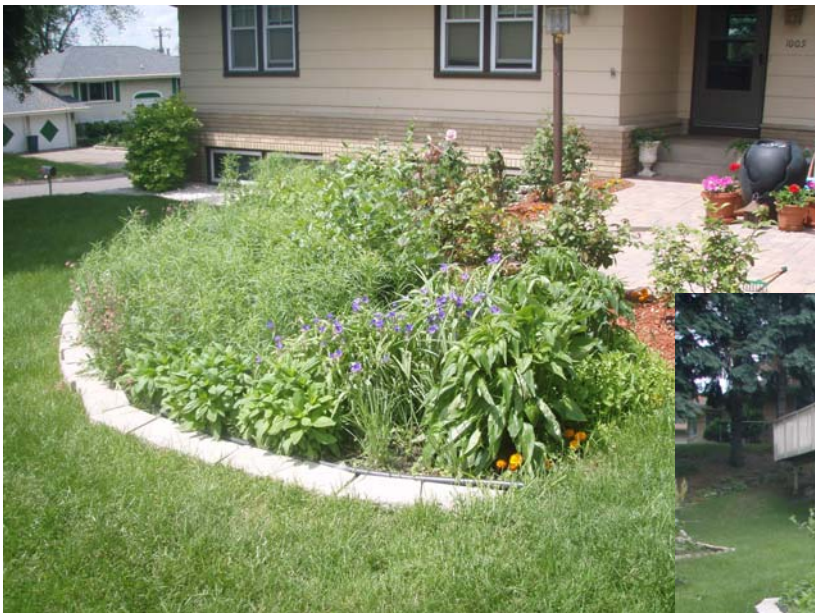
June 2008

The rain gardens can treat up to 127 ft³ of water, reducing pollution and nutrient input to the River.
