NIELSEN REVETMENT

PROJECT SPECS

ANOKA
CONSERVATION
DISTRICT

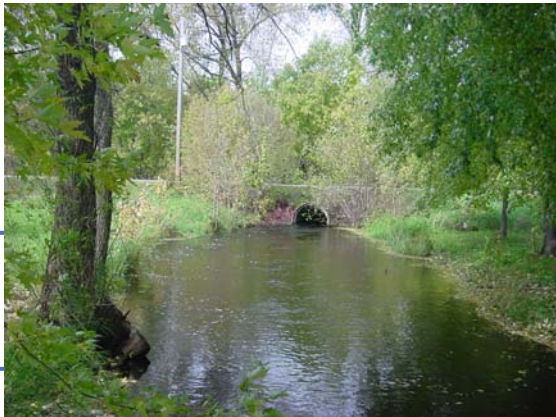
High flows along Trott Brook in Ramsey (October 2002)

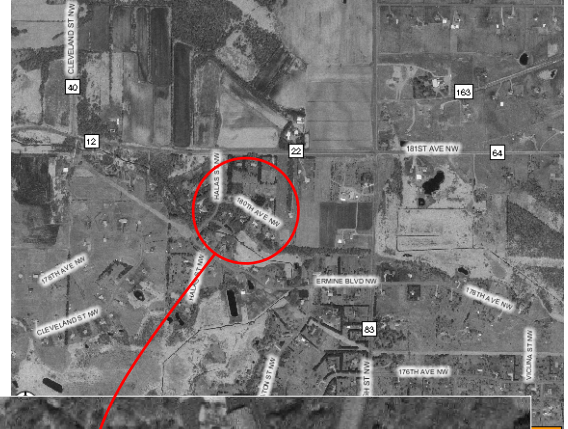
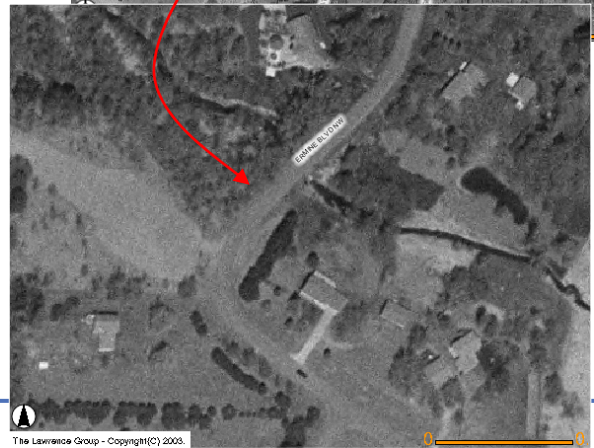
Increased development upstream from the Nielsen property has resulted in high water flows scouring the banks of Trott Brook. Combined with a loss of deep-rooted vegetation along the banks, excessive erosion was occurring on site. This resulted in:

- Increased sedimentation in the stream
- A reduction in water quality
- A reduction in upland area

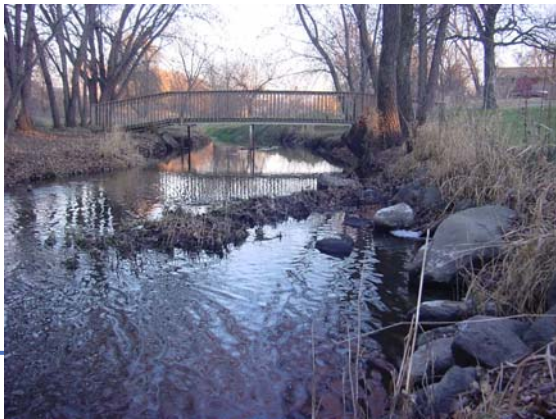
High, fast flows and removal of deep-rooted vegetation along the banks have begun eroding the banks (November 2002)

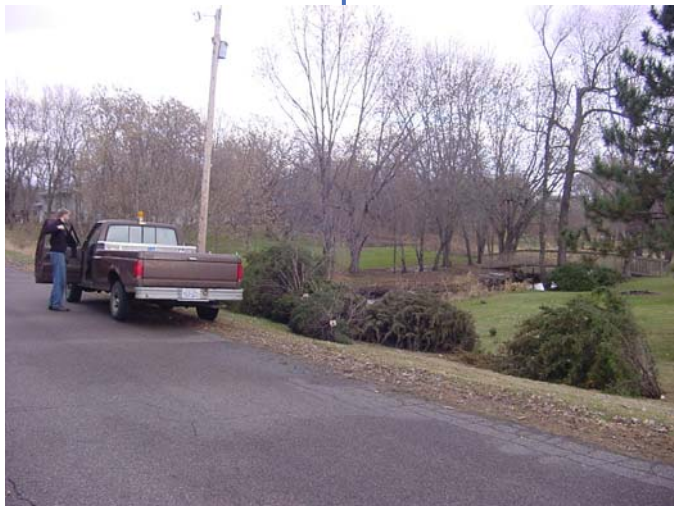
◀December 2002

8' - 12' cedar trees were harvested with permission from a local property. Branches from one side of the tree were removed so the tree trunks fit tight up against the bank. Enough cedars were harvested to allow for a 2' overlap of trees along both sides of the bank.

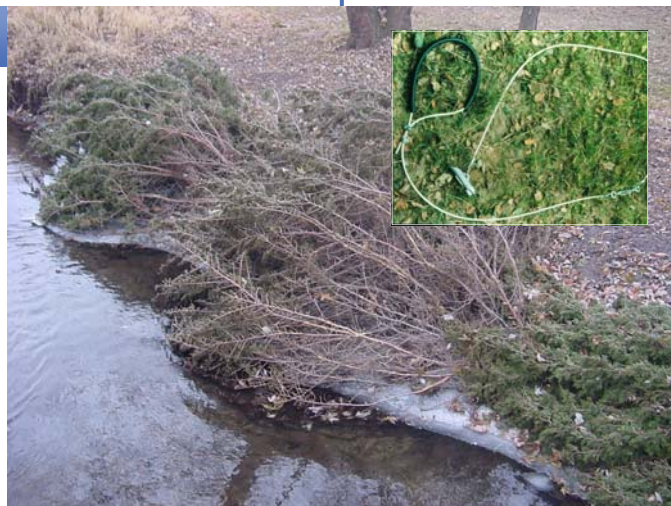
December 2002 ▶

The trees were placed in the stream with the tops facing downstream and a 2' overlap. 2 duckbill earth anchors are attached to each tree and pounded into the ground.

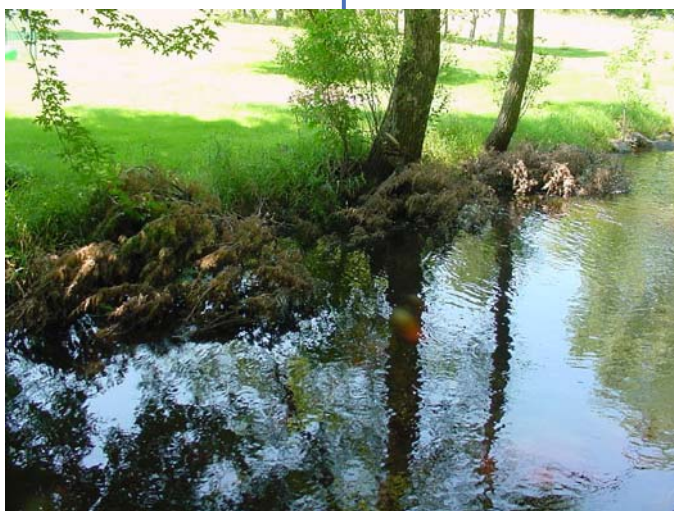
◀July 2003

The cedar revetment is holding up well after the spring melt. The high water is forced away from the bank into the center of the channel, protecting against erosion. The cedars will last another 6-10 years, giving newly planted vegetation time to establish extensive root systems to hold the bank together after the cedars are gone.
