RETZER RESIDENCE

Pre-Buffer Conditions

ANOKA
CONSERVATION
DISTRICT

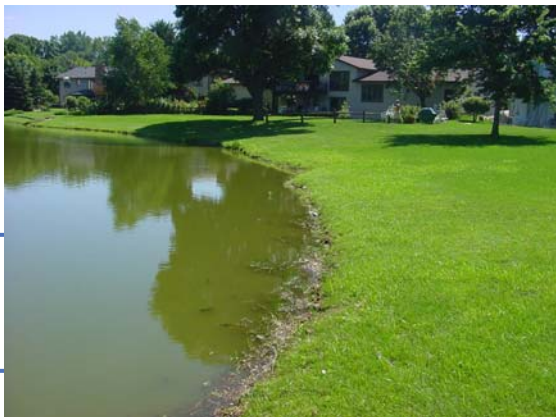
Harris Pond restoration site prior to buffer installation (July 2002)

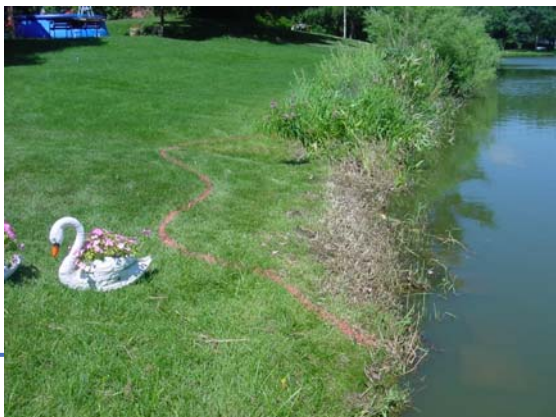
The small buffer area is outlined using marking paint. The existing turf was killed using an aquatic glyphosate (July 2002)

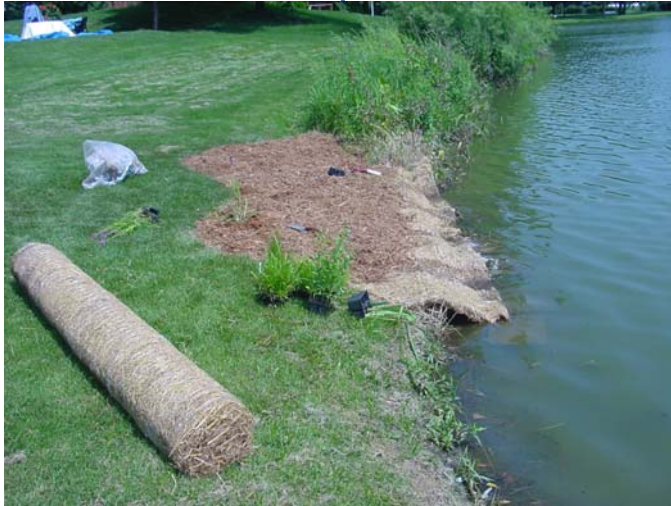
◀ August 2002

The site was prepared by eliminating the existing vegetation through application of glyphosate (e.g. Rodeo®). Erosion Control Blanket was staked to the edge to prevent soil loss. A 2" layer of shredded hardwood mulch was applied to the planting area. Aquatic, wet meadow, and upland plugs were planted at 12" spacing.

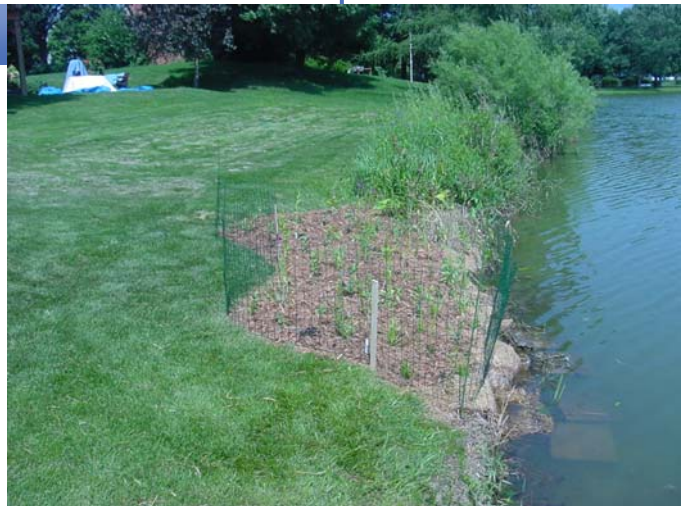
August 2002 ▶

After planting was completed the site was fenced off with a vinyl coated wire fencing to keep out geese and other herbivores. This site didn't require any watering due to the minimal difference between the water elevation and planting elevation.

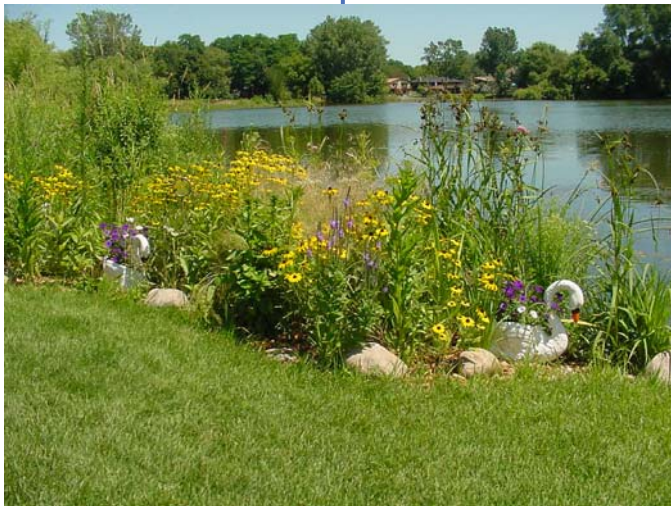
◀ July 2003

After one year's growth the planting is doing very well. All of the plants flowered in the first year. The 12" spacing between plugs has resulted in a very full looking buffer in the first year. A very small amount of weeding and no watering were required on this site.
