RUM RIVER SOUTH

Pre-Buffer Conditions

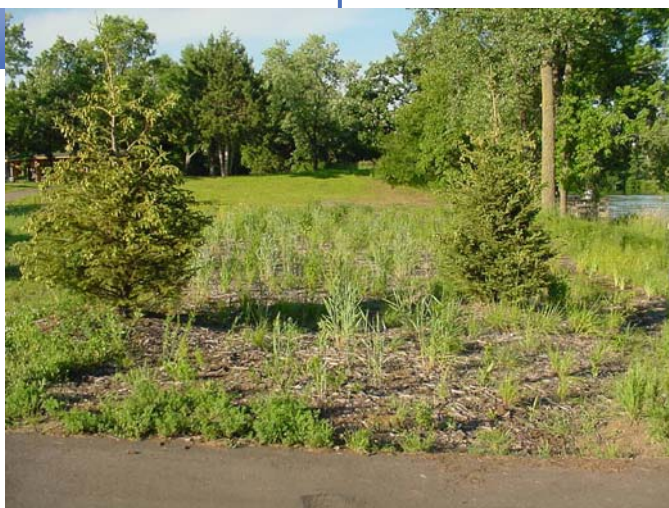
Two years after planting the area is densely covered with vegetation, in stark contrast with the bare soils existing before restoration. The ambers and yellows that arrive in the fall provide visual interest throughout the winter. Periodic weeding will continue for several years until the natives have become well established.
