HERB BEACH

Project Background

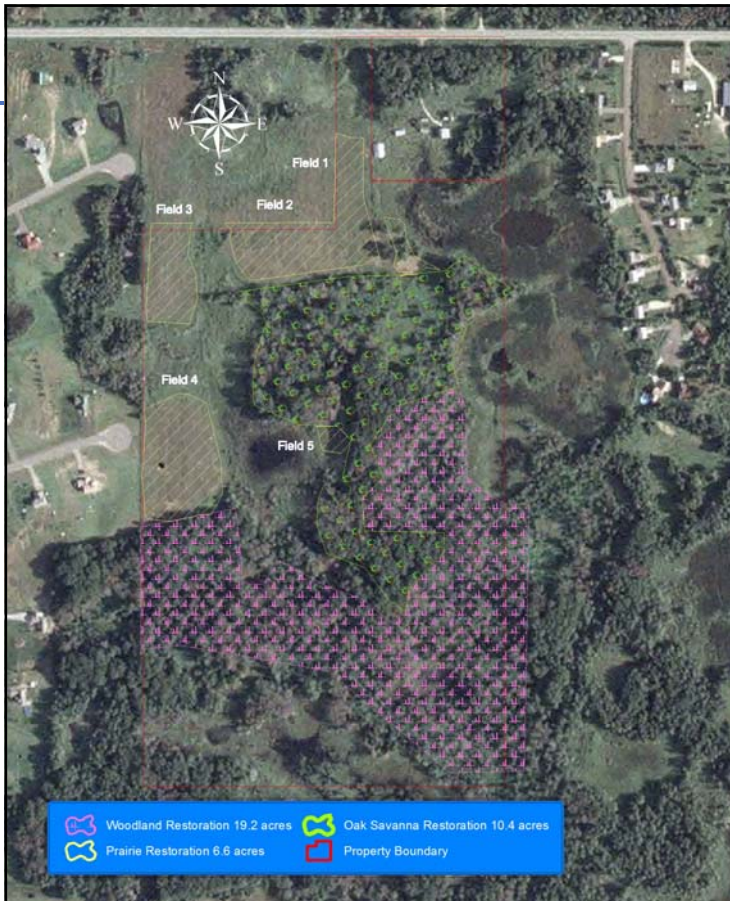
Beach Restoration Map

Restoration Goals

- Remove oak wilt infested trees
- Convert non-native grassland to tall-grass prairie
- Establish oak savanna forbs and grasses
- Restore oak woodland with native trees

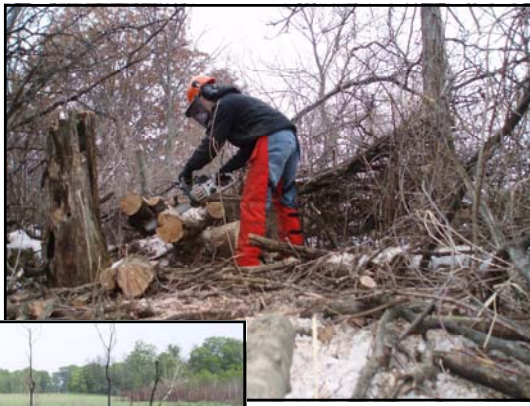
Site-prep

The site was prepared by removing oak-wilt killed and infested trees. Non-native vegetation was eliminated in some areas using a controlled burn. Other areas were treated with glyphosate (e.g. Rodeo®). Good site prep promotes seed germination and allows plants to establish, preventing the invasion of undesirable species.

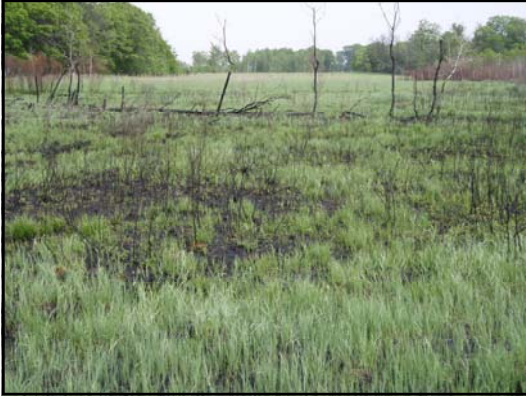
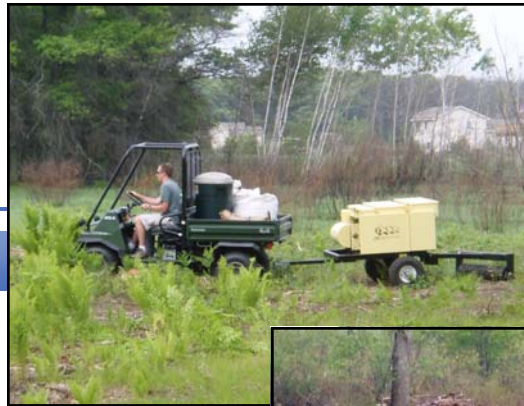
Installation

Several areas of the property were seeded with a mix of native grass and forb species selected to replicate grasslands and oak savanna. Native trees were also planted with the help of volunteers to re-establish the oak woodland that has been impacted by oak-wilt.
