PROJECT PROFILE

FLEISCHHACKER

Rain Garden

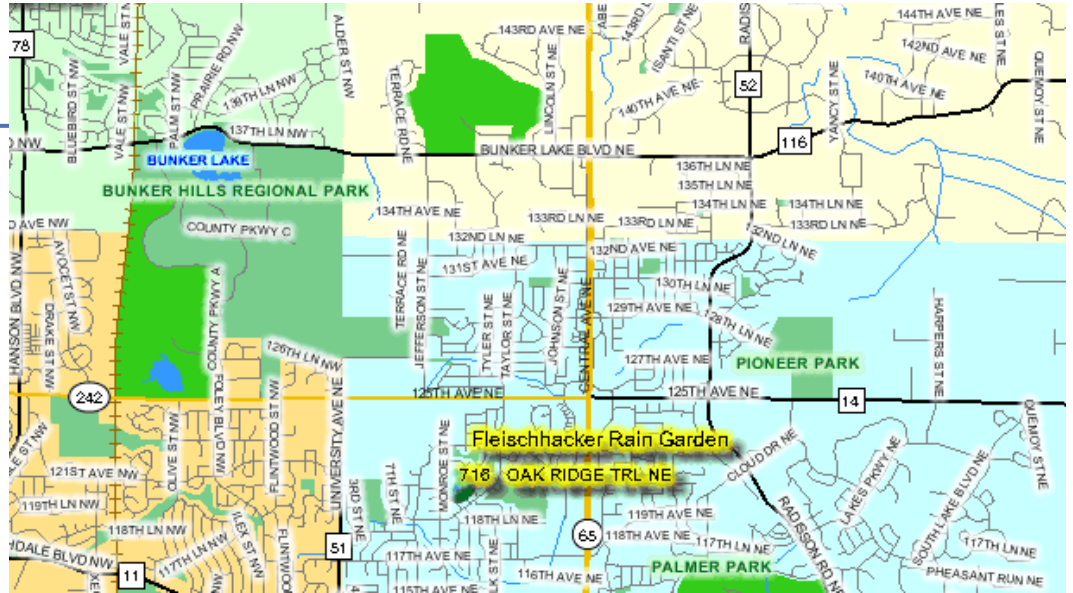
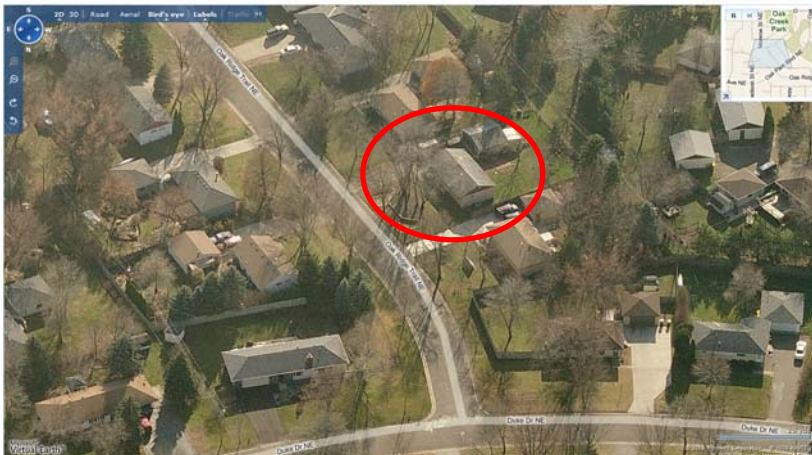
Fleischhacker rain garden site

Rain falling on the roof of the residence was directed by downspouts, unfiltered, into the street, eventually making its way to Coon Creek. This excess runoff from impervious surfaces can cause:

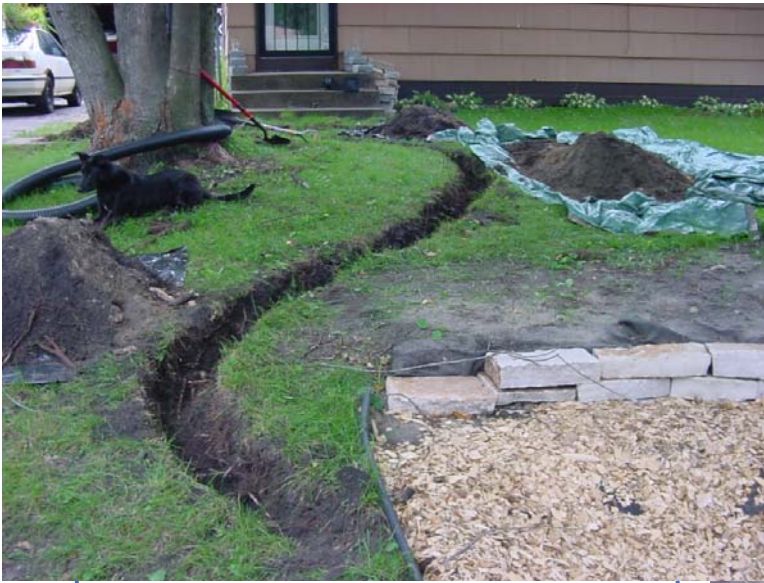
Trench for drain tile that will direct rain water from the downspout to the rain garden.

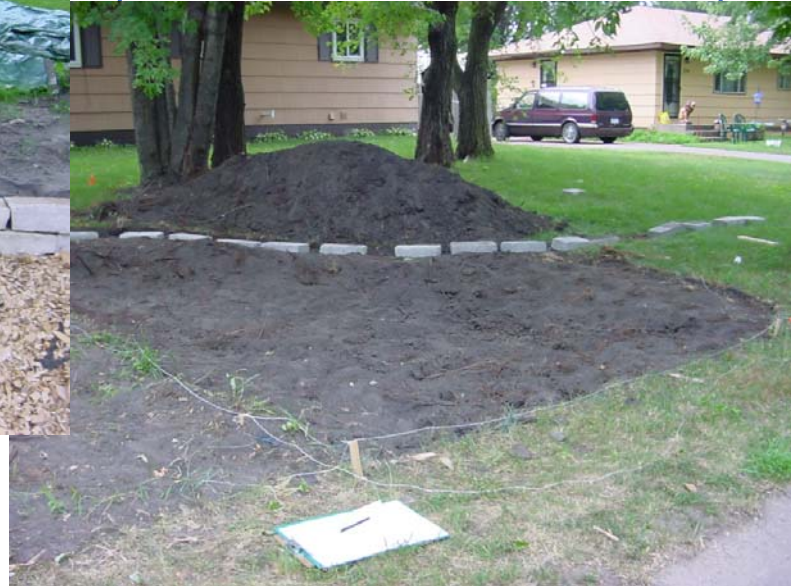
September 2006

The rain garden areas are dug down 8" to provide water storage capacity.

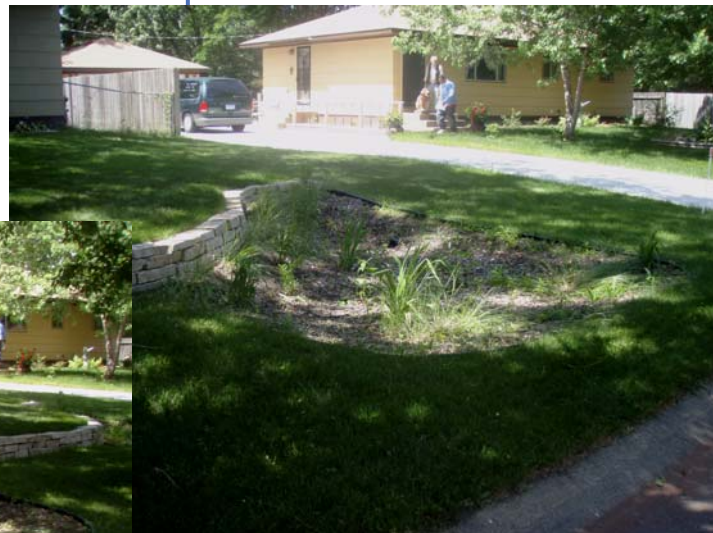
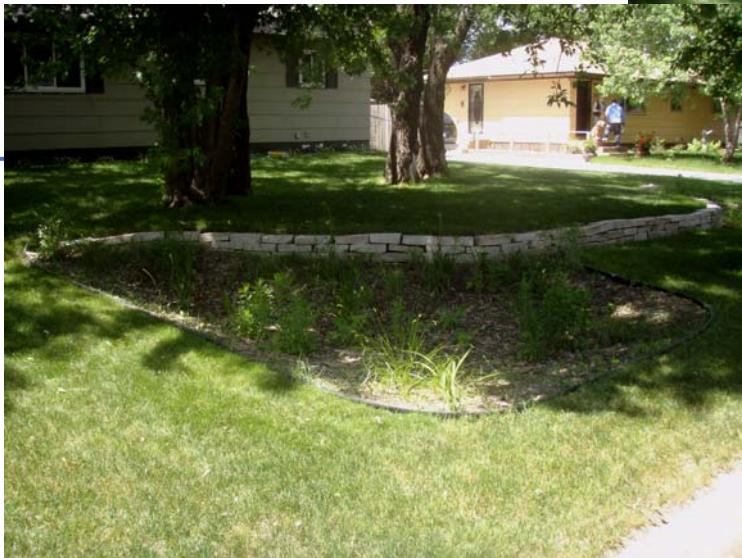
June 2008

- Rain falling on the roof is directed by drain tile to the rain gardens where it is treated to remove nutrients and pollutants.
- Up to 127 ft³ of water can be treated by the rain garden.
- In all, the rain garden detains, or slows down, up to 160 ft³ of rain water allowing the removal of sediment and solid particulate matter.
- By slowing the flow of water into the river, the rain garden helps to reduce flooding and erosion.
