PROJECT PROFILE

HERRALA AND RUSIN

River Bank
Stabilization

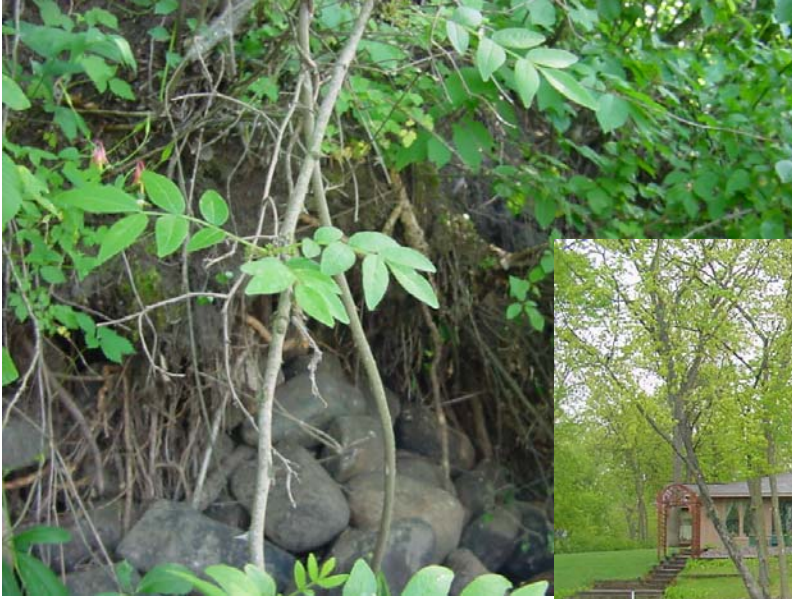
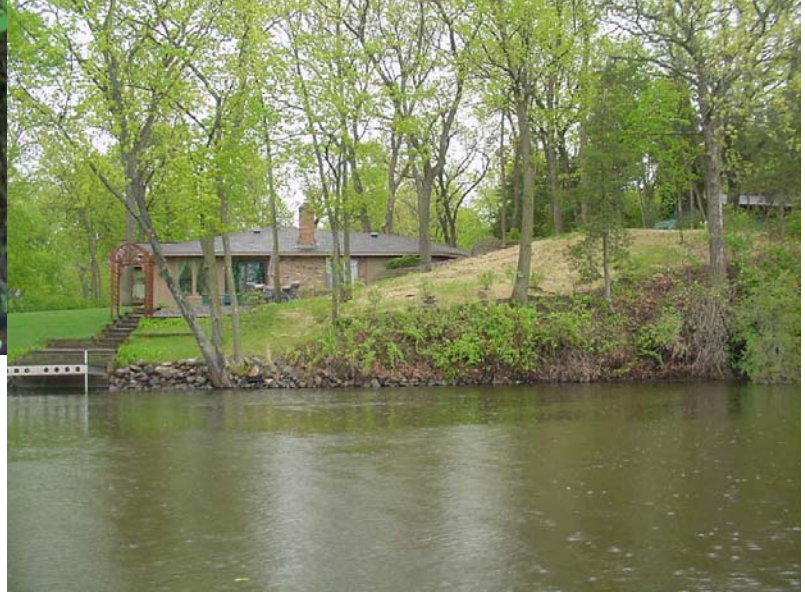
Before Installation

May 2006

This site had minor erosion and bank undercutting. Homeowners previously attempted to stabilize the shoreline with rock. The length of shoreline needing attention was approximately 158 ft.

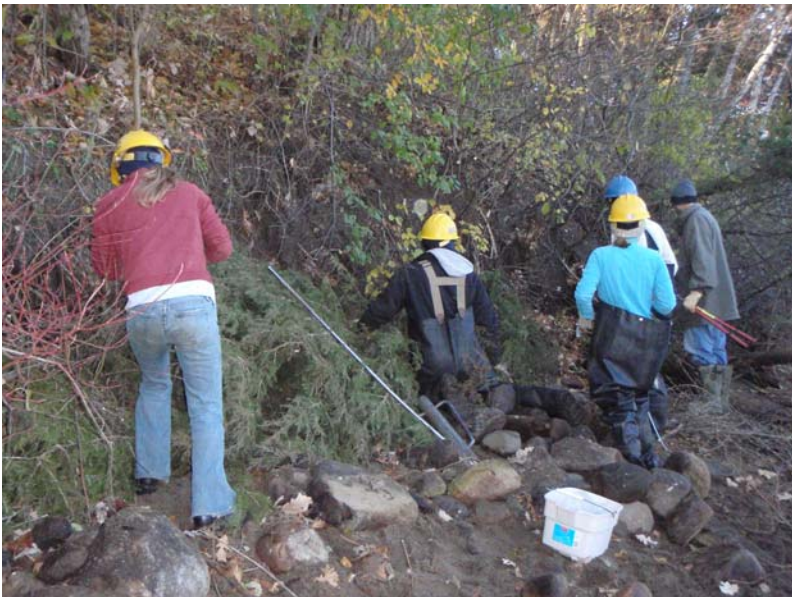
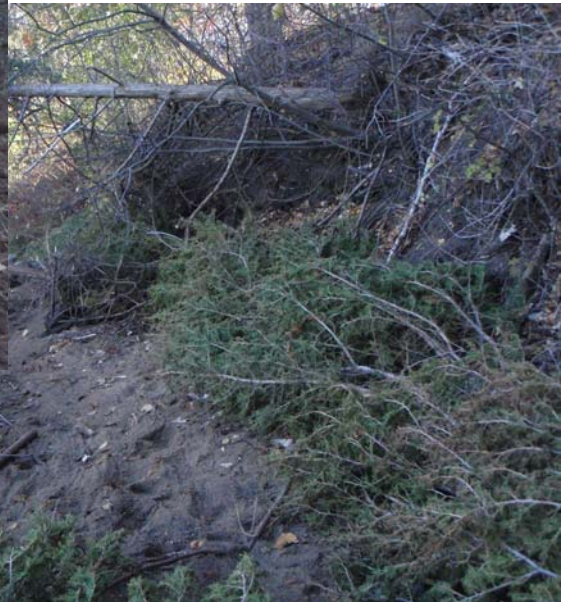
October 2008

Two rows of cedar trees were anchored along the normal waterline to repair erosion and undercutting as well as prevent more serious problems in the future. Installation occurred during low water.
