PROJECT PROFILE

LAKSO RESIDENCE

Rain Garden

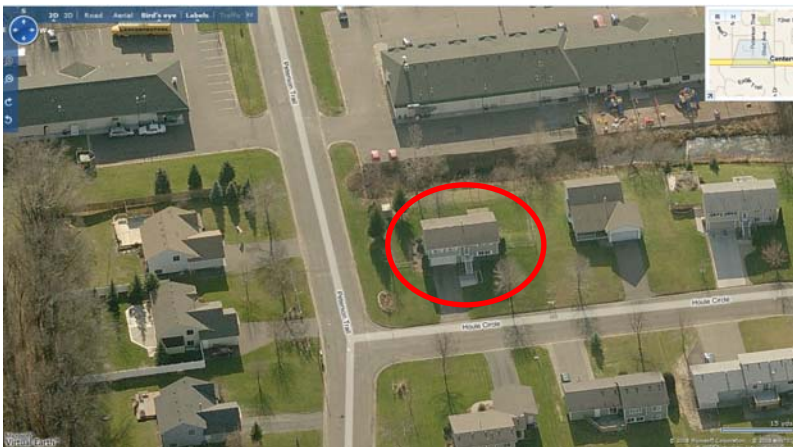
The Lakso residence is located adjacent to a stormwater pond in the Rice Creek watershed

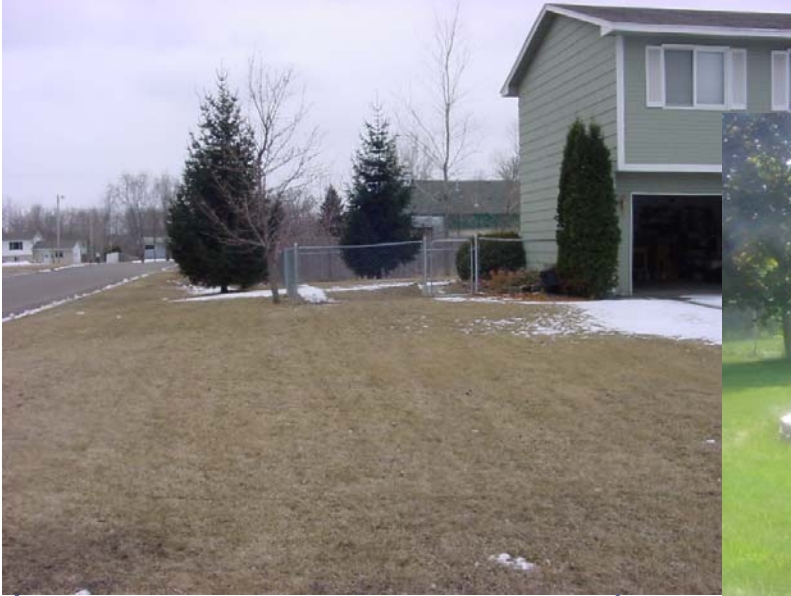
March 2006

Before rain garden installation, unfiltered stormwater ultimately flowed into an adjacent stormwater pond.

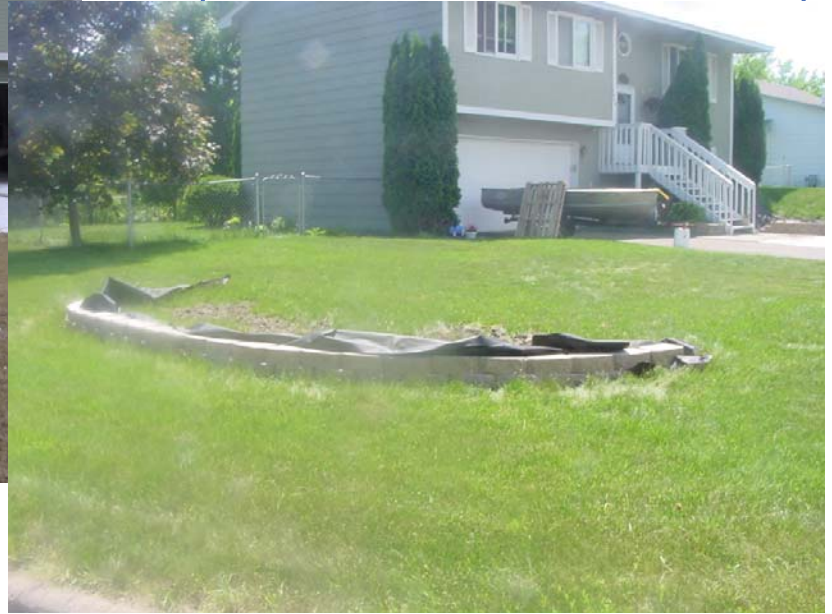
June 2006

A retaining wall rain garden was installed, and new gutters directed stormwater to the rain garden through drainage tile to be treated.
