PROJECT PROFILE
RUM RIVER CENTRAL PARK

**Riverbank
Stabilization**

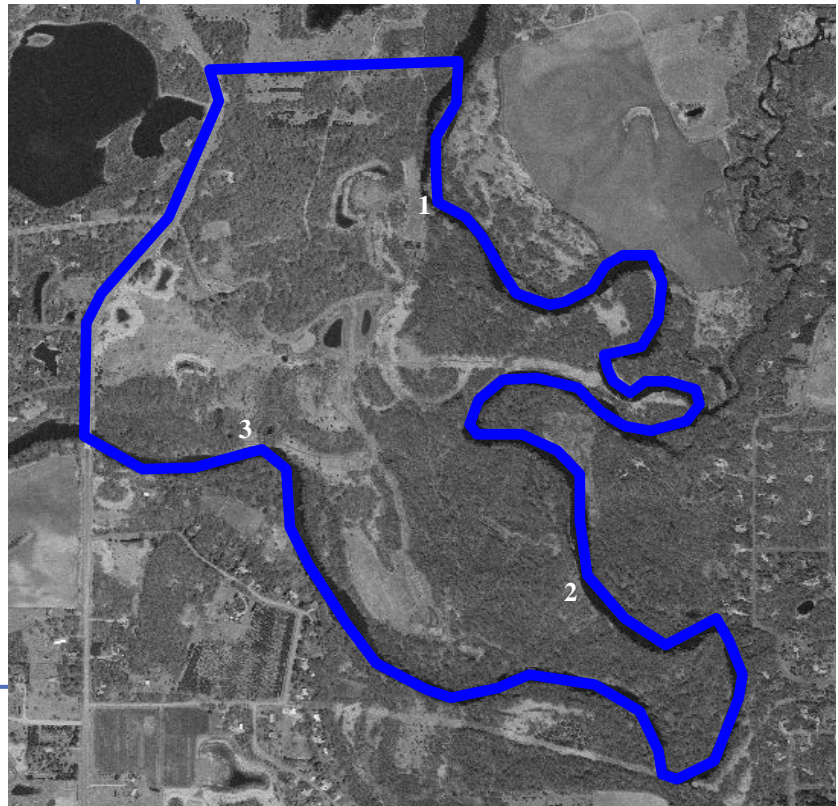
Anoka County Parks and Recreation Department staff first approached the Anoka Conservation District about correcting riverbank erosion in Rum River Central Regional park in 1999. ACD arranged for several funding sources to design and install the project. Three sites were stabilized, all of which are located within the park, which is located in the northeastern most corner of the City of Ramsey, at the intersection of Burns Township, and the cities of Oak Grove, Andover and Ramsey. The park consists of 460 acres of passive recreation including a network of paved and natural surface trails for walking, biking, and horseback riding. There is a canoe landing, several parking areas and a picnic shelter and playground in one portion of the park.

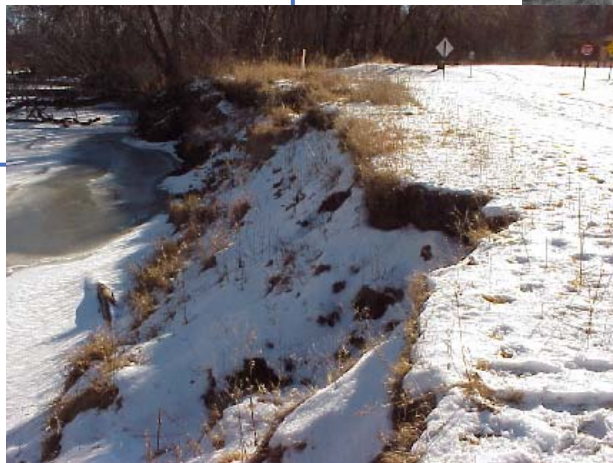
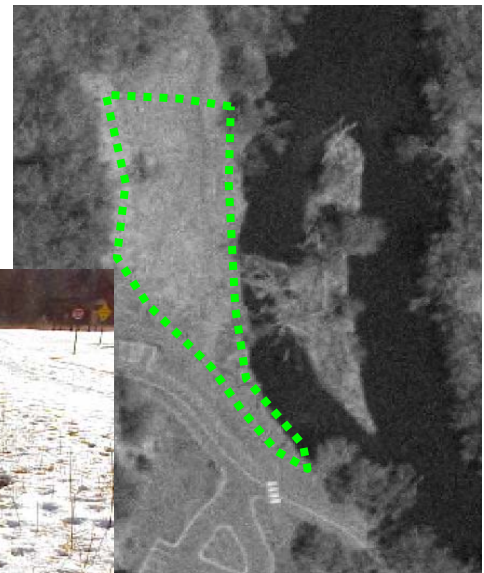
March 2002 ▶

Site 1 consisted of approximately 350 feet of eroding riverbank within ten feet of a bituminous trail and twenty feet of a road. A combination of submerged rock vanes, erosion fabric and a native plant buffer was selected to address the erosion problem.

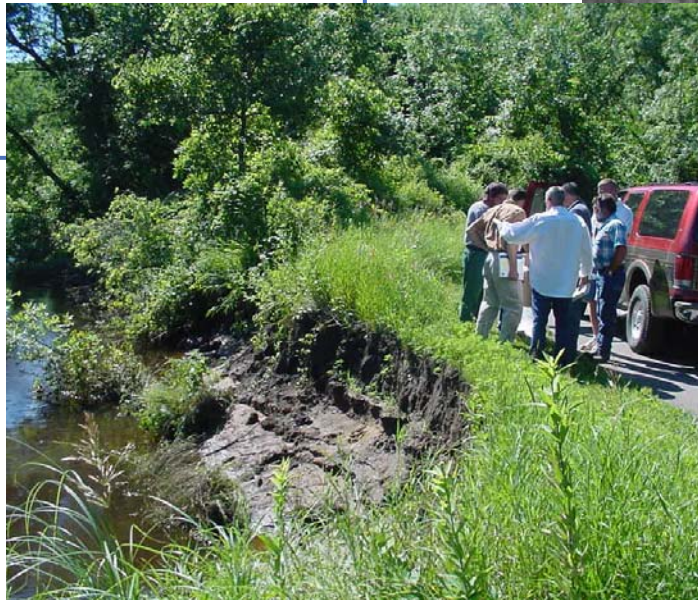
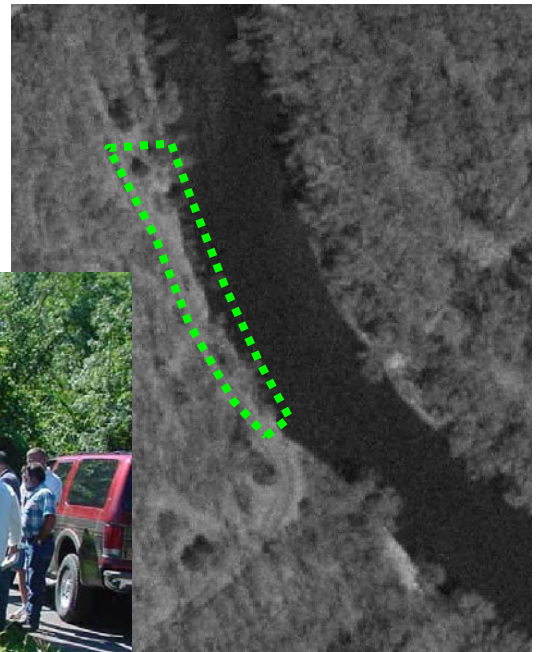
July 2002 ▶

Site 2 consisted of approximately 200 feet of eroding riverbank within five feet of a bituminous trail. A combination of root wads, minimal rock, erosion fabric and a native plant buffer was selected to address the erosion problem.

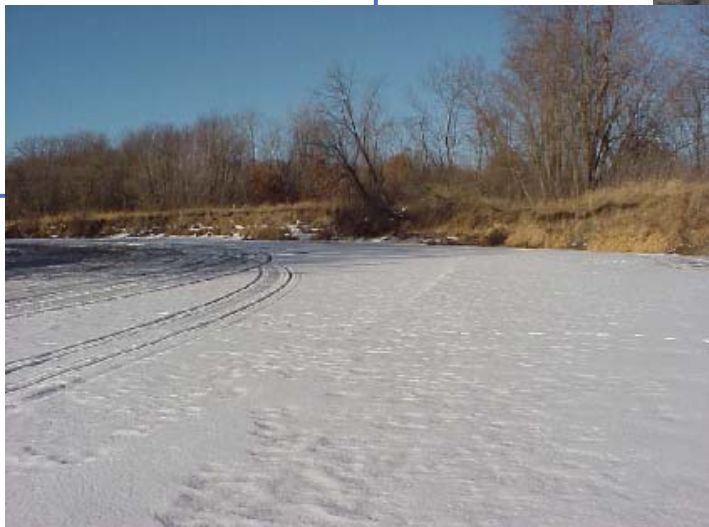
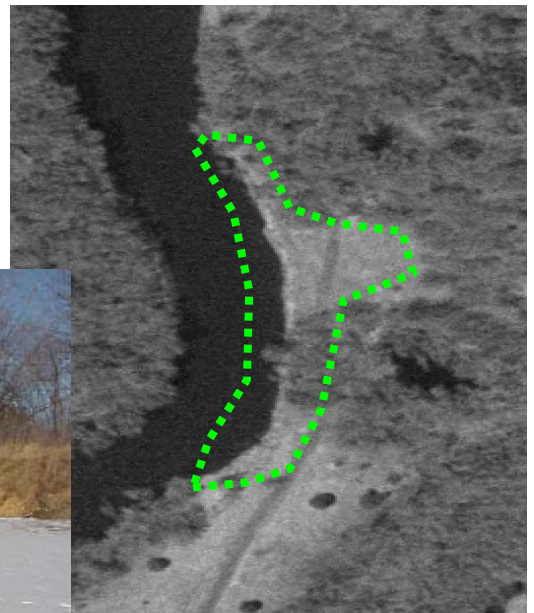
March 2002 ▶

Site 3 consisted of approximately 700 feet of eroding riverbank within twenty feet of a grass horse trail. A combination of root wads, submerged rock vanes, minimal toe reinforcement with rock, erosion fabric and a native plant buffer was selected to address the erosion problem.

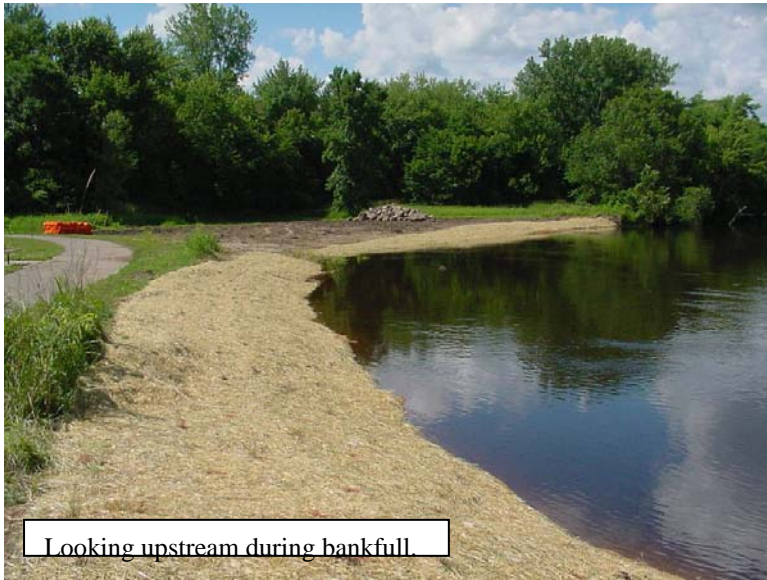
◀ June 2003

Looking upstream during bankfull.

Two submerged rock vanes were installed and the site was graded. Following grading, one root wad was installed. CF7 erosion fabric was installed on the bank below bankfull and straw erosion blanket was installed above bank full. Areas below bankfull were planted with native plant plugs at 18 inch intervals while areas above bankfull were seeded with a native seed mix and planted with native plugs at 36 inch intervals.

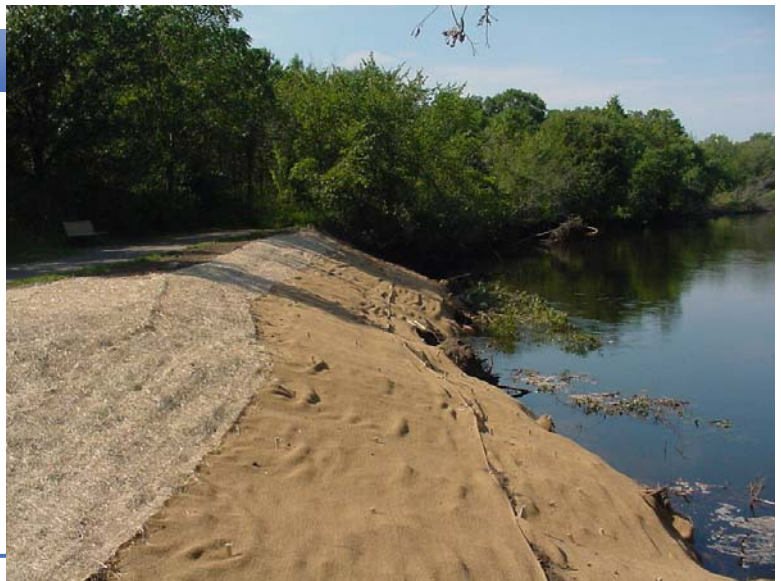
August 2003 ▶

High water delayed grading and project installation at site 2. However, after grading occurred, root wads and minimal rock were installed along with erosion control fabric and a native buffer as described above for site 1.

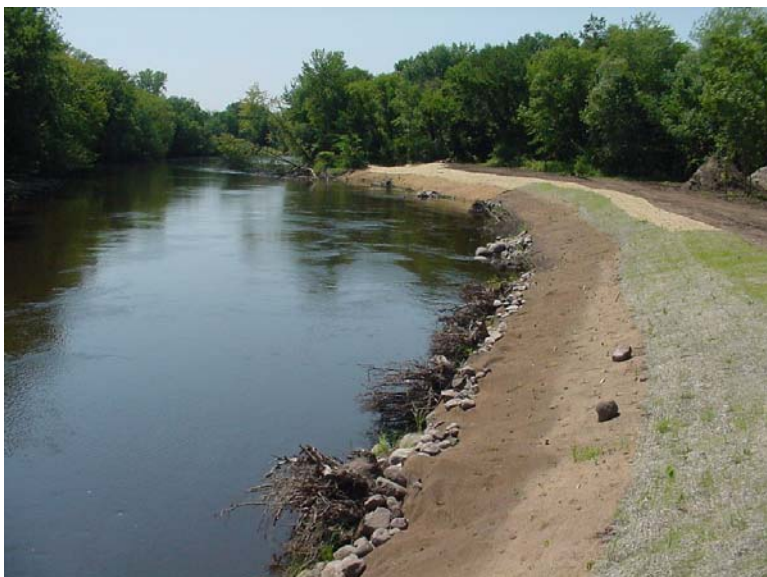
◀ June 2003

Two submerged rock vanes were installed along with six root wads. After grading, erosion control fabric and native buffer were installed as described above for site 1.
