# ZIMMER RESIDENCE

Rain Garden

## Pre-Rain Garden Conditions

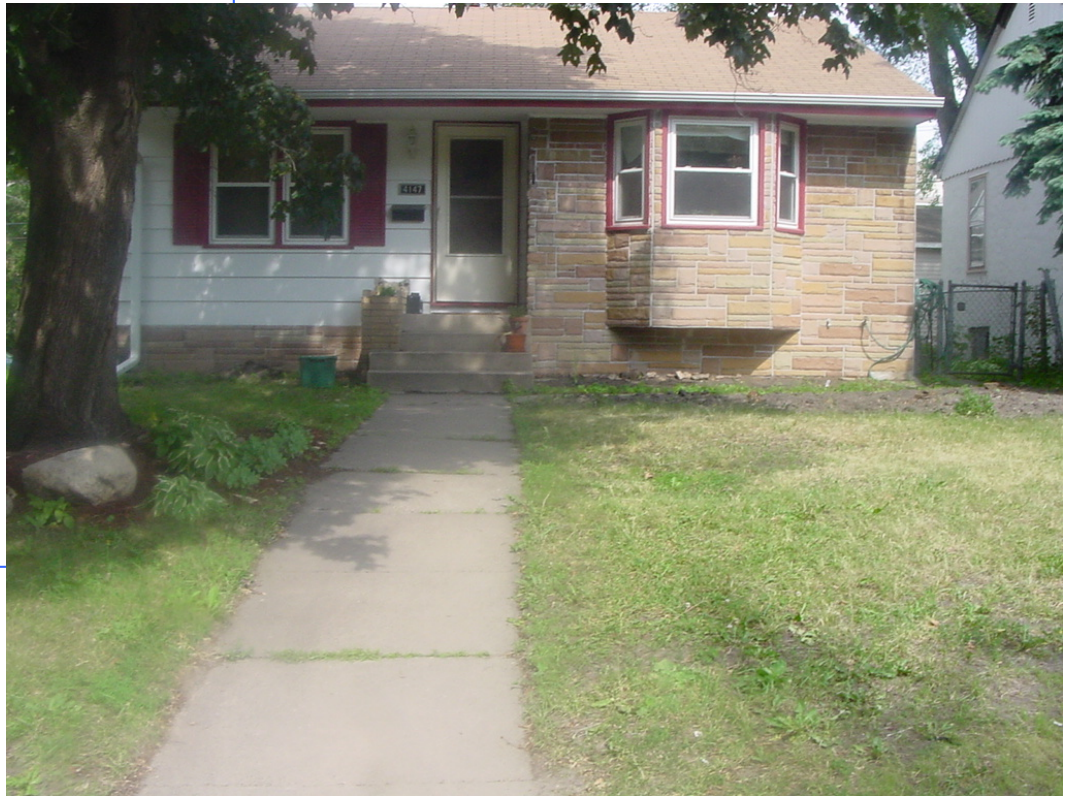
The rain gardens were designed to capture rainwater coming off of the roof. Value of labor provided by the homeowners was estimated at \$1,475.00. The project was authorized for up to \$1,227.97 in cost-share funds through the Met Council.

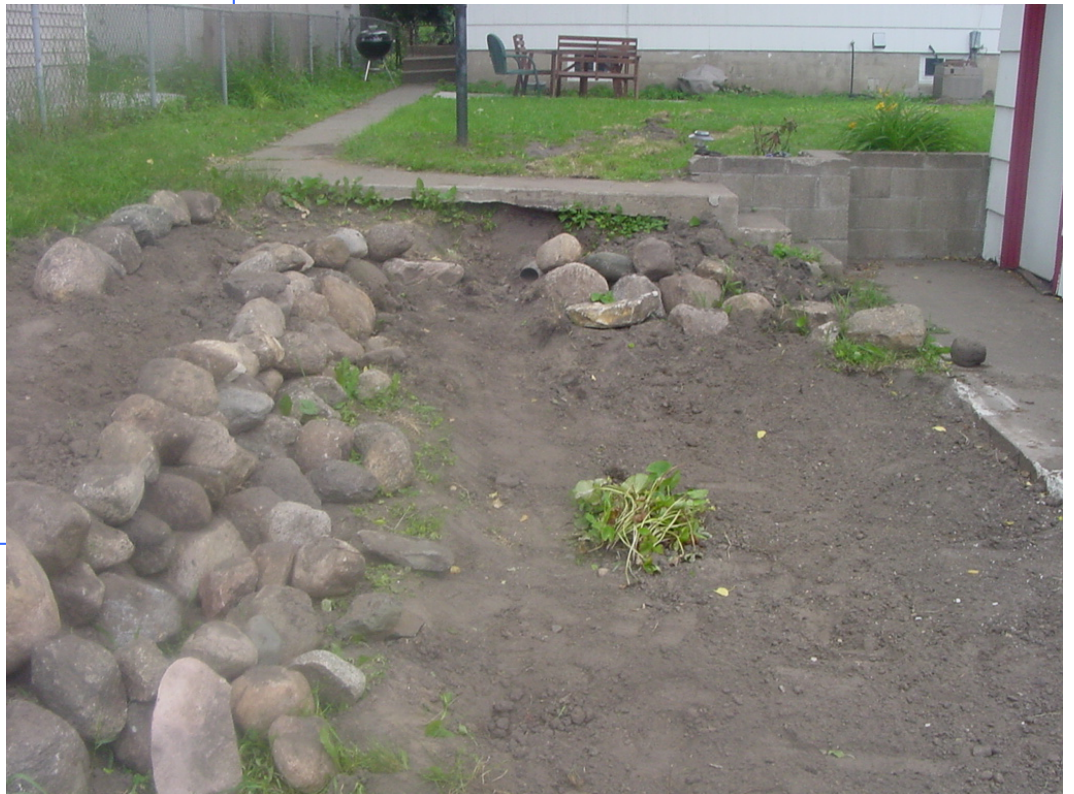
The rain garden in the back yard was designed to revitalize a previously landscaped area. The existing rock and drainage features were incorporated in the design.

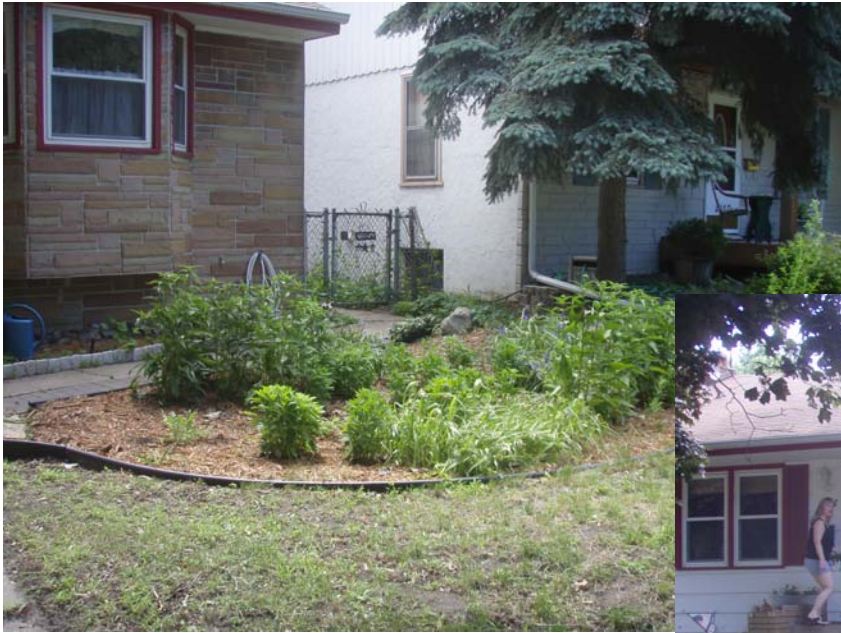
June 2008

Rain falling on the roof is directed by drain tile to the rain gardens for treatment.

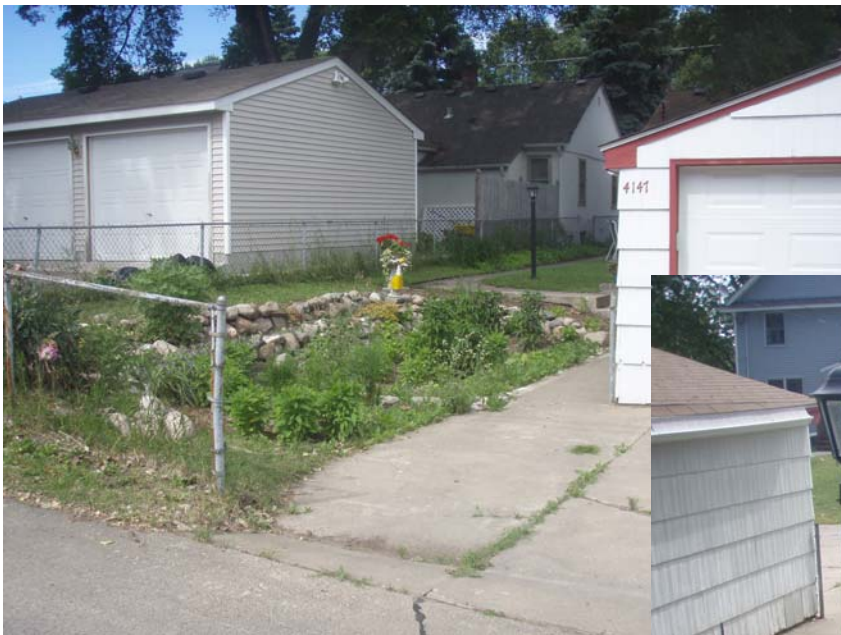
June 2008

The rain gardens can treat up to 81 ft<sup>3</sup>, reducing pollution and nutrient input to the Mississippi River..
