# ZWIERS PROPERTY

River Bank Stabilization

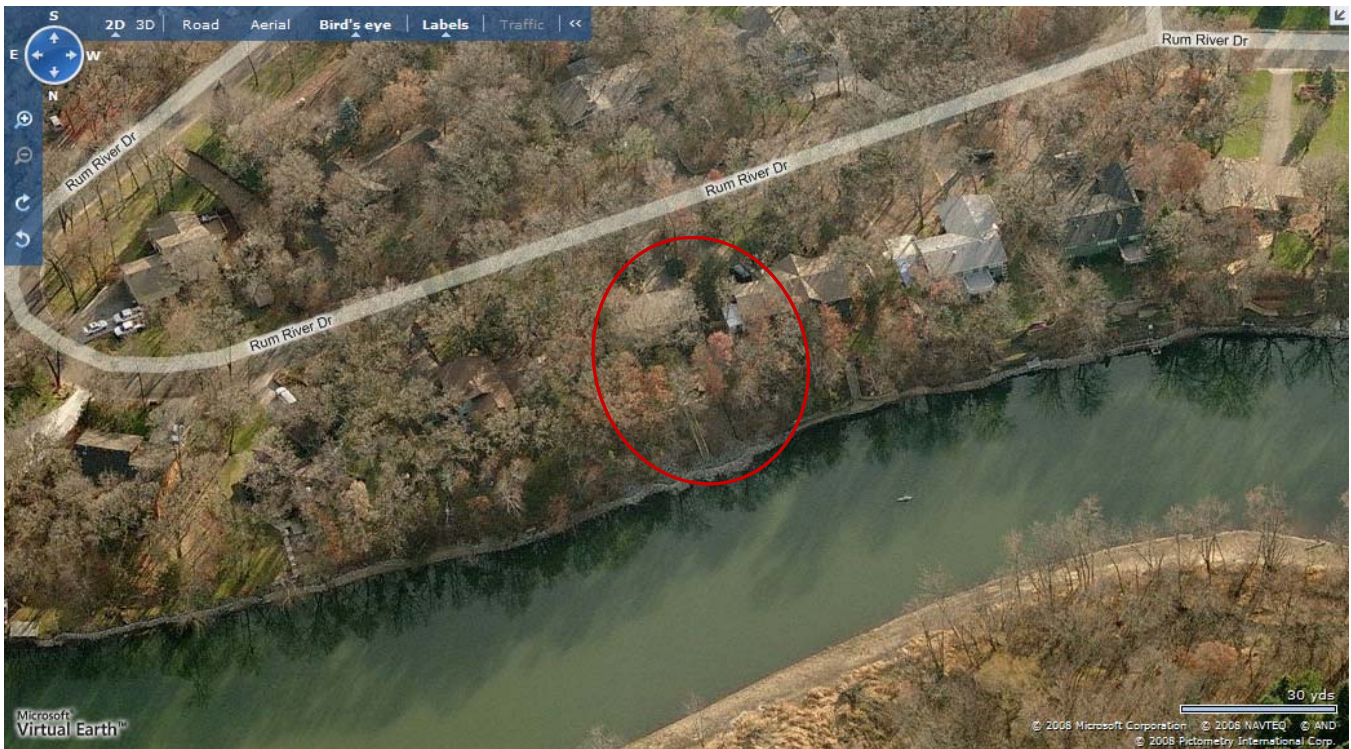
The Zwiwers property lies along the Rum River in Anoka. The site is on the outside of a bend with the deepest part of the channel adjacent to the bank.. Moderate erosion and bank undercutting had led to bank failure that would have continued to threaten the Zwiwers property if not addressed. For this site, the toe of the slope was first stabilized with riprap and the slope was vegetated using plants native to the area. Benefits of the project include:

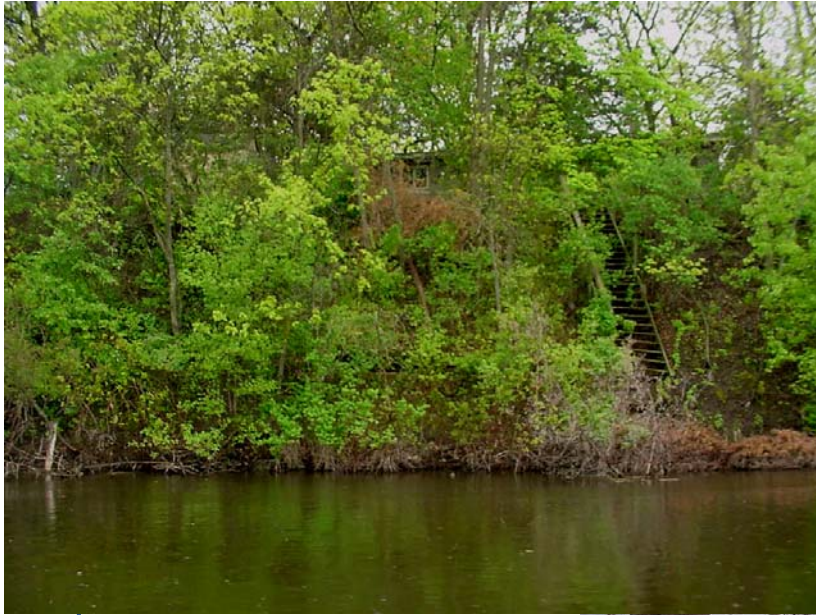
◀ June 2004

The Zwiers site had recently suffered a slope blow out and the toe of the slope showed signs of moderate erosion. A cedar tree revetment was installed to protect the toe until it could be further stabilized with riprap.

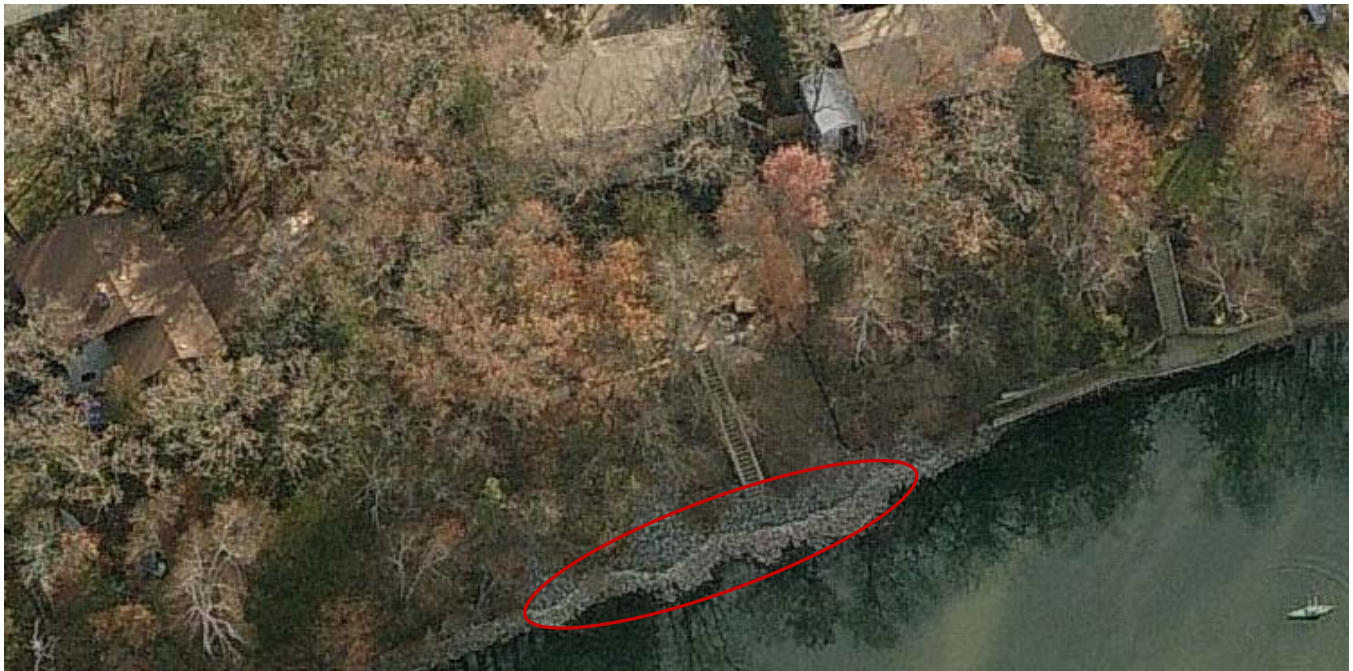
The project was designed by Barr Engineering and installed by a contractor. The newly installed riprap repaired the undercut banks and erosion already present. Additionally, the riprap stabilizes the toe of the slope and protects the slope from future erosion and bank failure resulting from river flow on the Rum River.
