# DELLWOOD RIVER PARK RUM RIVERBANK STABILIZATION, CITY OF SAINT FRANCIS

## Project Summary

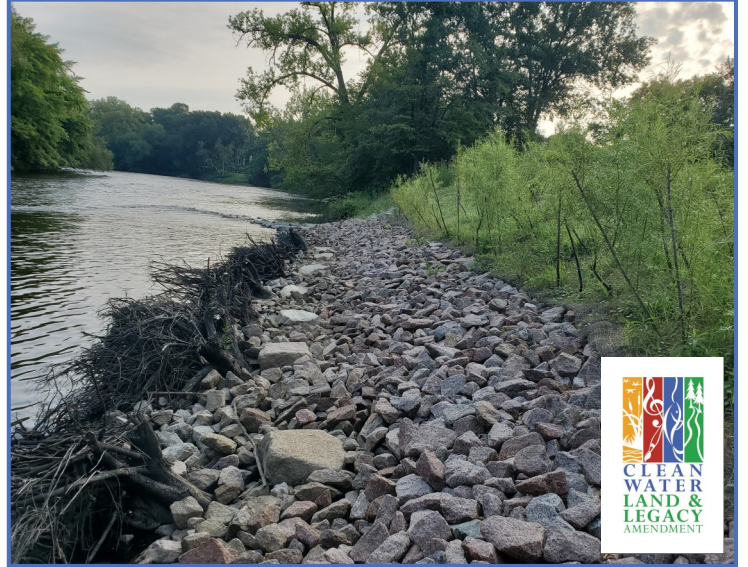
Photo nine months post-construction showing bendway weir directing flow off the previously eroded bank and native vegetation taking hold above the rock.

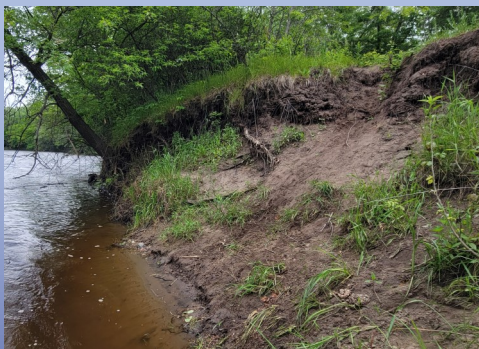
A range of moderate toe erosion to severe bank washouts existed. Several practices were implemented to armor where needed and enhance habitat where possible. These included; rock riprap, rootwads, cedar revetment, bendway weirs, and native live stakes and seed.

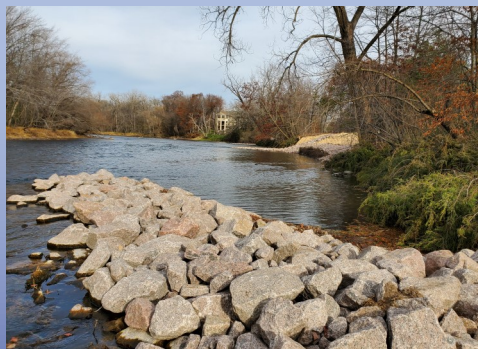
By redirecting flow and erosive scour away from the bank, we were able to minimize the riprap hard armoring to just the most severe areas. This greatly reduced the clearing of mature trees and unnecessary disturbance of the bank along the entire length.

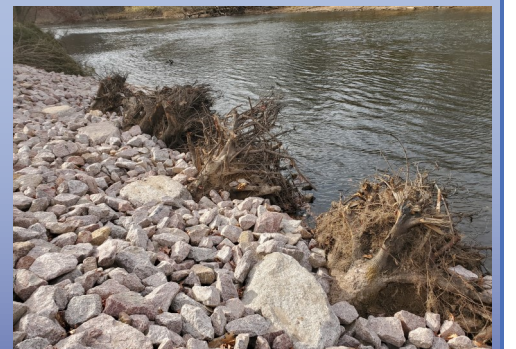
Rootwads at the rock/water interface provide additional cover and habitat value in the armored areas. Large boulders were placed on each rootwad, providing stable footing to fish from shore at a popular public park.
