PROJECT PROFILE

NAHRING RIVERBANK STABILIZATION RAMSEY, MN

Riverbank Stabilization

Project Summary

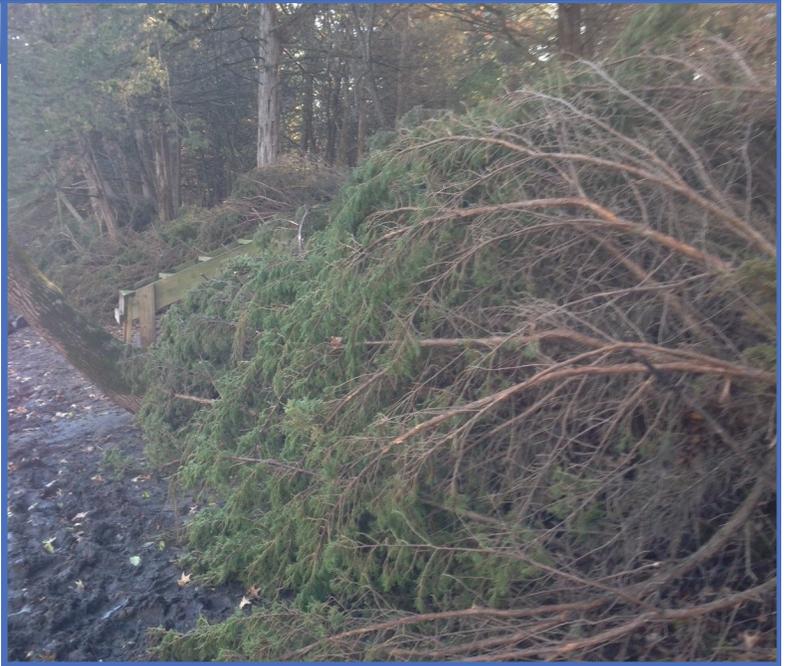
Completed project in the fall of 2016.

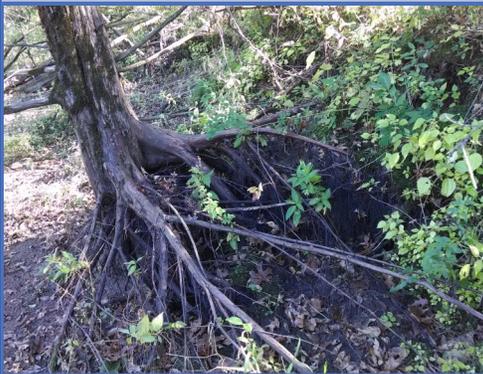
Pre-stabilization conditions consisted of an actively eroding riverbank and sparse understory vegetation, which provided no benefits to water quality. Bare soil and exposed tree roots were clearly visible.
