# PLAISTED PROPERTY BANK STABILIZATION OAK GROVE, MN

## Project Summary

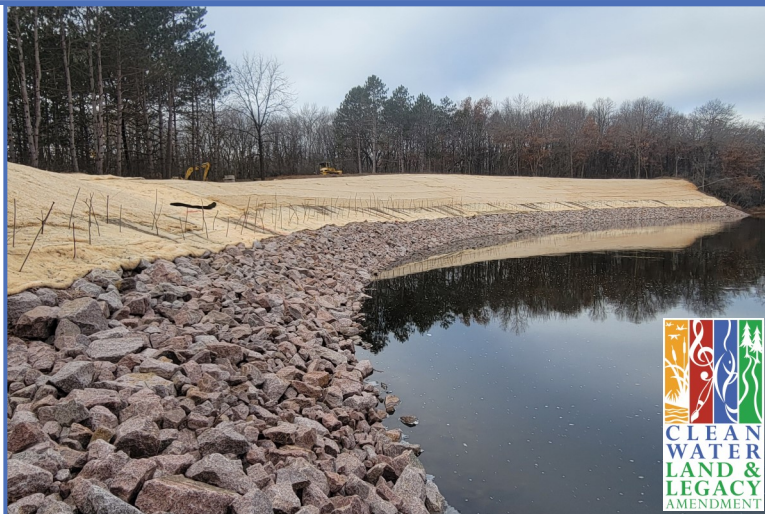
Post-construction November, 2024. Photo faces downstream.

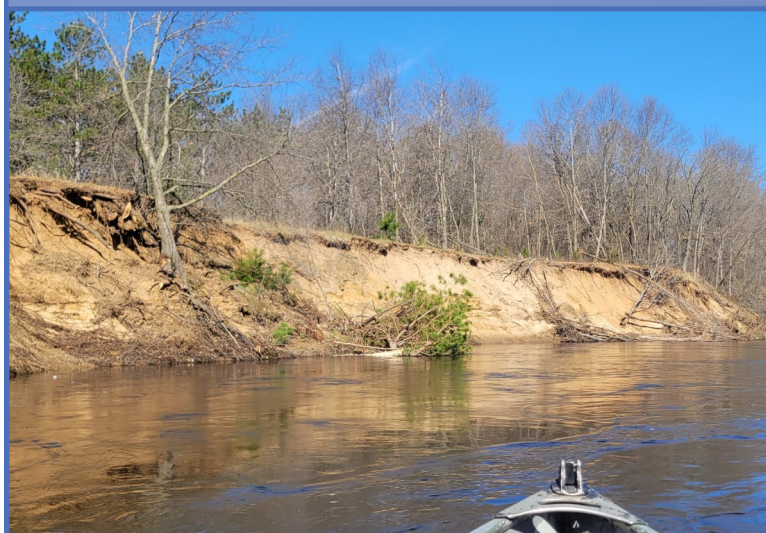
Prior to project installation, this site was one of the fastest receding Rum Riverbanks documented in Anoka County, contributing one of the most significant direct pollutant loads to the river each year.
