RUM RIVER CENTRAL REGIONAL PARK RIVERBANK STABILIZATION

Riverbank
Stabilization

Project Summary

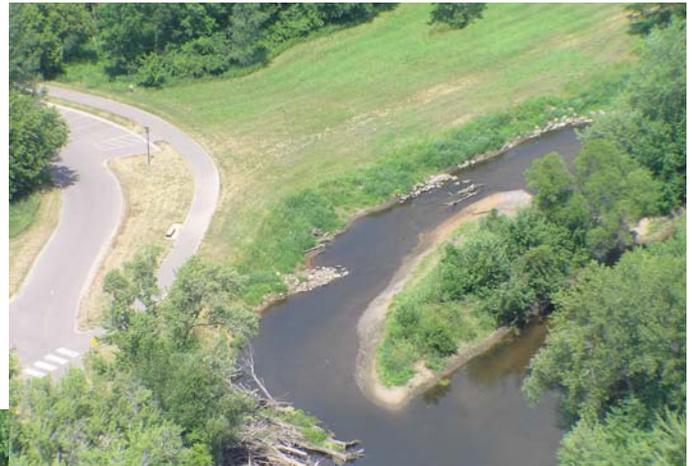
Site 1 ▶

July 2006, 3 years after installation

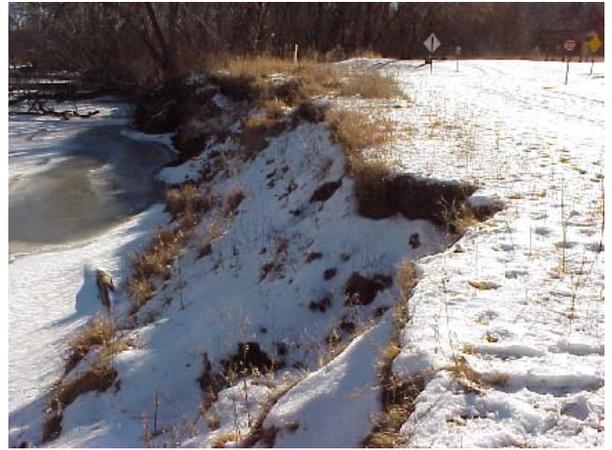
March 2002 ►

Site 1 consisted of approximately 350 feet of eroding riverbank within ten feet of a bituminous trail and twenty feet of a road. A combination of submerged rock vanes, erosion fabric and a native plant buffer was selected to address the erosion problem.

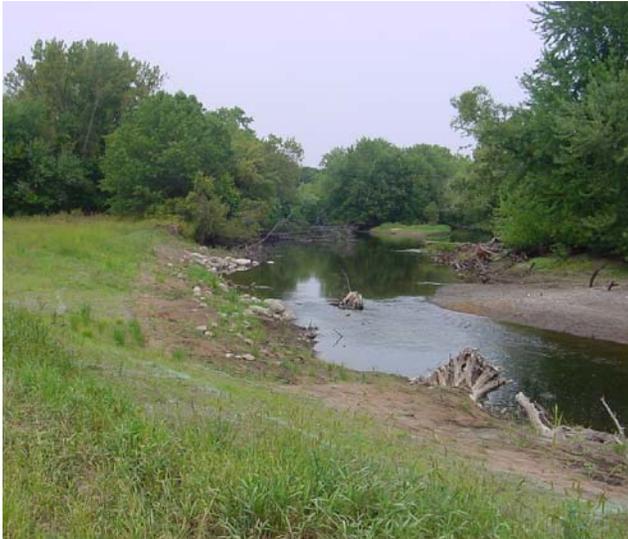
◀ September 2003

Two submerged rock vanes were installed and the site was graded. Following grading, one root wad was installed. CF7 erosion fabric was installed on the bank below bankfull and straw erosion blanket was installed above bank full. Areas below bankfull were planted with native plugs at 18 inch intervals while areas above bankfull were seeded with a native seed mix and planted with native plugs at 36 inch intervals.

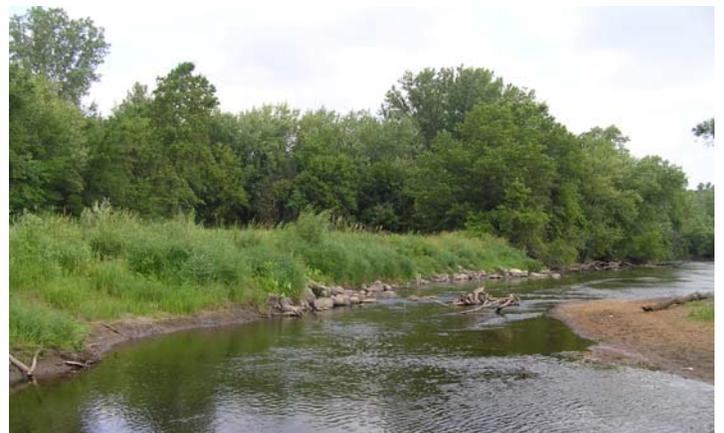
July 2006 ►

Three years after project installation, the slopes are well vegetated. Root wad deteriorated.

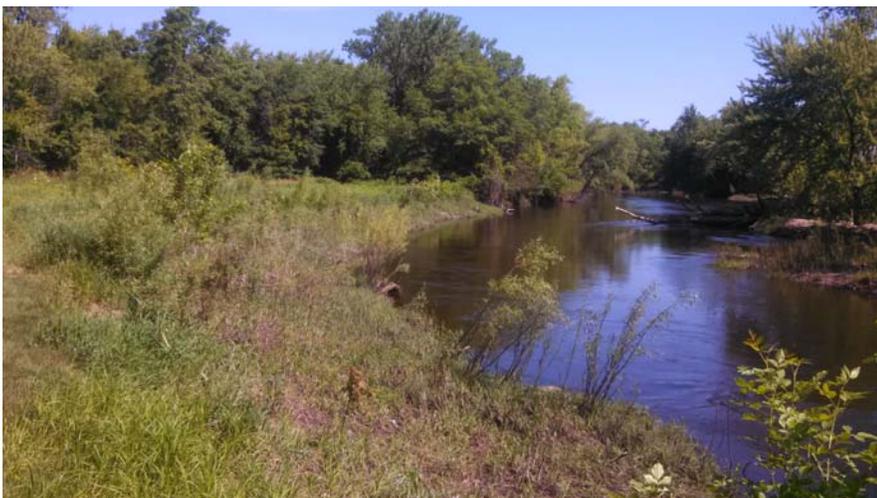
◀ July 2014

Several years following installation. Very little of root wad remaining on downstream end of project. Severe blow out just downstream of project follow sustained high water in spring.

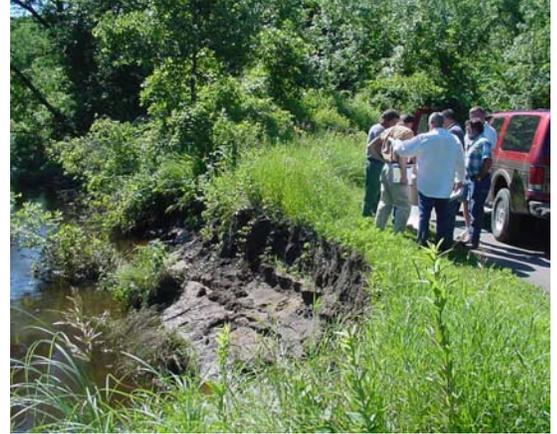
July 2002 ►

Site 2 consisted of approximately 200 feet of eroding riverbank within five feet of a bituminous trail. A combination of root wads, minimal rock, erosion fabric and a native plant buffer was selected to address the erosion problem.

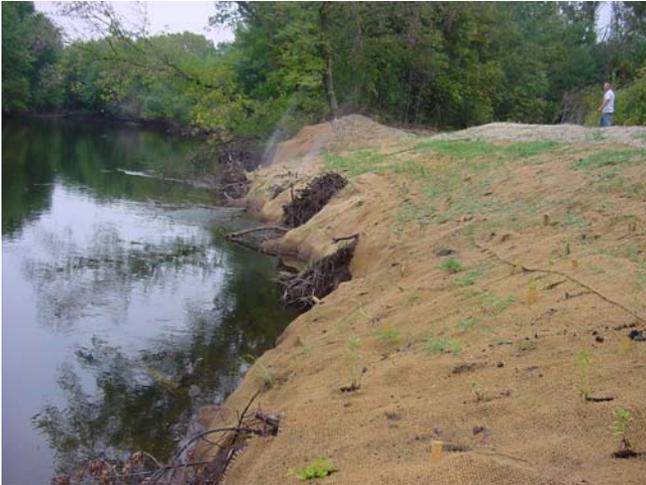
◀ September 2003

High water delayed grading and project installation at site 2. However, after grading occurred, root wads and minimal rock were installed along with erosion control fabric and a native buffer. Areas below bankfull were planted with native plugs at 18 inch intervals while areas above bankfull were seeded with a native seed mix and planted with native plugs at 36 inch intervals.

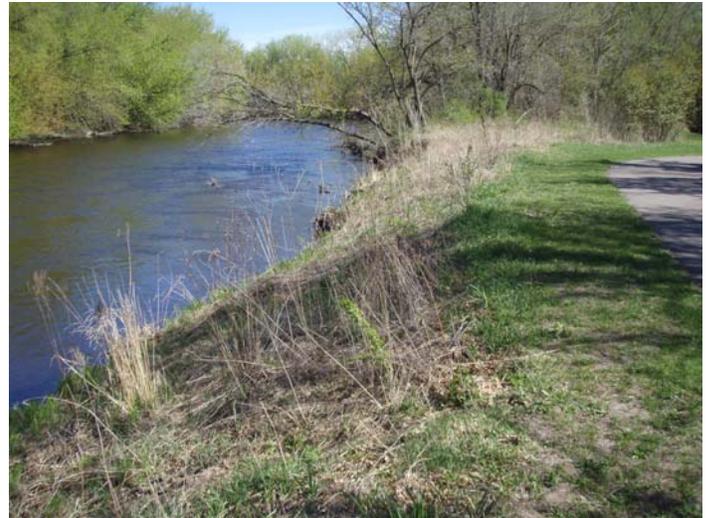
May 2007 ►

Four years after project installation, the slope is well vegetated. Root wad heavily degraded.

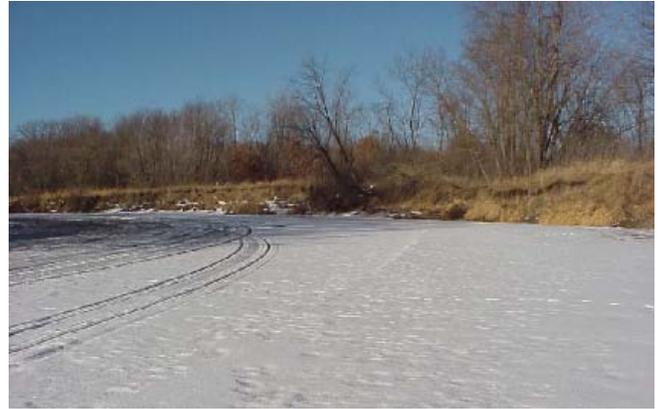
March 2002 ▶

Site 3 consisted of approximately 700 feet of eroding riverbank within twenty feet of a grass horse trail. A combination of root wads, submerged rock vanes, minimal toe reinforcement with rock, erosion fabric and a native plant buffer was selected to address the erosion problem.

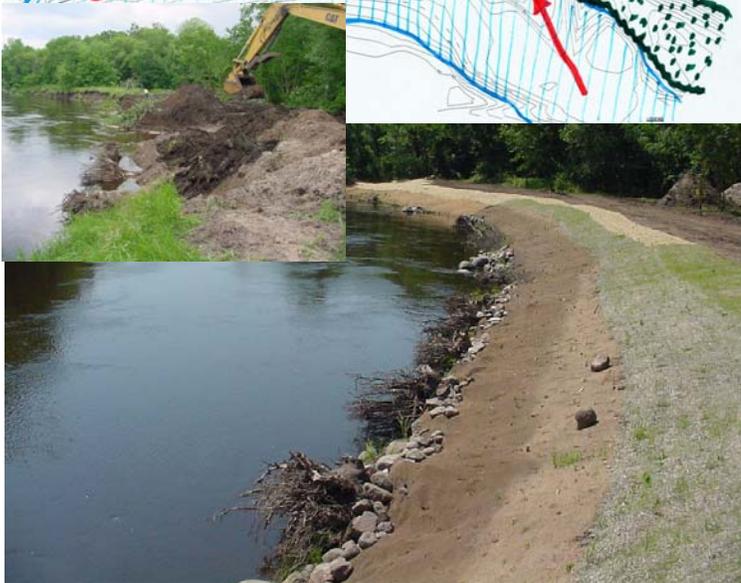
Two submerged rock vanes were installed along with six root wads. After grading, erosion control fabric and native buffer were installed. Areas below bankfull were planted with native plugs at 18 inch intervals while areas above bankfull were seeded with a native seed mix and planted with native plugs at 36 inch intervals.
