# **2013 Anoka Water Almanac**

## **Water Quality and Quantity Conditions of Anoka County, MN**

**A Report of Activities by  
Watershed Organizations and the  
Anoka Conservation District**

**Prepared by the Anoka Conservation District**

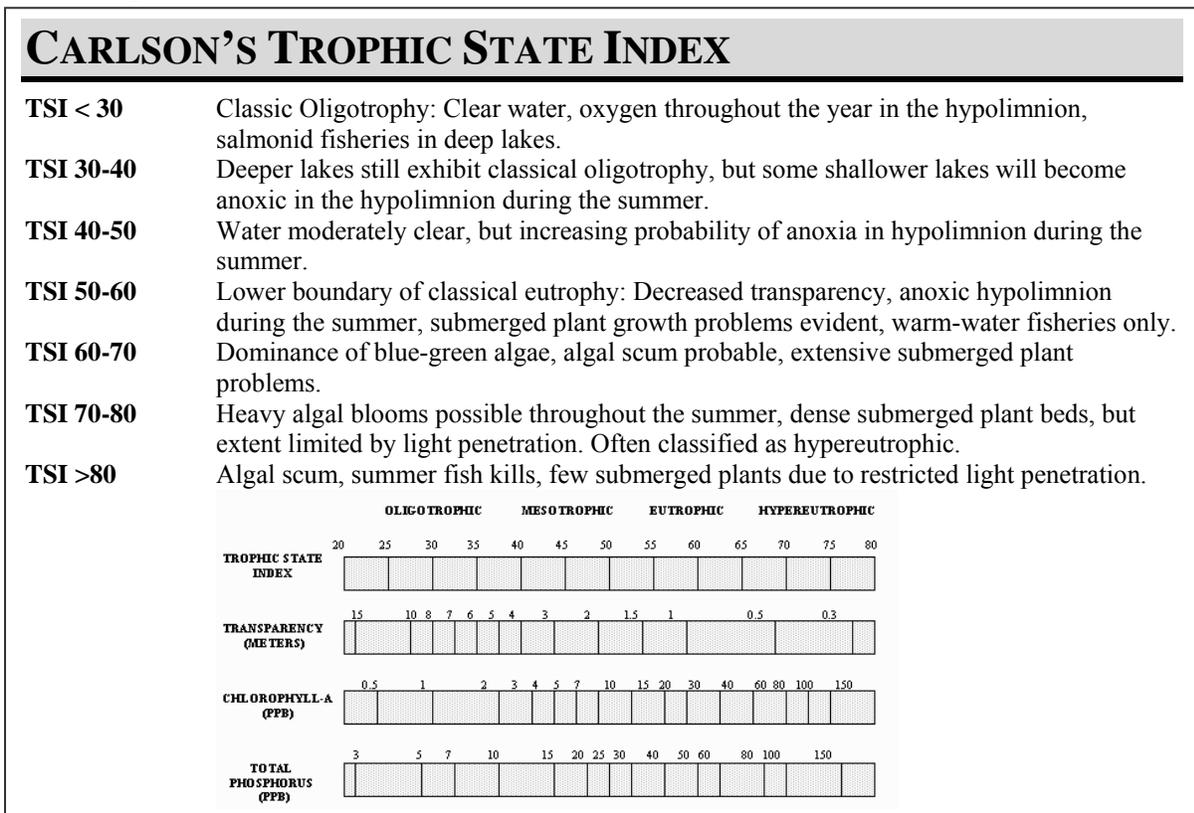
**A-** Carlson’s Trophic State Index (see figure below) is a number used to describe a lake’s stage of eutrophication (nutrient level, amount of algae). The index ranges from oligotrophic (clear, nutrient poor lakes) to hypereutrophic (green, nutrient overloaded lakes). The index values generally range between 0 and 100 with increasing values indicating more eutrophic conditions. Unlike the lake letter grading system, the Carlson’s Trophic State Index does not compare lakes only within the same ecoregion; it is a scale used worldwide.

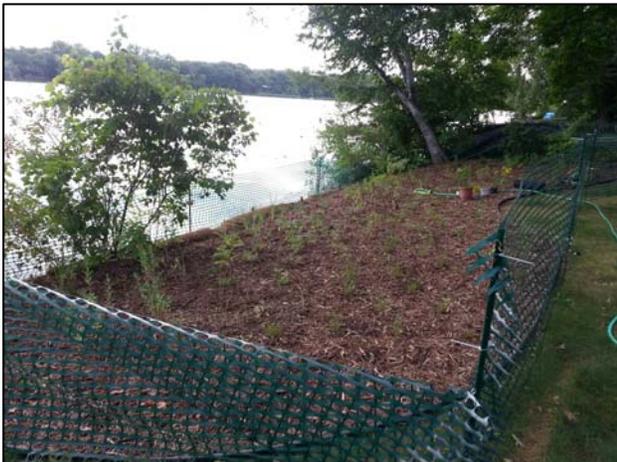
**Example project** – The photo on the left shows a lakeshore restoration on Golden Lake in Circle Pines completed in the summer of 2013. ACD provided technical/design assistance and construction oversight. The project consisted of bioengineering techniques to stabilize an actively eroding shoreline. Furthermore, native plant species were used to provide wildlife habitat. Cost-share funds were provided to the homeowner from the RCWD cost-share program.

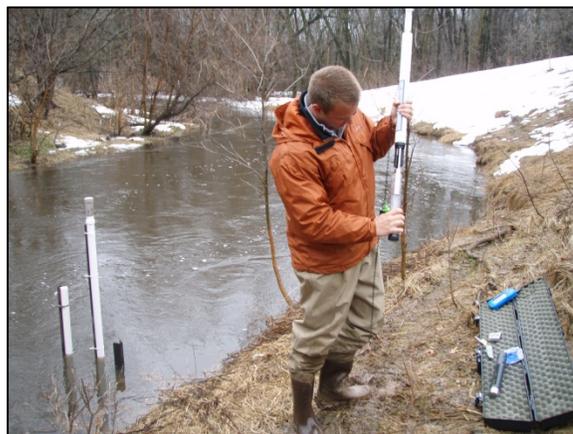
Staff deploying the Hydrolab MS5. In the background are the Hydrolab casing (shorter) and a Measura continuous water level monitoring device.

The Hydrolab was deployed into the stream when a storm predicted to drop at least 0.5 inches of rain, and preferably greater, was approaching. Past grab sample monitoring had found that the greatest water quality problems occurred after storms exceeding one inch. In some instances, water level

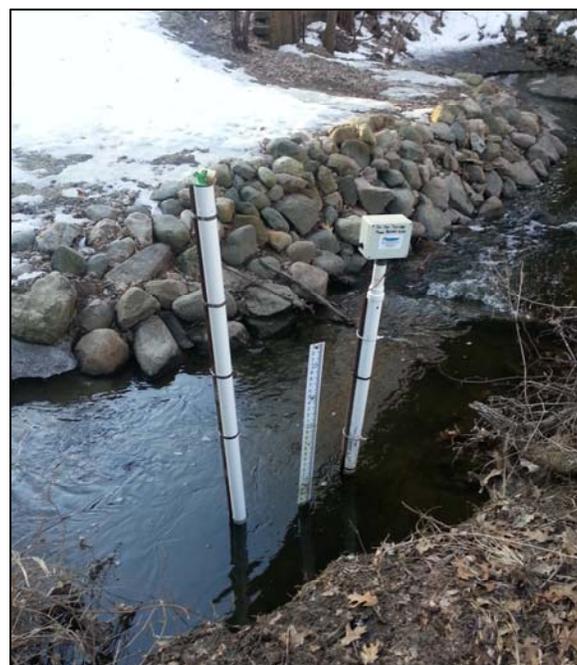
Hydrolab MS5 casing (taller) and a Measura continuous water level monitoring device in Pleasure Creek. A staff gauge is shown in the middle.

The Hydrolab was deployed into the stream when a storm predicted to drop at least 0.5 inches of rain, and preferably greater, was approaching. In some instances, water level was

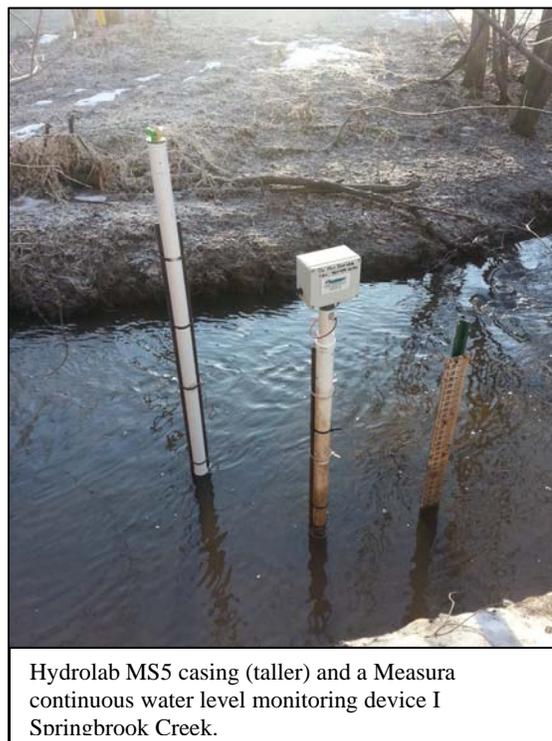
Hydrolab MS5 casing (taller) and a Measura continuous water level monitoring device I Springbrook Creek.

The Hydrolab was deployed into the stream when a storm predicted to drop at least 0.5 inches of rain, and preferably

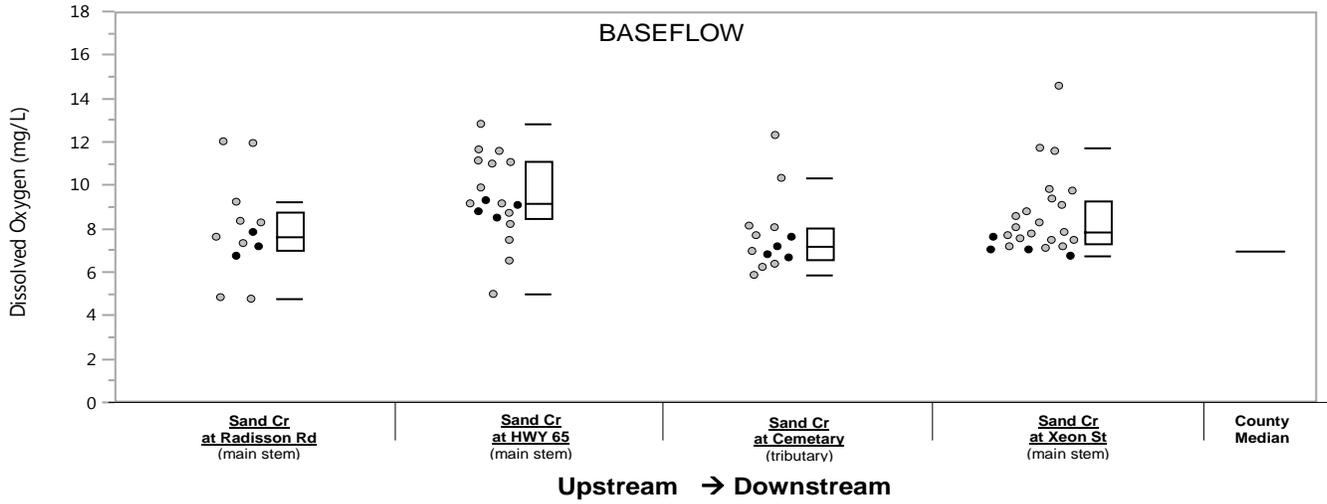
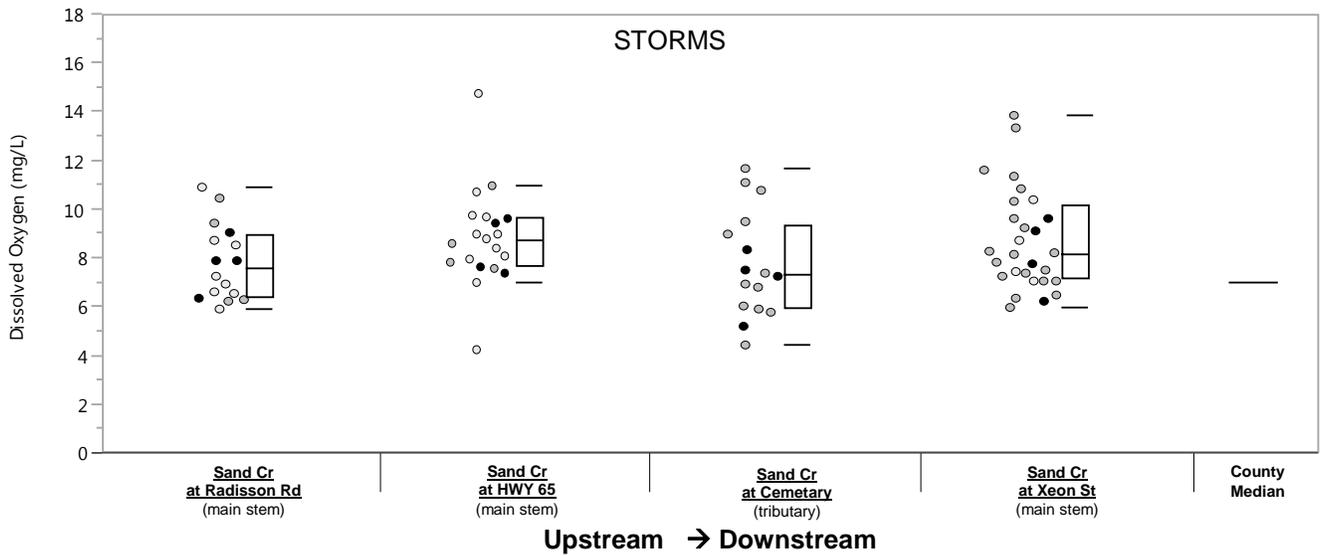
**Dissolved Oxygen at Sand Creek.** Dots are individual readings. Black dots are 2013 readings; grey dots are from previous years. Box plots show the median (middle line), 25<sup>th</sup> and 75<sup>th</sup> percentile (ends of box), and 10<sup>th</sup> and 90<sup>th</sup> percentiles (floating lines).

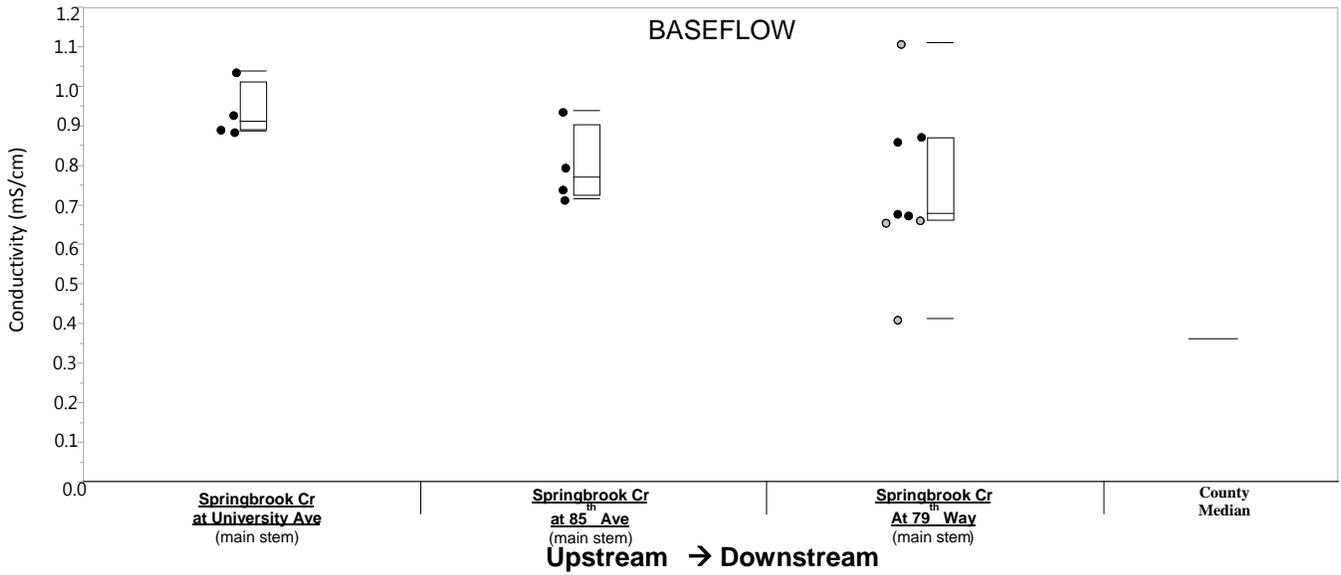
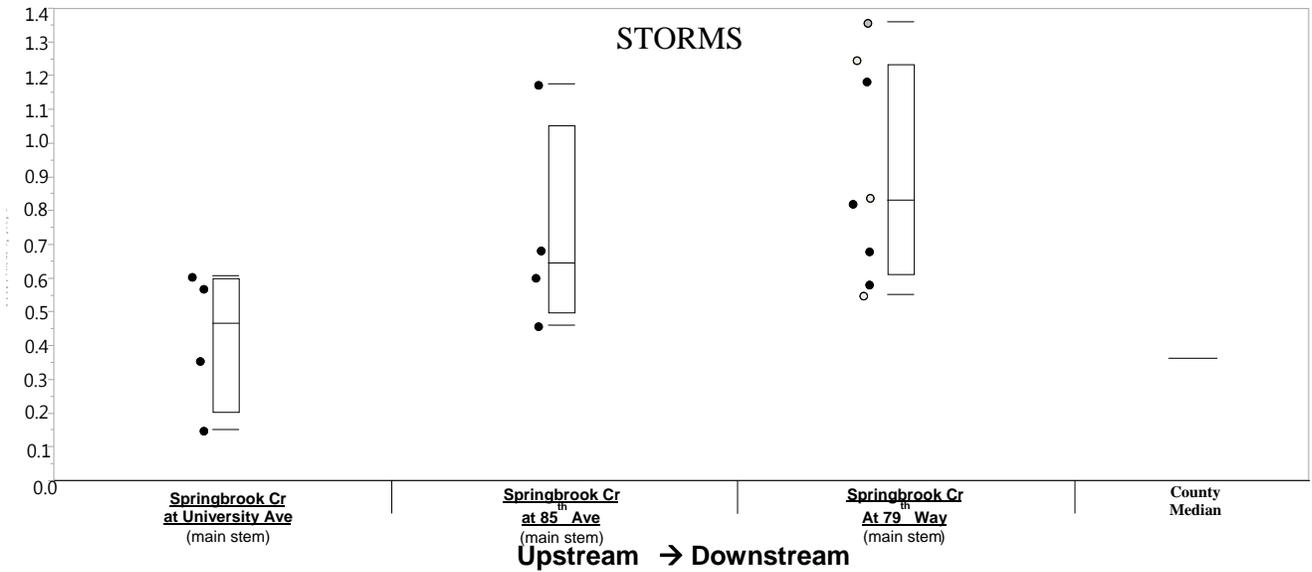
**Conductivity at Springbrook Creek.** Dots are individual readings. Black dots are 2013 readings; grey dots are from previous years. Box plots show the median (middle line), 25<sup>th</sup> and 75<sup>th</sup> percentile (ends of box), and 10<sup>th</sup> and 90<sup>th</sup> percentiles (floating outer lines).

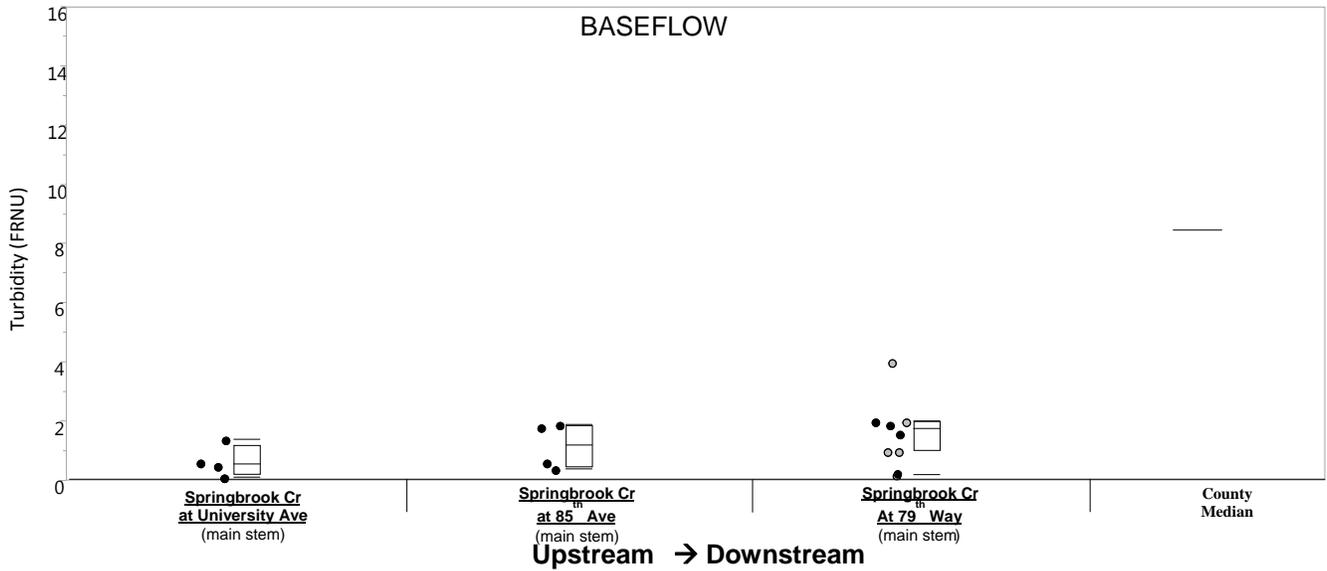
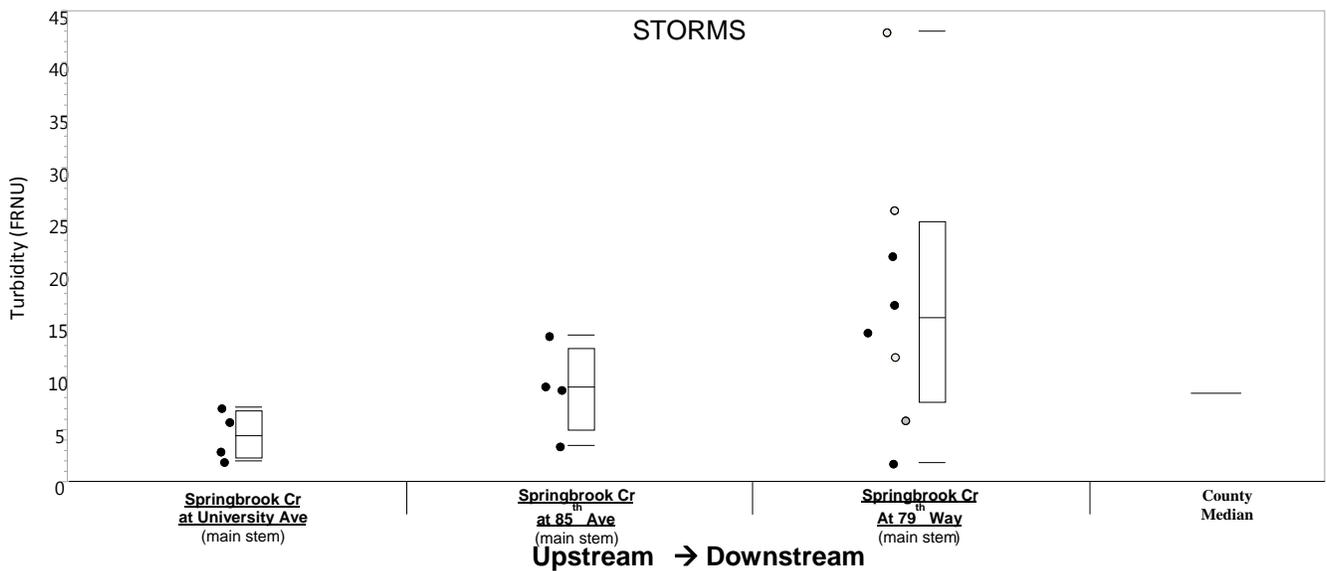
**Turbidity at Springbrook Creek.** Dots are individual readings. Black dots are 2013 readings; grey dots are from previous years. Box plots show the median (middle line), 25<sup>th</sup> and 75<sup>th</sup> percentile (ends of box), and 10<sup>th</sup> and 90<sup>th</sup> percentiles (floating outer lines).

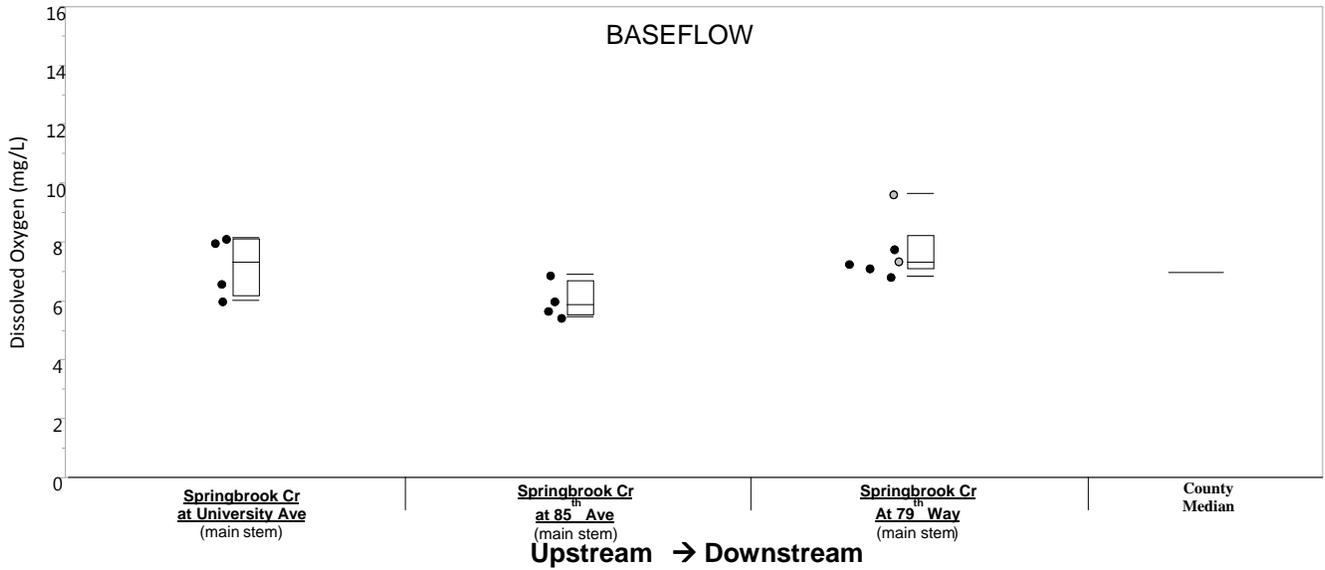
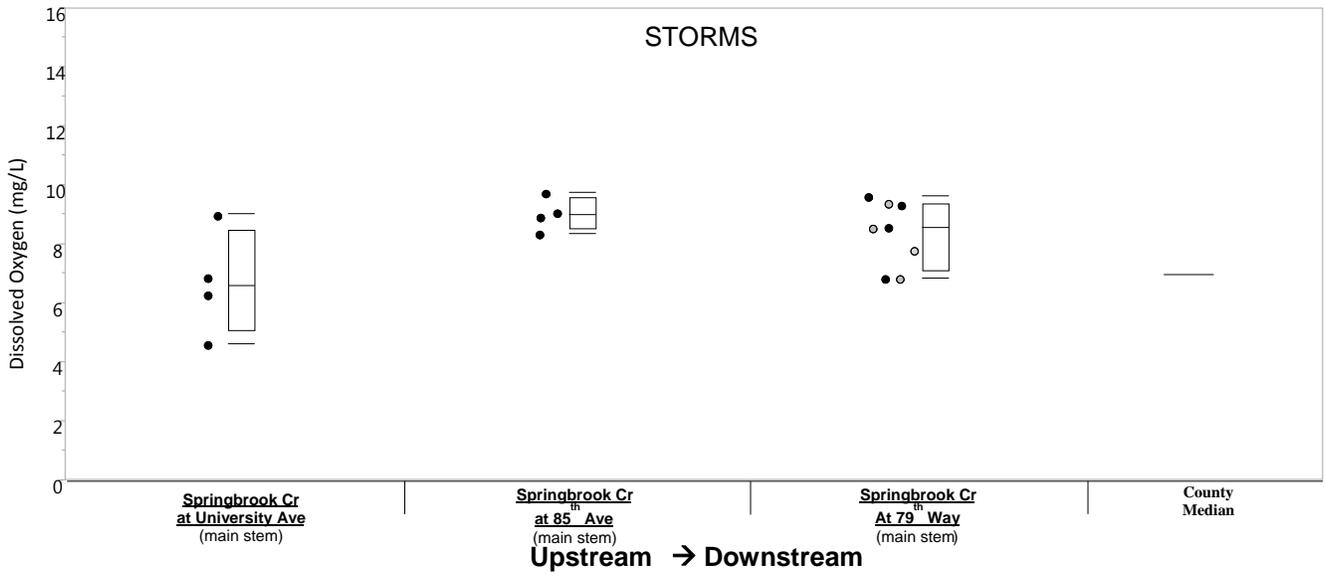
**Dissolved Oxygen at Springbrook Creek.** Dots are individual readings. Black dots are 2013 readings; grey dots are from previous years. Box plots show the median (middle line), 25<sup>th</sup> and 75<sup>th</sup> percentile (ends of box), and 10<sup>th</sup> and 90<sup>th</sup> percentiles (floating outer lines).

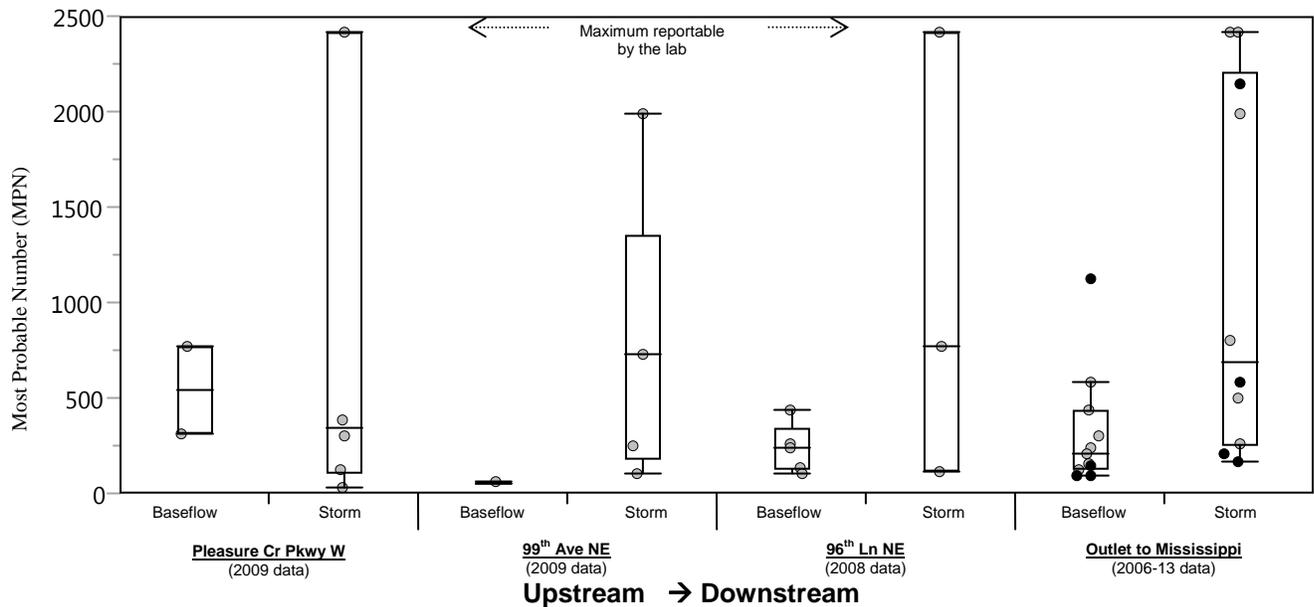
**E. coli Bacteria Results During Base and Storm Conditions.** Black dots are 2013 readings; grey dots are from previous years. Box plots show the median (middle line), 25<sup>th</sup> and 75<sup>th</sup> percentile (ends of box), and 10<sup>th</sup> and 90<sup>th</sup> percentiles (floating outer lines).

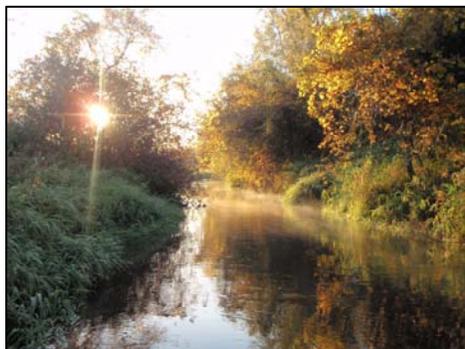
Coon Creek at Andover High School sampling site.

The invertebrate community suggests Coon Creek's health is average compared to other nearby streams. The stream's habitat is relatively sparse, mostly due to past excavations aimed at making the creek perform like a ditch. The supplemental stream water chemistry readings taken during biomonitoring indicate a higher than expected level of dissolved pollutants, as measured by conductivity. Conductivity and salinity were similar to, though not as extreme as, some urbanized streams at the same time of year. The source could be road salts, failing septic systems, and/or chemical wastes. These factors, as well as the general lack of habitat in this ditched stream, probably limit the invertebrate community.

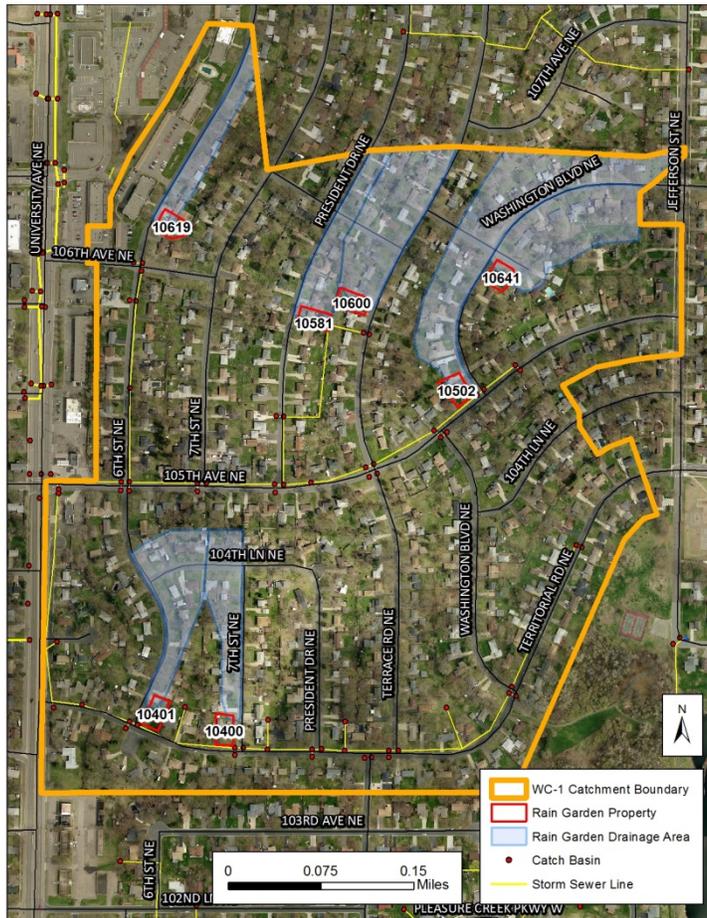
**Sites of seven rain gardens installed in the WC-1 catchment of the Woodcrest Creek subwatershed in 2013.**

- Purpose:** To improve stormwater quality and reduce the volume of runoff generated within the WC-1 catchment. All stormwater runoff from this catchment previously discharged directly into the stormwater system without receiving treatment, which contributes to the degradation of Woodcrest Creek and Coon Creek.

- Results:** ACD staff targeted approximately 65 priority properties in the residential neighborhood located within catchment WC-1 to identify landowners interested in participating in the rain garden program. Interested landowners attended an educational meeting held by ACD. Those landowners with favorable rain garden sites and willingness to move forward with the program entered into contracts with the CCWD for rain garden construction. ACD staff provided design and construction management for the installation of seven rain gardens throughout the WC-1 catchment. The rain gardens were installed at strategic locations to ensure sufficient contributing drainage areas and maximize treatment. Long-term maintenance will be provided by the landowners under an agreement with the CCWD. Cumulatively, these seven rain gardens provide treatment to 15% of the WC-1 catchment and reduce stormwater runoff volumes into Woodcrest Creek by 6.1 acre-ft/yr, total suspended solids by 2,771 lbs/yr, and total phosphorus by 8.6 lbs/yr.
