Excerpt from the 2022 Water Almanac

Chapter 4: Lower Rum River Watershed

Prepared by the Anoka Conservation District

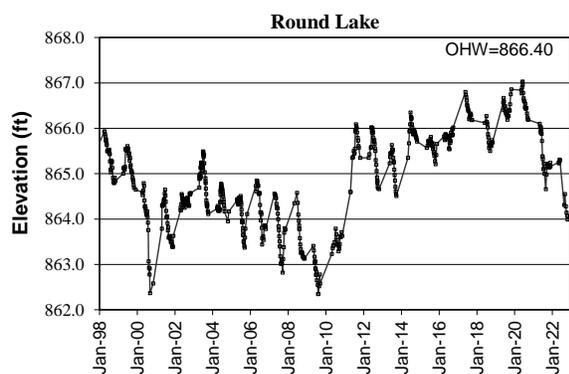
Round Lake Levels – last 25 years

Water levels on all lakes were well below the lake levels that were recorded over the last five years. Round lake reached its lowest water level since 2010, including the lowest average and the lowest maximum water level. This year was similar to the extremely low water levels observed on Round Lake during years 2000-2010. Water levels on Sunfish/Grass and Lake Itasca also reached their lowest level since 2010. Water levels in Lake Itasca and Rogers Lake, receded to the point where excessive vegetation made it difficult to accurately take readings were no longer possible to obtain. Water levels on Rogers Lake were only recorded for the month of May and the last reading collected for the year on Lake Itasca was in July, 2022.

The Ordinary High Water Level (OHW) is listed for each lake on the corresponding graphs below and any work that is to occur below this elevation a DNR permit is required.

Lake	Year	Average	Min	Max
Round	2018	865.80	865.50	866.27
	2019	866.45	866.19	866.86
	2020	866.61	866.19	867.03
	2021	865.41	864.66	866.10
	2022	864.70	863.99	865.31

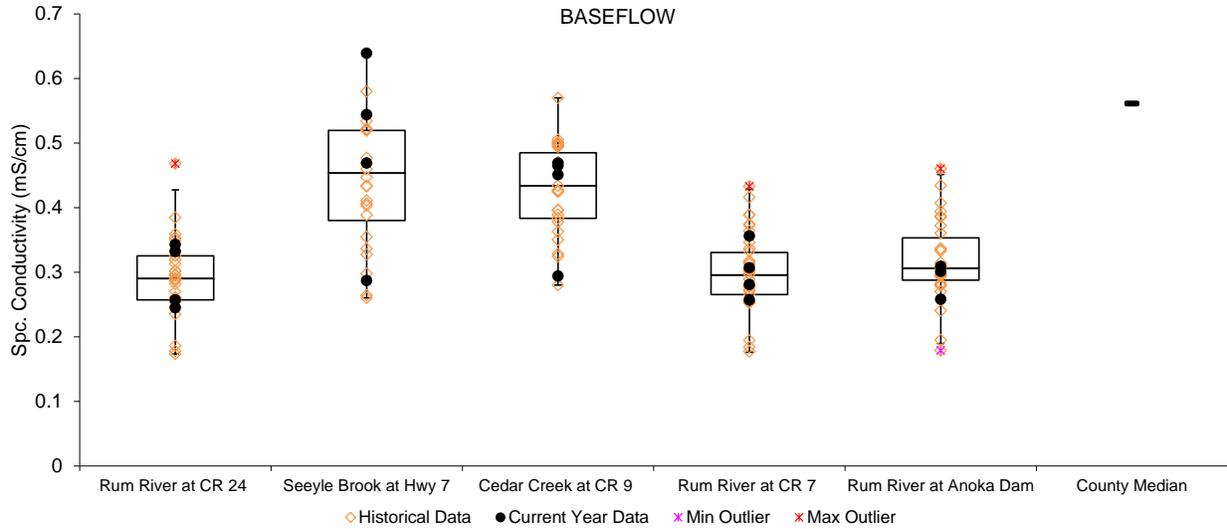
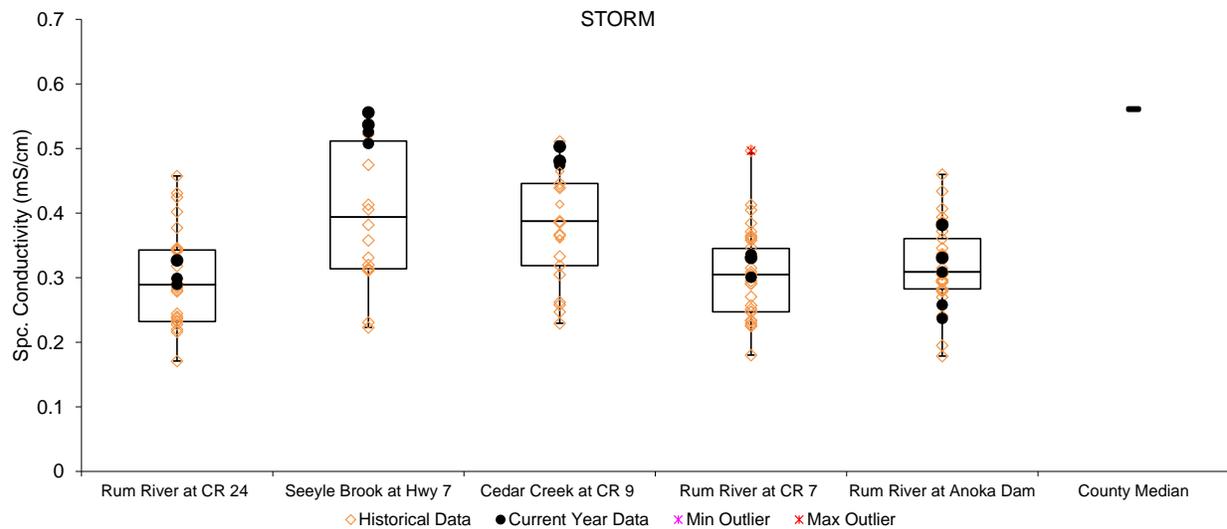
Specific Conductivity during Baseflow and Storm Conditions. Orange diamonds are historical data from previous years and black circles are 2022 readings. Box plots show the median (middle line), 25th and 75th percentile (ends of box), and 10th and 90th percentiles (floating outer lines).

Specific conductivity was acceptably low in the Rum River including in 2022. Conductivity at Rum River sites was similar, and in nearly all years it increases slightly upstream to downstream. Average specific conductivity from upstream to downstream in 2022 (all conditions) was 0.299 mS/cm, 0.310 and 0.298 mS/cm, respectively. This consistent trend of increasing conductivity from upstream to downstream likely reflects higher road densities and greater deicing efforts with salt application as well as other pollutant sources associated with higher road density and development. All three sites had levels lower than the historical median for Anoka County streams of 0.561 mS/cm.

In past years' conductivity was usually higher during baseflow conditions but this was not the case in 2022. Lower conductivity following a storm event suggests that stormwater runoff contains fewer dissolved pollutants than the surficial water table that feeds the river during baseflow. High baseflow conductivity has been observed in many area streams with the largest source believed to be road salts that have infiltrated into the shallow aquifer. Water softening salts and geologic materials can also be contributors. Lower baseflow conductivity than storm conductivity in 2022 could be influenced by low water levels in the river, variabilities in precipitation and/or runoff, or the timing when the sampling occurred.

Specific conductivity is higher in Seeyle Brook and Cedar Creek compared to the Rum River but still remains lower than the median for Anoka County streams (0.561 mS/cm). Average conductivity (all years, all conditions) was 0.508 mS/cm at Seeyle Brook and 0.452 mS/cm at Cedar Creek.

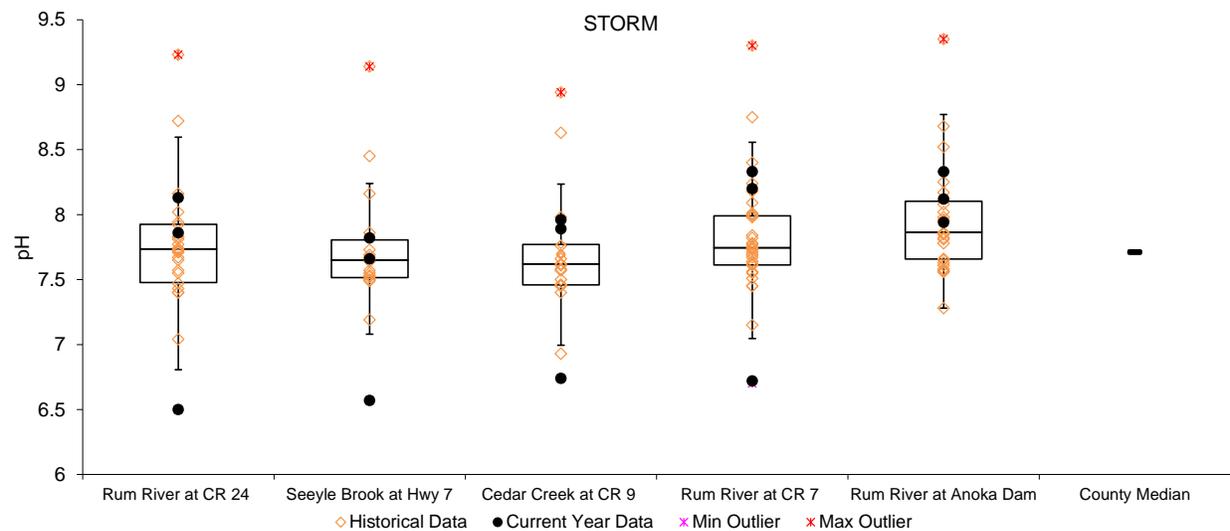
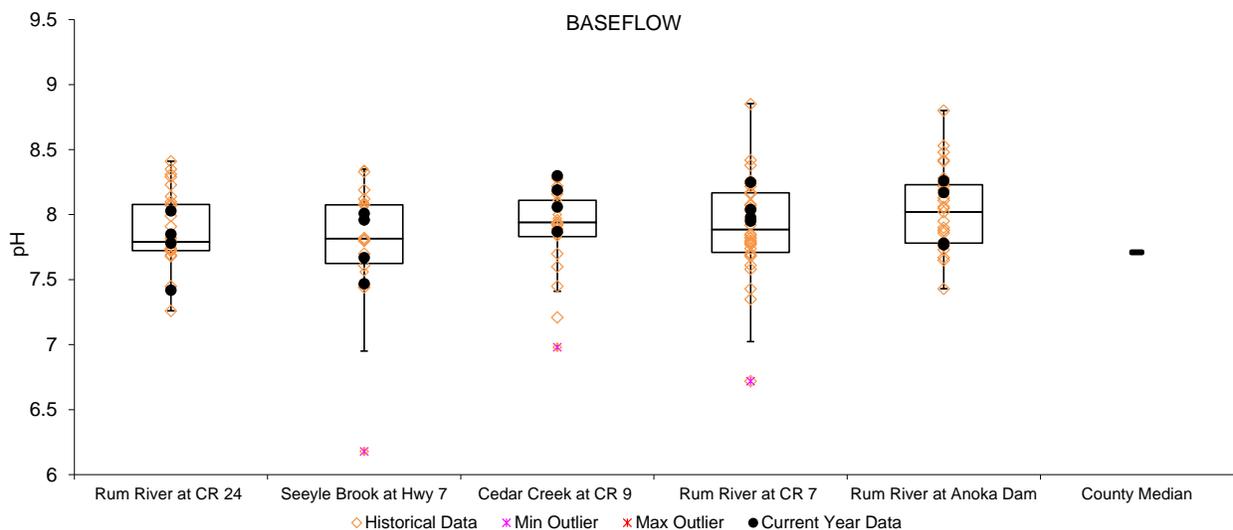
pH during Baseflow and Storm Conditions. Orange diamonds are historical data from previous years and black circles are 2022 readings. Box plots show the median (middle line), 25th and 75th percentile (ends of box), and 10th and 90th percentiles (floating outer lines).

pH refers to the acidity of the water. The state standard for pH is between 6.5 - 8.5 and pH is generally lower during storm events than during baseflow conditions because the pH of rain is typically lower (more acidic). While acid rain is a longstanding problem, its effect on this aquatic system is minimal. pH in the Rum River is generally within the healthy range and has only exceeded 8.5 on a few occasions in the past. The rare occasion when pH does exceed the state standard should not be concerning.

pH in Cedar Creek and Seeyle Brook were both within the normal healthy range in 2022. Cedar Creek has only exceeded 8.5 on two occasions historically. Seeyle Brook has only exceeded the state range (6.5-8.5) on one sampling occasion. Discharge of nutrient rich algae waters from lakes or wetlands into waterways is a factor that could influence spikes in pH. Spikes over 8.5 seem to be happening more frequently in recent years, although it is a positive development that they did not occur this year.

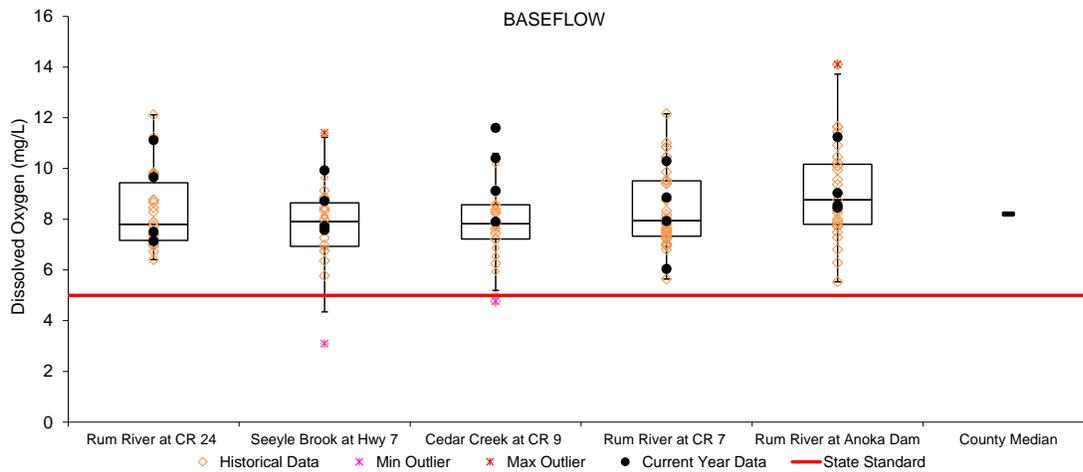
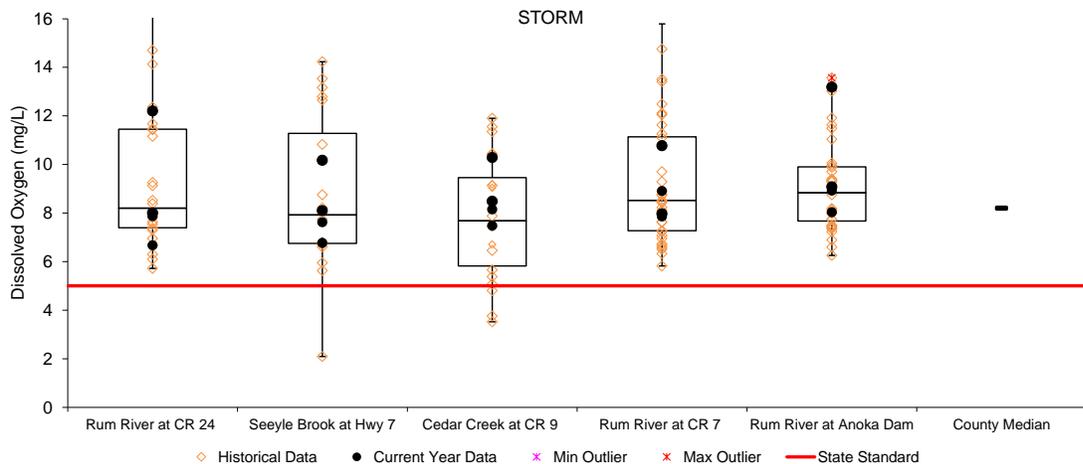
Dissolved Oxygen during Baseflow and Storm Conditions. Orange diamonds are historical data from previous years and black circles are 2022 readings. Box plots show the median (middle line), 25th and 75th percentile (ends of box), and 10th and 90th percentiles (floating outer lines).

Dissolved oxygen is necessary for aquatic life, including fish. Organic pollution causes oxygen to be consumed during decomposition. If oxygen levels in water fall below 5 mg/L, aquatic life begins to suffer. A stream is considered impaired if 10% of observations are below 5 mg/L in the last 10-years. Dissolved oxygen levels are typically lowest in the early morning because of decomposition consuming oxygen at night without the offsetting of oxygen production by photosynthesis. In 2022, all measurements of dissolved oxygen in the Rum River were above 5 mg/L. Dissolved oxygen has never been observed below the state standard (5 mg/L) at any of the Rum River sites. Only on a handful of occasions has dissolved oxygen been recorded below 6.0 mg/L and many of these results were recorded during the same storm event.

2022 dissolved oxygen measurements in Cedar Creek and Seeyle Brook were all above 5 mg/L. Median dissolved oxygen, for all years and all conditions, was 7.82 mg/L for Cedar Creek and 7.91 mg/L at Seeyle Brook. Only a few readings of dissolved oxygen below 5 mg/L have ever been recorded at either of these sites and there is no management concern at this time. Decreases in dissolved oxygen levels may be a result of increased nutrients in the system. Managing phosphorus and nitrogen loading to the streams will help ensure healthy dissolved oxygen levels.

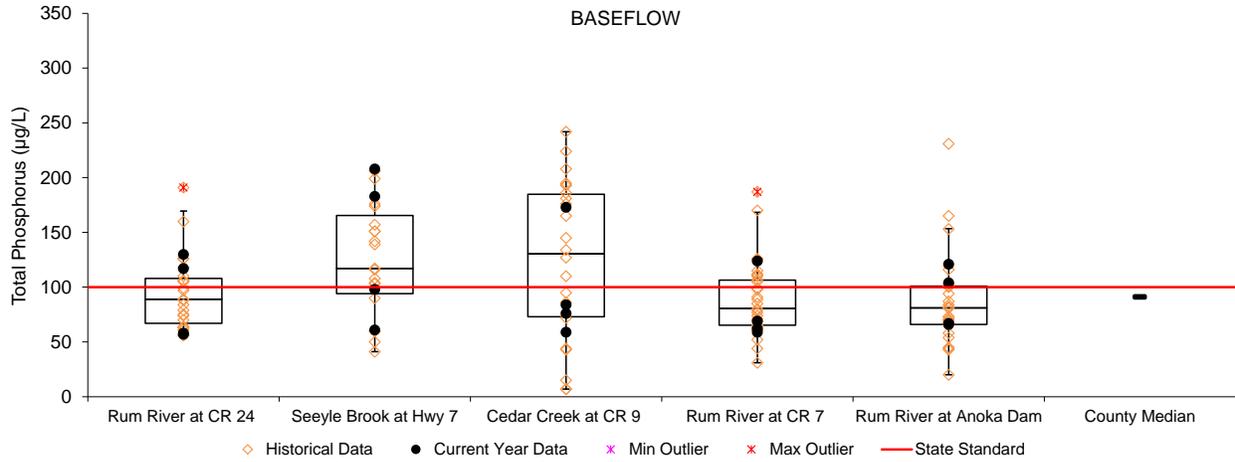
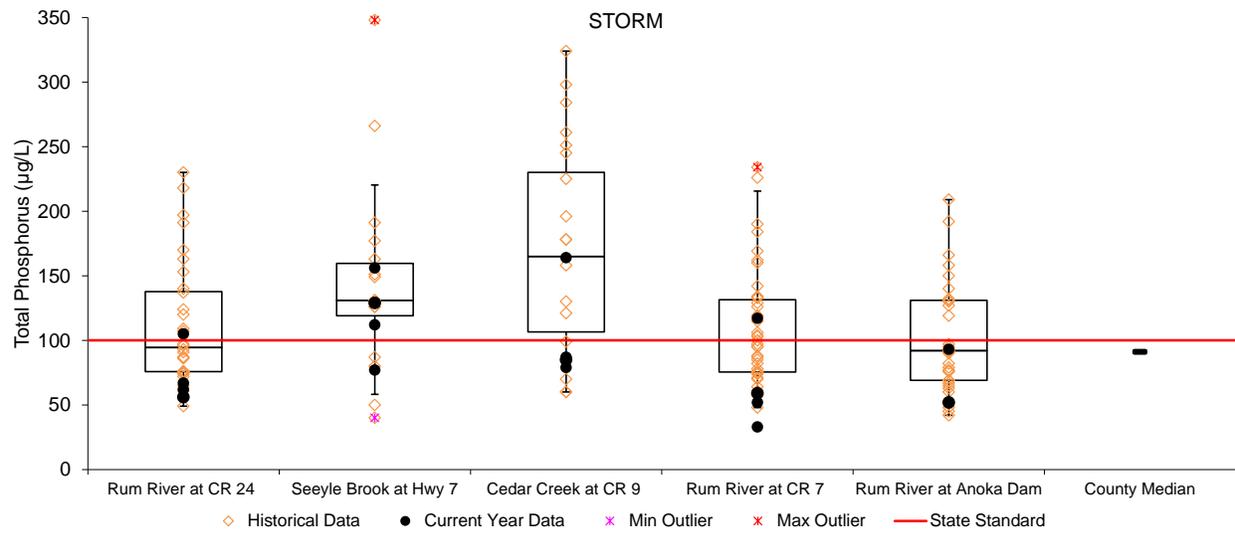
Total Phosphorus during Baseflow and Storm Conditions. Orange diamonds are historical data from previous years and black circles are 2022 readings. Box plots show the median (middle line), 25th and 75th percentile (ends of box), and 10th and 90th percentiles (floating outer lines).

The nutrient phosphorus is one of the most common pollutants to local waterways, and can be associated with stormwater runoff, wastewater, fertilizers, soil loss, and many other sources. Since it is an essential nutrient in the natural ecosystem, even a slight increase of phosphorus levels in a waterway can result in harmful algae blooms, accelerated plant growth, low dissolved oxygen levels and other negative effects to fish, macroinvertebrates, and other aquatic animals. Phosphorus levels in the Rum River are nearing the state impairment thresholds. Average phosphorus concentrations at the three Rum River monitoring sites regularly exceeds the state standard for impairment (100 µg/L) but on average is slightly lower. In 2022, average phosphorus concentrations at the Rum River sites for all conditions, upstream to downstream, were 81.5, 71.87 and 84.75 µg/L, respectively. Phosphorus during storm flows is higher than base flows. For example, at County Road 7 the average TP across all years monitored is 87.5 µg/L during base flow and 108.1 µg/L during storms. Of the 86 samples taken across all years at that site there have been twelve exceedances of the state standard during baseflow and 21 during storm flows.

Cedar Creek had TP similar to the Rum River in 2022 but was higher in previous years. The 2022 total phosphorus levels in Cedar Creek averaged 104.0 µg/L during all conditions. The median phosphorus concentration in Cedar Creek at CR 9 (all years) is 124 µg/L during baseflow and 169 µg/L post-storm. The median for Anoka County streams is 91 µg/L and the state standard is 100 µg/L. Historically, 33 of the 50 measurements taken at the Cedar Creek site have been greater than 100 µg/L, with an average of 146 µg/L and median of 151 µg/L. Individual results over 200 µg/L have been a near-annual occurrence since 2015 but were not observed in 2022.

Seelye Brook TP is higher than the Rum River or Cedar Creek. In 2022, total phosphorus concentration in Seelye Brook was 135 µg/L across all conditions. It averaged 137.50 µg/L during baseflow and 118.5 µg/L post-storm. The median phosphorus concentration in Seelye Brook at Hwy 7 for all years is 126 µg/L during baseflow, 144 µg/L during storm events, and 134 µg/L across all events. 74% of samples taken since 1998 have had TP concentrations above the state standard.

Phosphorus in both Cedar Creek and Seelye Brook are at concerning levels. Because Cedar Creek's subwatershed has rural residential development, little stormwater infrastructure or agriculture, and abundant wetlands it is reasonable to think that natural sources and wetlands are a significant phosphorus source. Seelye Brook has more agriculture including at least one feedlot, a City of St. Francis wastewater treatment plant that was upgraded in 2017, and wetlands its phosphorus sources may be more mixed. Continued monitoring and efforts to reduce phosphorus are needed throughout the watershed. Areas to focus can include ensuring robust stormwater treatment in residential development and agricultural best management practices. Keeping the Rum River off of the state impaired water's list is a priority for the area.

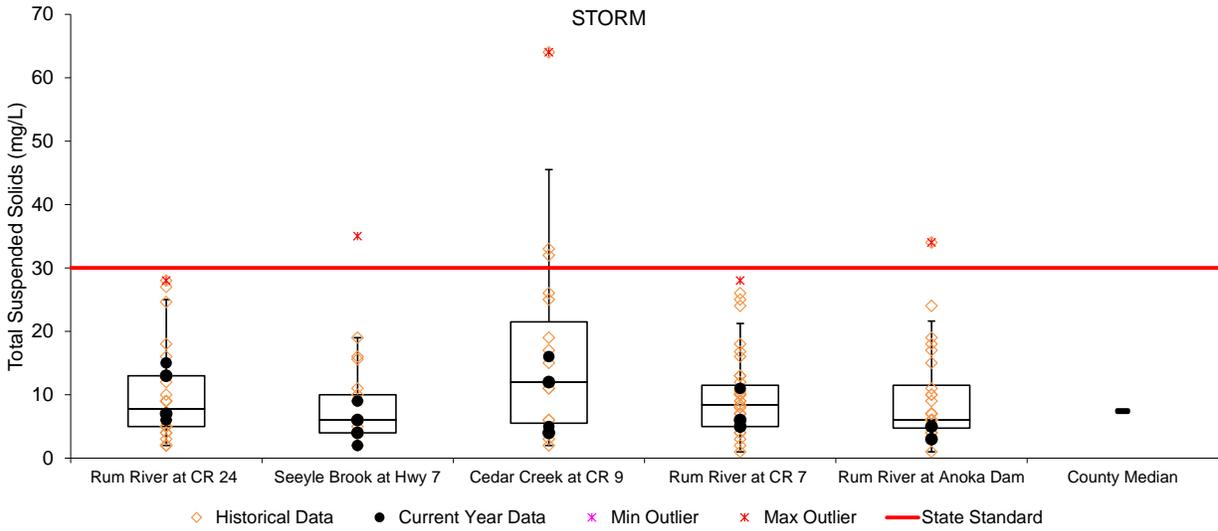
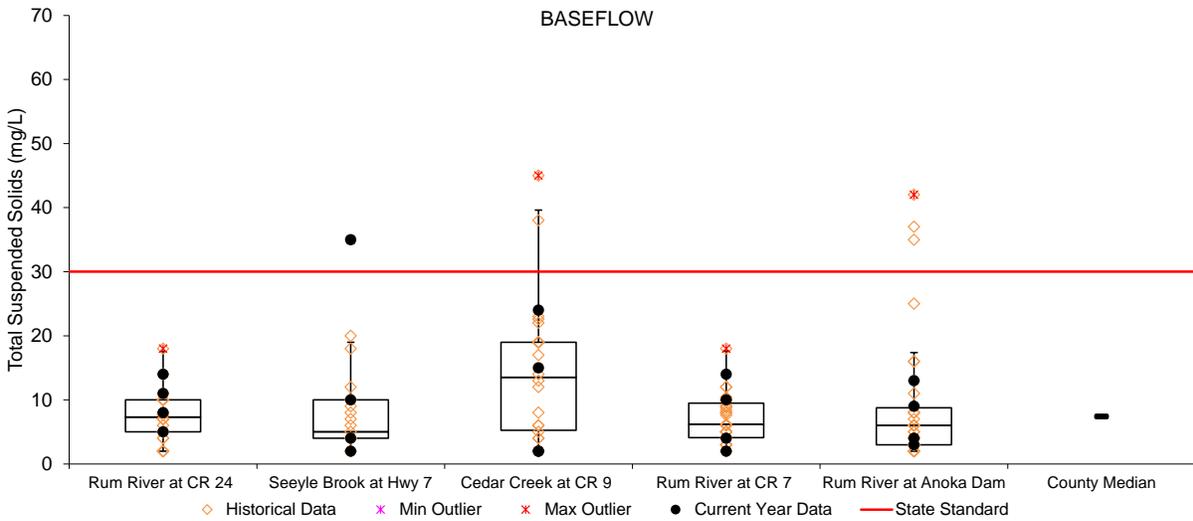
Total Suspended Solids during Baseflow and Storm Conditions. Orange diamonds are historical data from previous years and black circles are 2022 readings. Box plots show the median (middle line), 25th and 75th percentile (ends of box), and 10th and 90th percentiles (floating outer lines).

TSS results were similar to those for turbidity. In 2022, average TSS results (all conditions) upstream to downstream were 9.9, 7.1, and 5.6 mg/L. These results were generally lower than the Anoka County stream median for TSS of 7.4 mg/L and also better than the state standard of 30 mg/L. The highest TSS level recorded in 2022 was 24 mg/L. ACD has not collected a sample over 30 mg/L since 2010.

Turbidity and TSS have also been low in Seelye Brook. In 2022 turbidity in Seelye Brook averaged 4.1 NTU across all conditions. The median turbidity (all years) has been 5.45 NTU during baseflow and 6.2 NTU post-storm, much lower compared to other local streams. TSS in Seelye Brook was also observed at healthy levels with medians for all years being 5.00 mg/L during baseflow and 6.00 mg/L post-storm, well below the state standard of 30 mg/L.

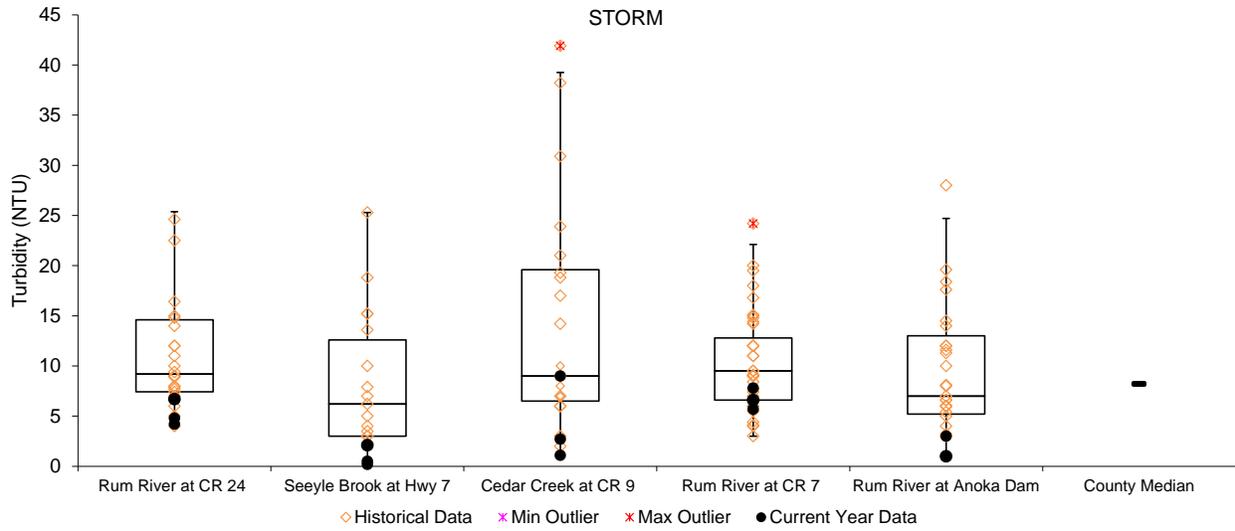
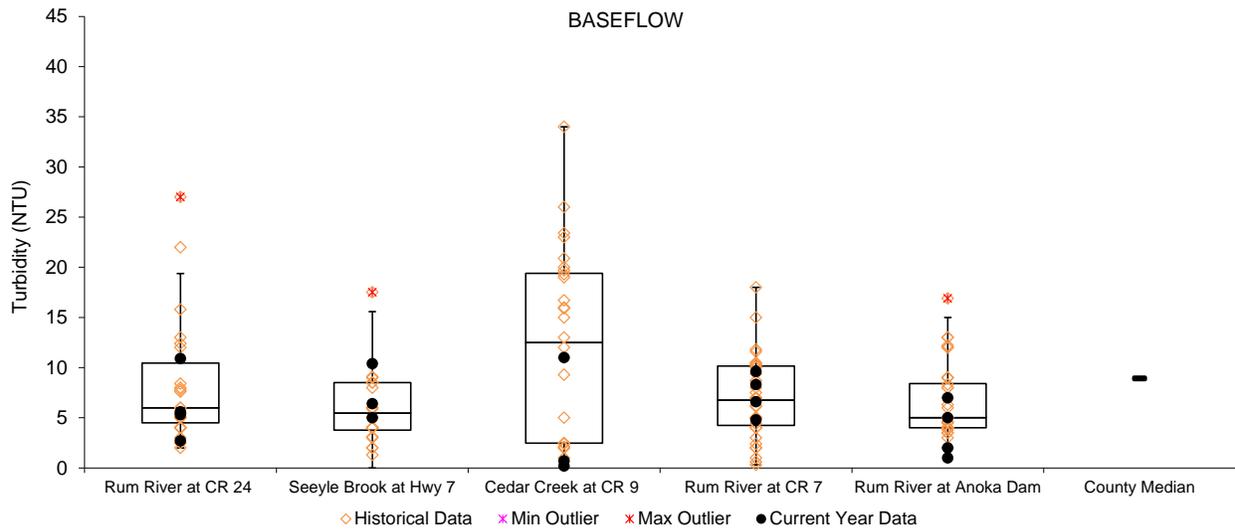
Turbidity during Baseflow and Storm Conditions. Orange diamonds are historical data from previous years and black circles are 2022 readings. Box plots show the median (middle line), 25th and 75th percentile (ends of box), and 10th and 90th percentiles (floating outer lines).

Turbidity is generally low in the river but increases are observed after storm events. There is no clear trend of changing turbidity or suspended solids from upstream to downstream. In 2022 average turbidity (all conditions) for sites upstream to downstream were 7.2, 19.4, and 3.85 NTU. The historical median for Anoka County streams is 8.9 NTU. Turbidity was elevated on a few occasions, especially following storm events. In 2022 water levels were low most of the year, except in spring.

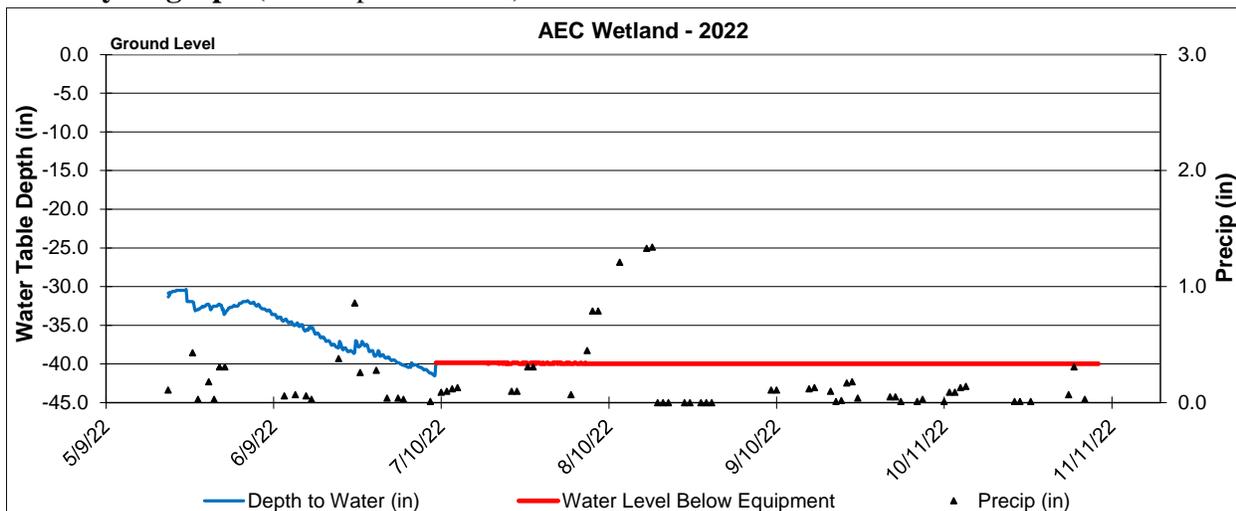
2022 Hydrograph (Well depth 35 inches)

Other Notes: This boring is located at the wetland boundary. In 2022, Anoka County was abnormally dry or experiencing drought conditions. This boring was dry the majority of the year.

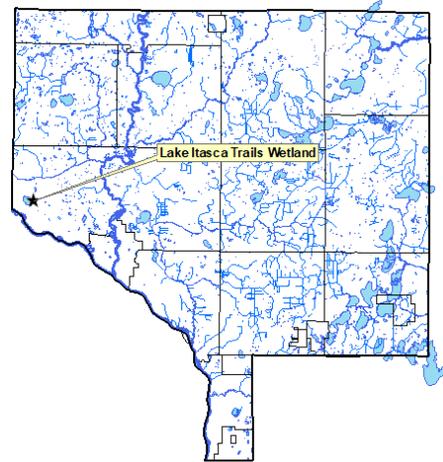
Monitored Since: 2013
Wetland Type: 2/6
Wetland Size: ~10 acres
Isolated Basin: Yes
Connected to a Ditch: No
Surrounding Soils: Hubbard coarse sand
Soils at Well Location:

Horizon	Depth	Color	Texture	Redox
A1	0-12	10yr2/0	Mucky sand	-
A2	12-20	10ry2/1	Sand	-
B1	20-36	10yr4/1	Sand and fine gravel	-
B2	36-48	10yr6/1	Sand and fine gravel	-

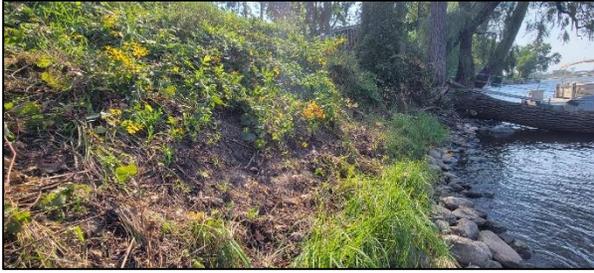
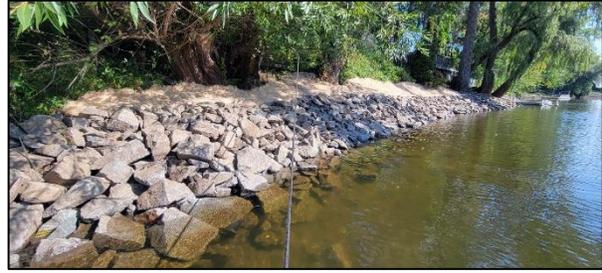
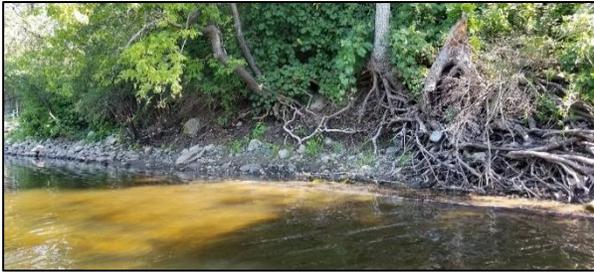
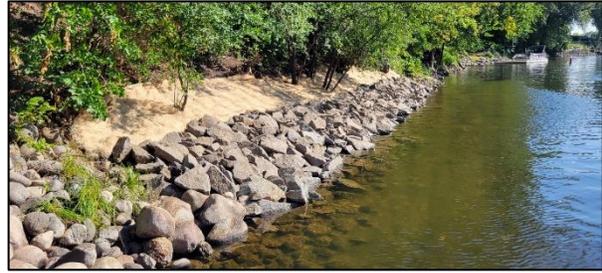
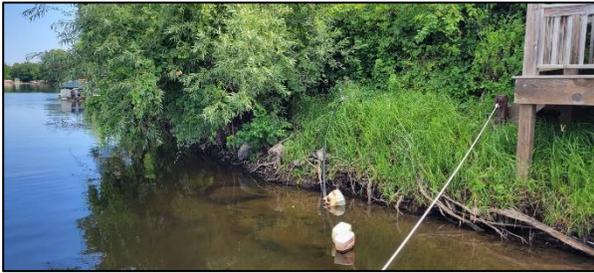
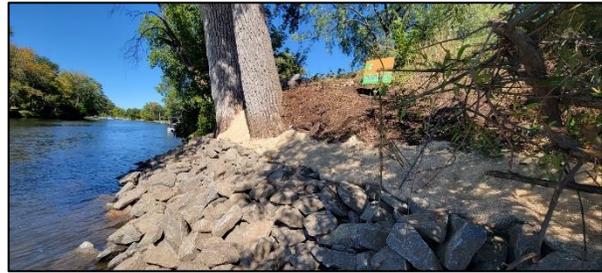
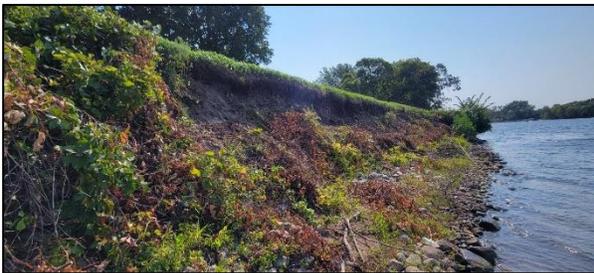
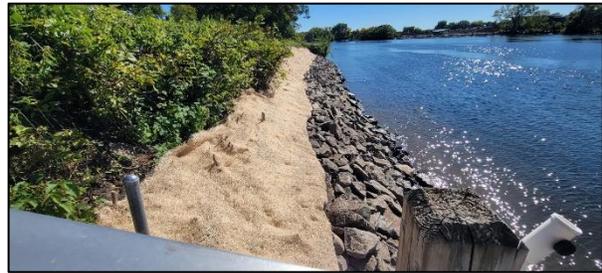
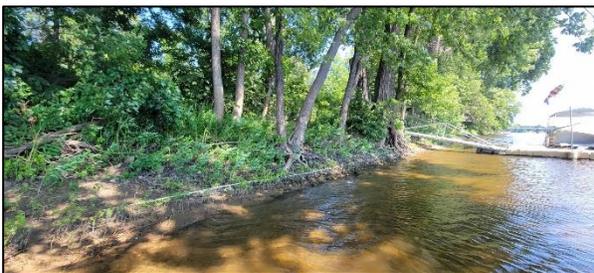
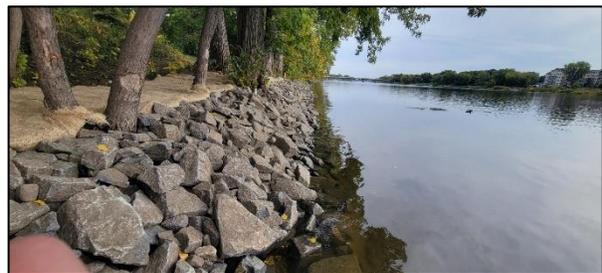
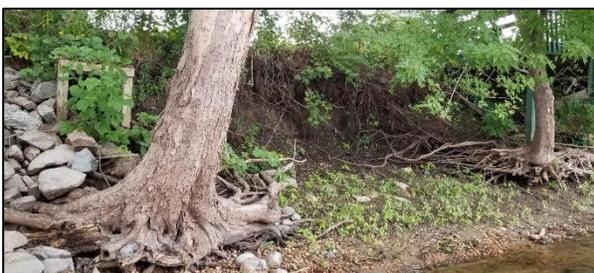
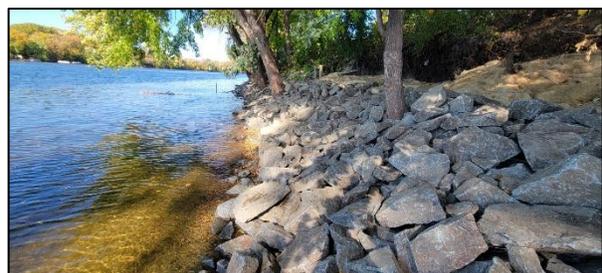
Photos of Riverbank Stabilization Project Sites Before (left) and After (right) Construction

Results: Stabilized 449 linear ft. of Mississippi Riverbank and 278 on the Rum River.
Reduced Phosphorus loading by 30 lbs/year, and TSS (sediment) by 35 tons/year.

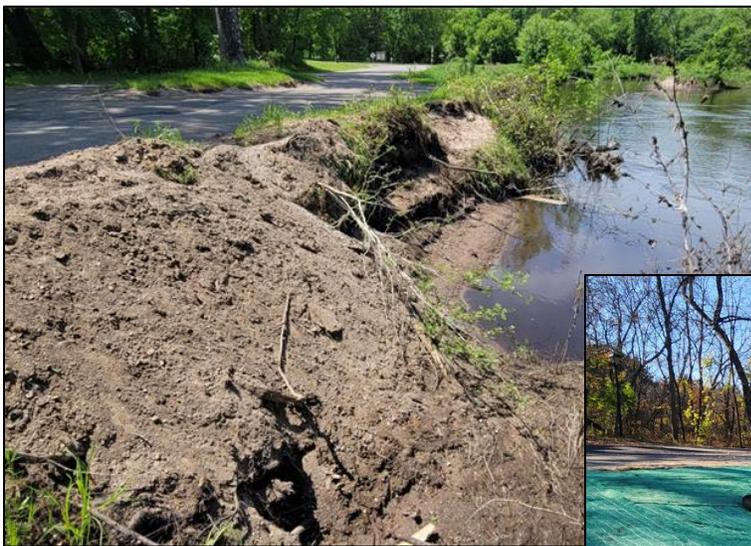
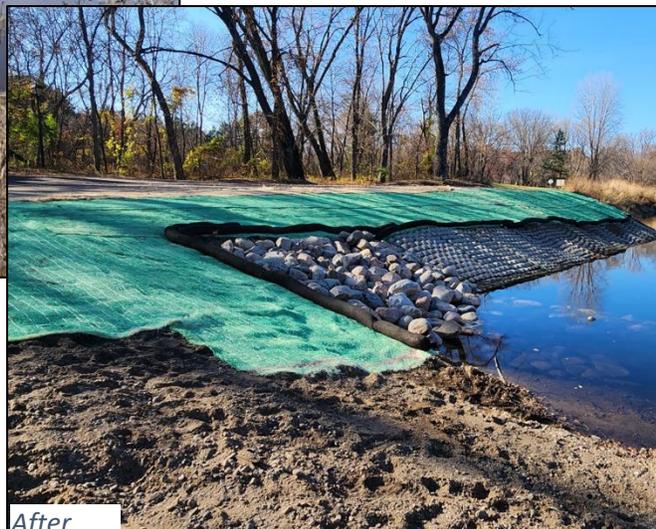
Rum Central Boat Launch Riverbank Stabilization

Results: Stabilized 90 linear-feet of riverbank on the Rum River. Reduced Phosphorus loading by 13.8 lbs/year, and TSS (sediment) by 16.2 tons/year.

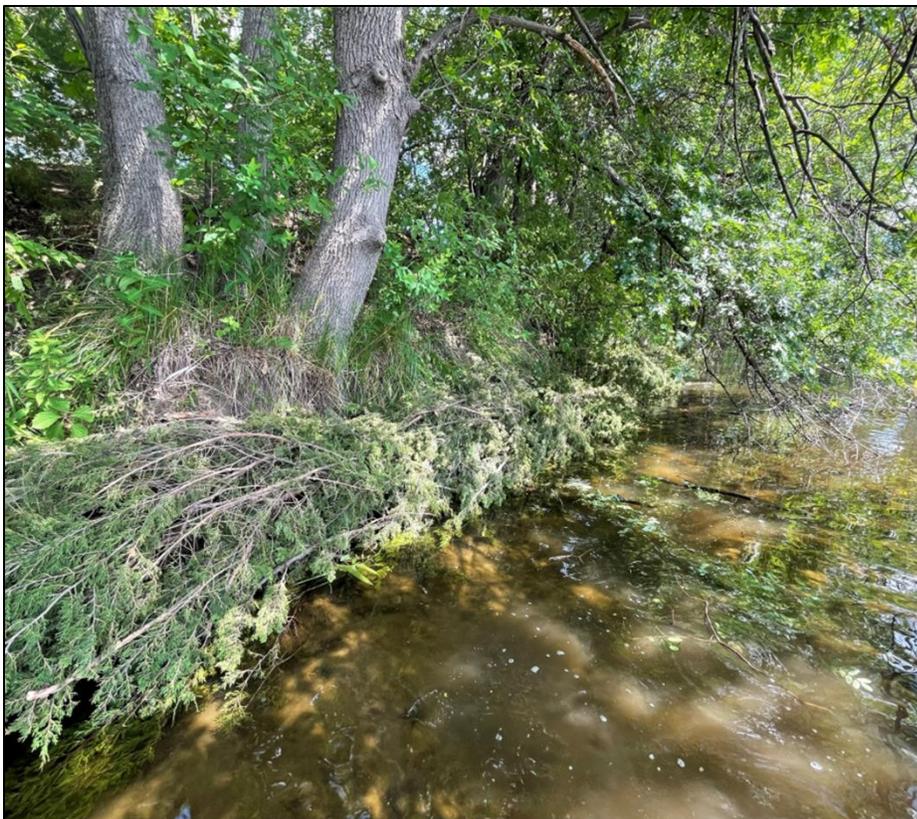
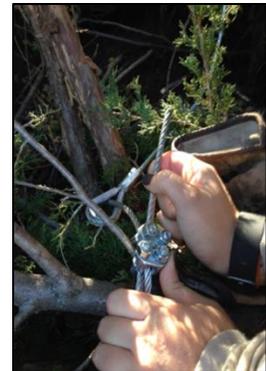
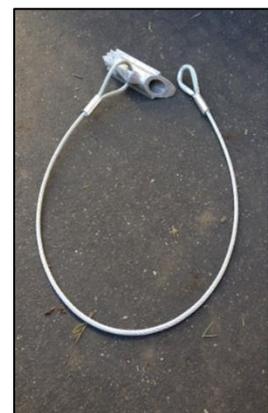
Rum South Regional Park Riverbank Revetments

Results: Stabilized 550 linear feet of riverbank along the Rum River. Reduced phosphorus loading by 21.03 lbs/year, and TSS (sediment) by 24.75 tons/year.
