# Excerpt from the 2022 Water Almanac

## Chapter 6: Coon Creek Watershed

Prepared by the Anoka Conservation District

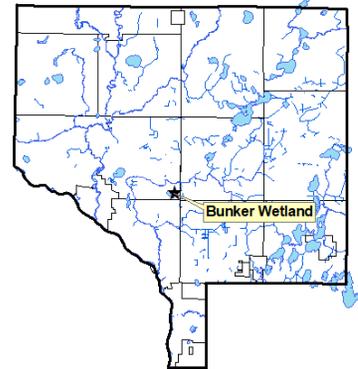
Horizon	Depth	Color	Texture	Redox
AC1	0-3	7.5yr3/1	Sandy Loam	50% 7.5yr 4/6
AC2	3-20	10yr2/1-5/1	Sandy Loam	-
2Ab1	20-31	N2/0	Mucky Sandy Loam	-
2Oa	31-39	N2/0	Organic	-
2Oe	39-44	7.5yr 3/3	Organic	-

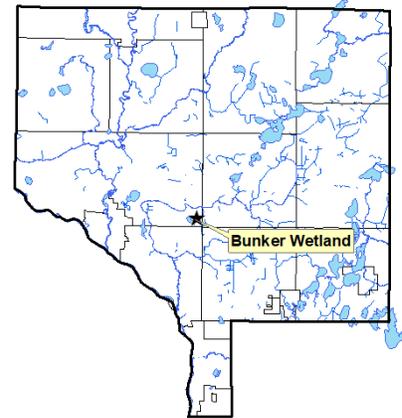
Horizon	Depth	Color	Texture	Redox
Oa	0-22	N2/0	Organic	-
Oe1	22-41	10yr2/1	Organic	-
Oe2	41-48	7.5yr3/4	Organic	-

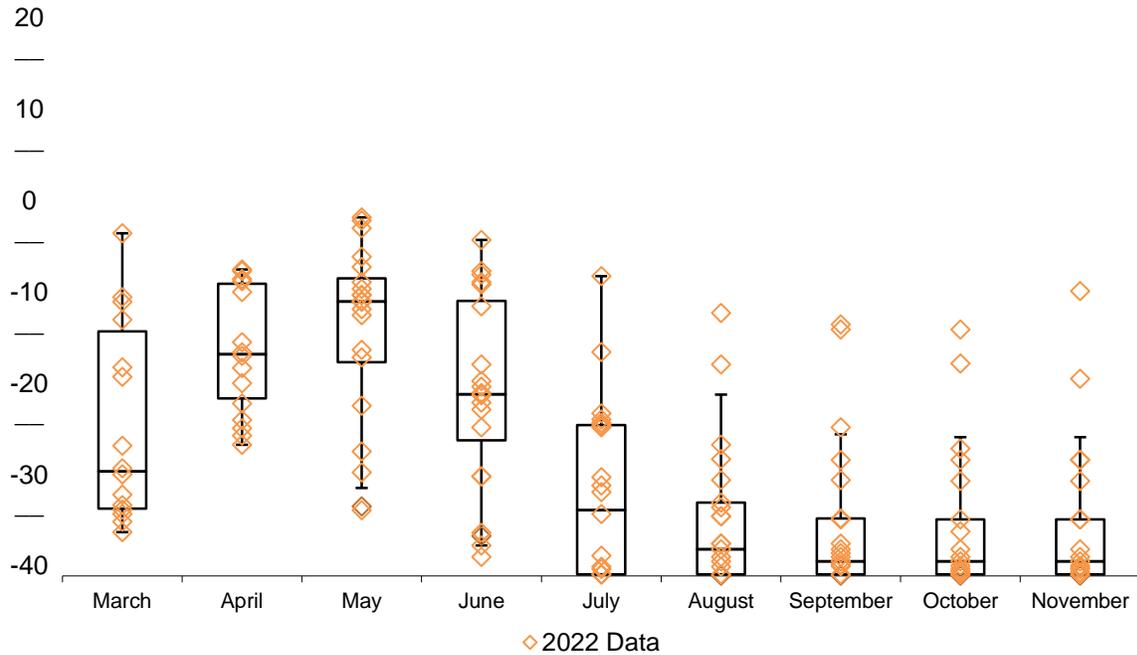
**2022 Reference Wetland Water Levels Summary:** Each marker represents the median depth to the water table at the edge of one reference wetland for a given month in 2022. The quantile boxes show the median (middle line), 25<sup>th</sup> and 75<sup>th</sup> percentile (ends of box), and 10<sup>th</sup> and 90<sup>th</sup> percentile (floating horizontal lines). Maximum well depths were 40 to 45 inches, so a reading greater than -40 inches likely indicates water below the well at an unknown depth.

The simplest use of the reference wetland data in a regulatory setting is to compare water levels in the monitored wetlands to water levels in a possible wetland area. The tables above are based upon percentiles of the water levels documented at known wetland boundaries. The quantile boxes in the figures delineate the 10th, 25th, 50th, 75th, and 90th percentiles. Water table depths outside of the box have a low likelihood of occurring, or may only occur under extreme circumstances such as abnormal climate conditions or in the presence of anthropogenic hydrologic alterations. If sub-surface water levels in an area are similar to those in reference wetlands, there is a likelihood that the disputed area is a wetland.

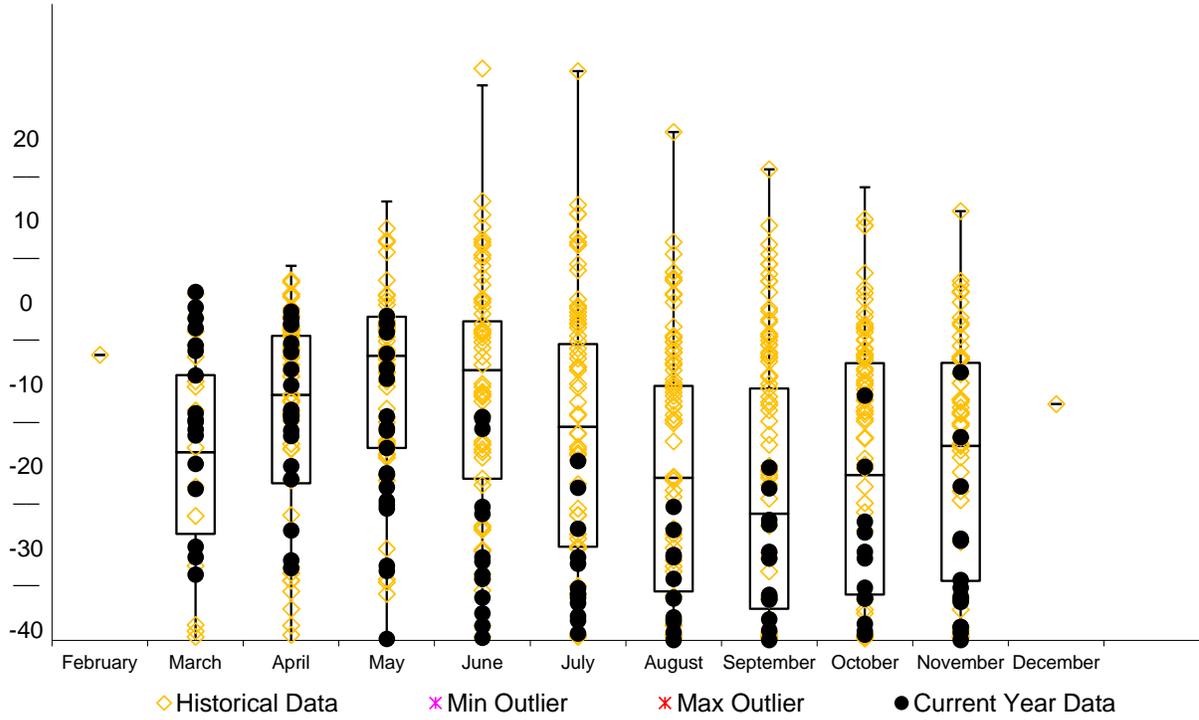
**1996 – 2022 Reference Wetland Water Levels Summary:** Each dot represents the median depth to the water table at the edge of one reference wetland for a month between 1996 and 2022. The quantile boxes show the median (median line), 25th and 75th percentile (ends of box), and 10th and 90th percentile (floating horizontal lines). Maximum well depths were 40 to 45 inches, so a reading greater than -40 inches likely indicates water below the well at an unknown depth.

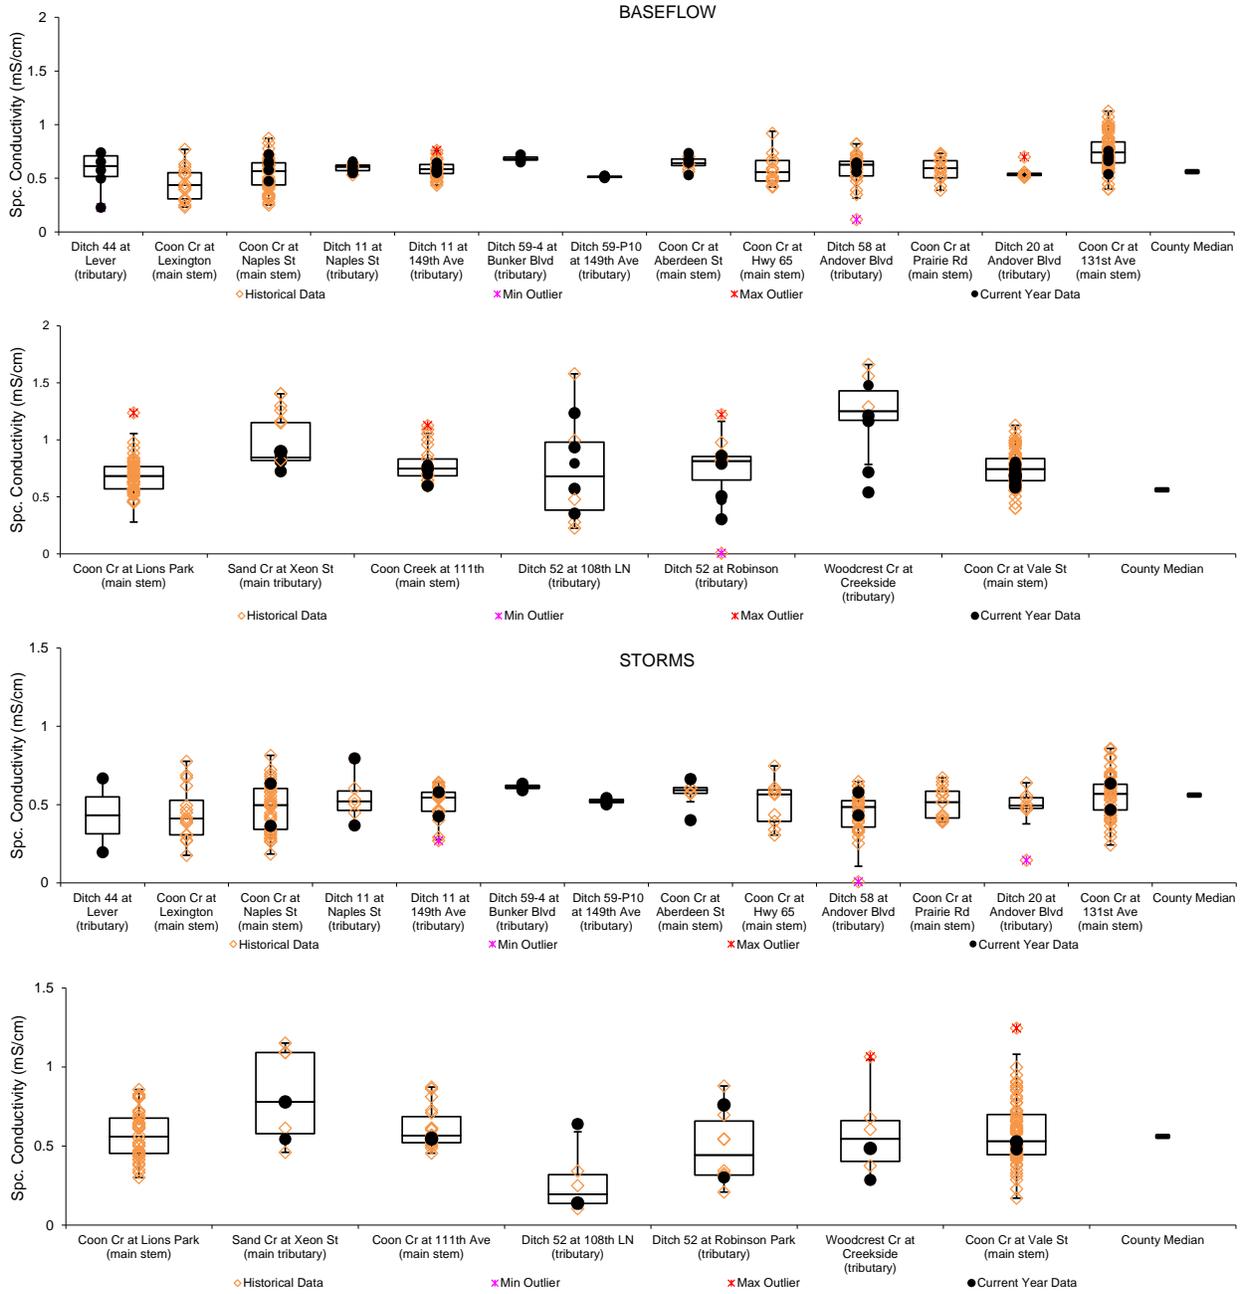
**Specific Conductivity at Coon Creek** Orange diamonds are historical data from previous years and black circles are 2022 readings. Box plots show the median (middle line), 25th and 75th percentile (end of box), and 10th and 90th percentile (floating outer lines) of all data collected at these sites.

Dissolved pollutant levels are higher in the downstream reaches of Coon Creek, where there is more impervious surface area with denser development. Median specific Conductivity increases gradually from upstream (0.437 mS/cm) to downstream (0.742 mS/cm) during baseflow conditions for all years. Median specific Conductivity (all years) following storm events shows a smaller change between upstream and downstream measurements, ranging from 0.410 to 0.531 mS/cm. The median specific Conductivity in Coon Creek at Vale Street (farthest downstream) is higher during baseflow conditions and above the countywide median for Anoka County streams of 0.561 mS/cm. Although after storm events the median at Vale Street is below the county median.

Modestly higher conductivity during baseflow lends some insight into the pollutant sources. If dissolved pollutants were only elevated after storm events, stormwater runoff would be suspected as the primary driver. Since dissolved pollutants are highest during baseflow conditions, pollution of the shallow groundwater table, which feeds the stream during baseflow, is likely a significant contributor. Storm events are likely both delivering additional pollutant load and offering mild dilution, and in this way, storm conductivity is only modestly lower than baseflow. Dissolved pollutant levels in the upstream portions of Coon Creek, during all conditions, are still above average compared to other local streams.

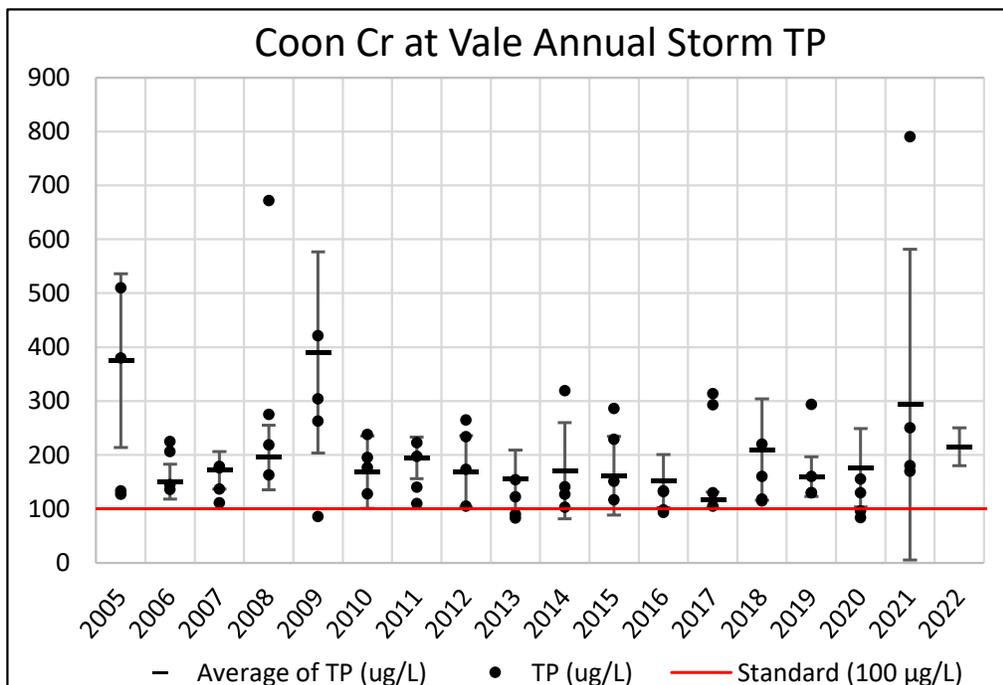
Parameters	Significant Change in Annual $\bar{x}$ (2005-2022)	p-value	Standard Error of Means
Total Phosphorus – Baseflow	None	0.89	20.08
Total Phosphorus – Storm	None	0.36	75.81

No significant increase was observed for baseflow or storm TP concentrations at Vale St. over time, although storm flow TP conditions have marginally improved. The Coon Creek Watershed District has made large financial investments into stormwater treatment practices and other types of stream improvement projects in this portion of the watershed, which seem to be indicating successes towards phosphorus reduction, especially during larger storm events.

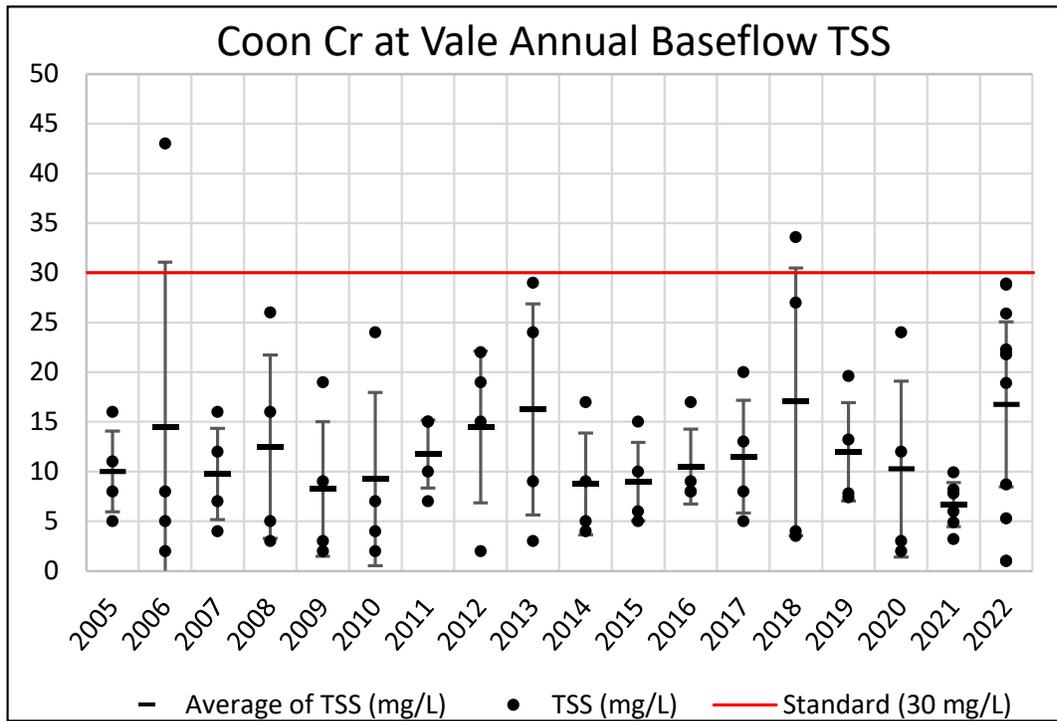
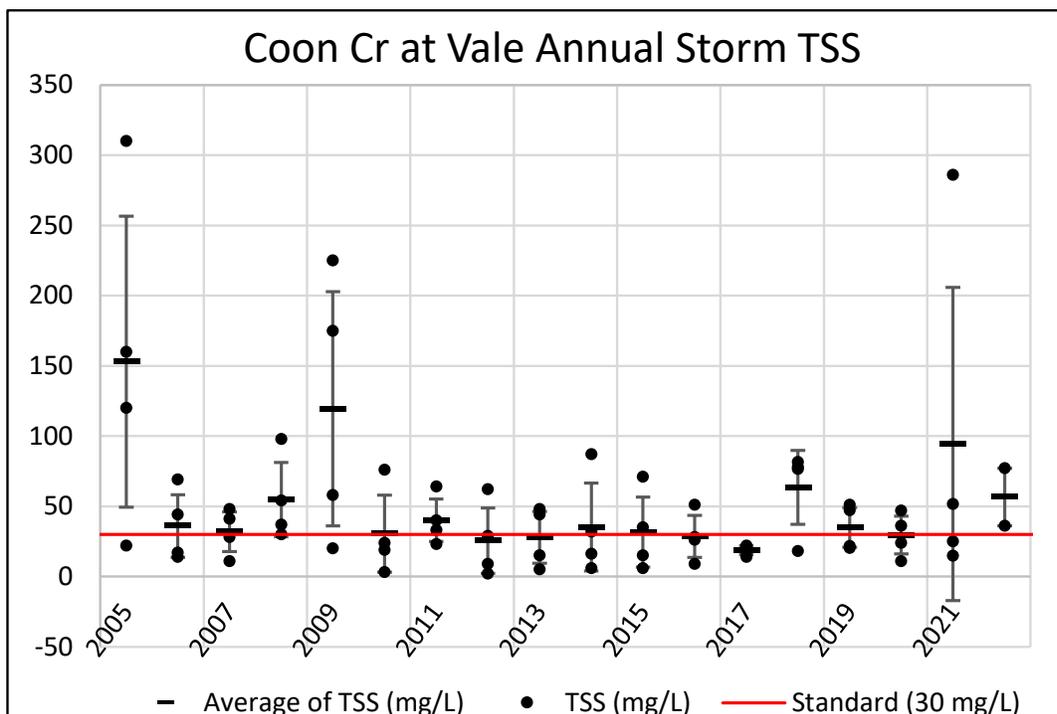
Parameters	Significant Change in Annual $\bar{x}$ (2005-2022)	p-value	Standard Error of Means
Total Suspended Solids – Baseflow	None	0.65	3.14
Total Suspended Solids – Storm	None	0.32	36.21

ANOVA analyses at three sites, upstream to downstream, (Coon Creek at Naples St, 131st Ave, and Vale St.) show a significant increase in TSS concentrations from the upstream site to the mid-point site (Naples St. to 131st Ave.) during all types of conditions. During storm flow a significant increase is also present from 131st Avenue to the downstream monitoring site at Vale St. There is no significant change in TSS levels at Vale Street over time. The LDC plot for TSS in the Coon Creek TMDL (Page 42, Figure 13) shows that allowable TSS loads are ordinarily only exceeded during high flows at Vale Street. Grab samples data provides similar evidence that TP concentrations only exceed the state standard occasionally following storm events.

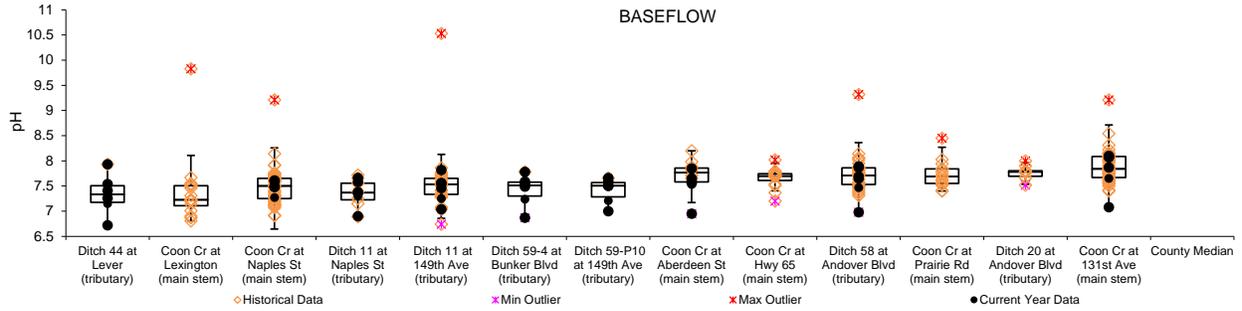
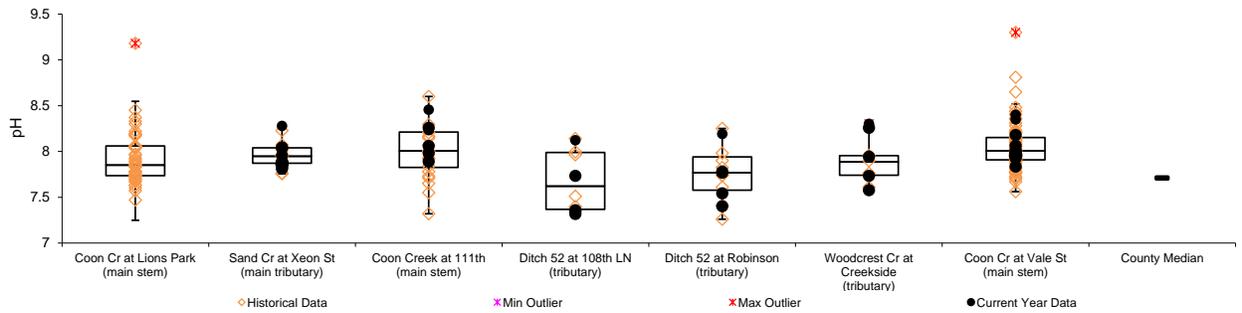
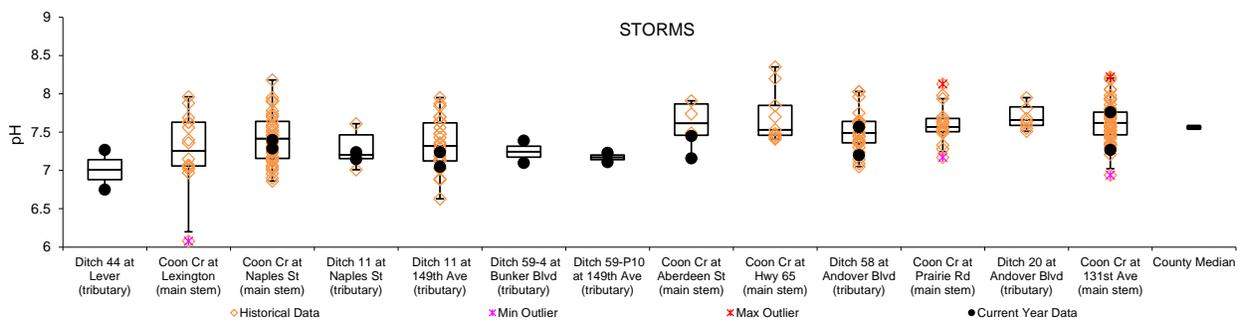
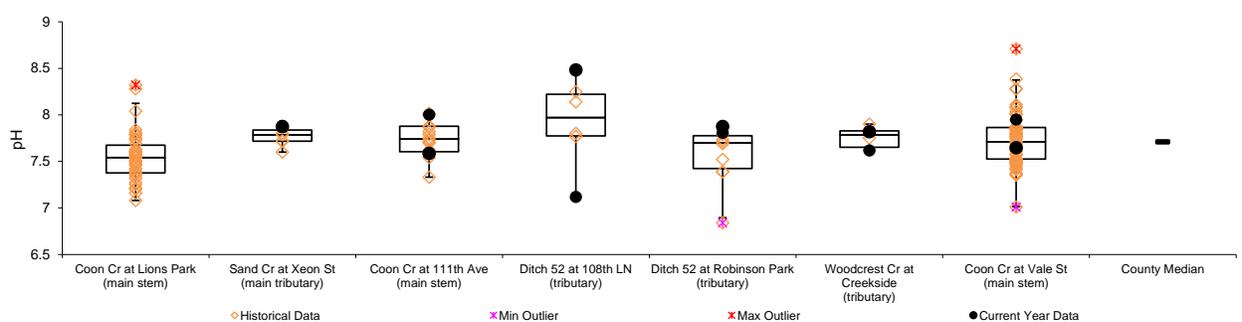
**pH at Coon Creek** Orange diamonds are historical data from previous years and black circles are 2022 readings. Box plots show the median (middle line), 25th and 75th percentile (ends of box), and 10th and 90th percentiles (floating outer lines).

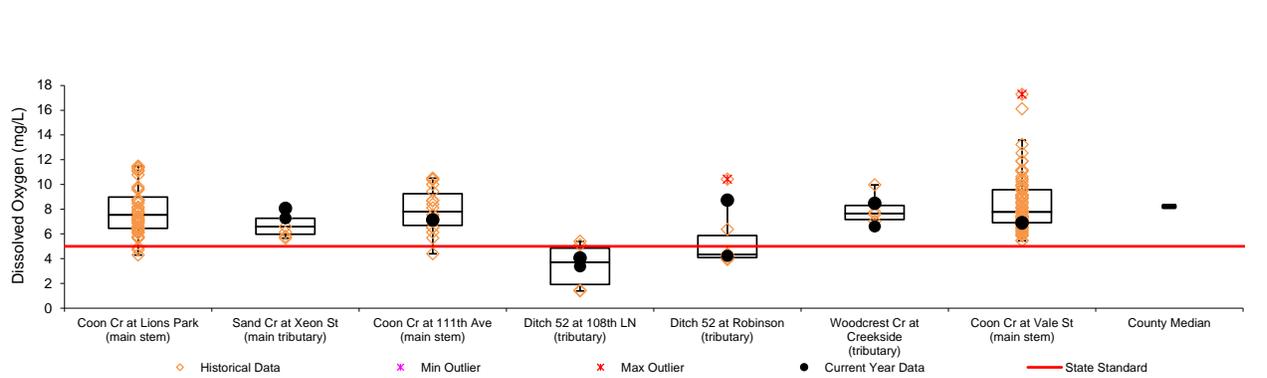
**Dissolved oxygen at Coon Creek** Orange diamonds are historical data from previous years and black circles are 2022 readings. Box plots show the median (middle line), 25th and 75th percentile (ends of box), and 10th and 90th percentiles (floating outer lines) of all data collected at these sites.

Low dissolved oxygen (DO) levels have generally not been observed in Coon Creek during day time measurements, but low DO was identified as a stressor to aquatic life in the headwaters. Coon Creek and Ditch 11 were listed for pending dissolved oxygen impairments in 2024. Low DO can also exacerbate phosphorus loading as it can create redox conditions where phosphate is released from sediments. Historically, low DO readings have occurred in the upstream ditched channels of the main stem and in Ditch 11. Higher DO is found in the more natural sections of the channel, further downstream. In 2022, DO levels fell below the state standard (5 mg/L) in Ditch 11 and Ditch 52. These lower DO levels may have been influenced by low water level drought conditions. Measurements must be taken prior to 9am for comparison with state standards, precluding robust analysis with our current dataset.

<b>Average Dissolved Oxygen (mg/L)</b>	<b>Median Dissolved Oxygen (mg/L)</b>	<b>State Standard</b>	<b>N</b>
<b>Baseflow</b>	8.90	8.65	5 mg/L daily minimum	79
<b>Storms</b>	8.46	7.78		69
<b>All</b>	8.69	8.37		148
<b>Occasions &lt;5 mg/L</b>				0

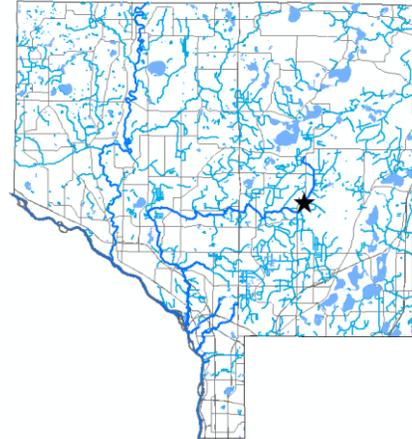
2022 was the first year stage was monitored at this site. Stage fluctuated 1.94ft between its minimum and maximum-recorded stage Discharge at this site was recorded at high volumes at the beginning of the season but then remained low and periodically absent.

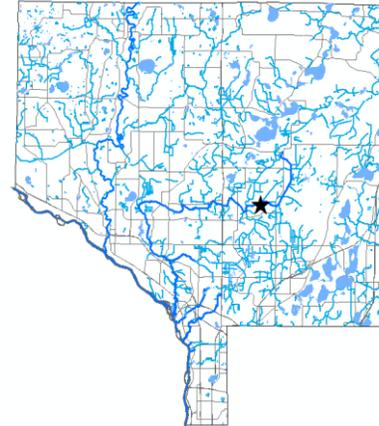
During 2022 Coon Creek at Naples Street fluctuated 2.50ft. between its minimum and maximum-recorded stage. This was a 1.62ft increase from 2021 water levels when the smallest range was recorded. Stage at this site changed little in response to rain events and had minimal flow throughout 2022.

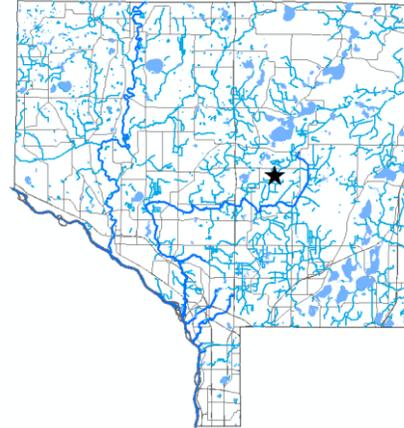
2022 was the first year stage was monitored at this site. Stage was flashy in response to rainfall, reacting quickly. Baseflow water elevation steadily declined throughout the season and stage at stage at this site fluctuated 1.32ft between its minimum and maximum recorded elevations. This ditch is likely influenced by water management being conducted in the ditch system by local agricultural producers for irrigation purposes.

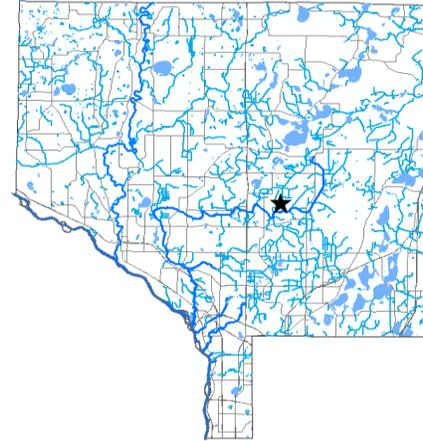
2022 was the third year monitoring was completed at this site. Stage at this site is typically flashy in response to storms, reacting quickly to rainfall. During the 2022 season, water levels fluctuated 2.13ft between its minimum and maximum-recorded stage. This site had relatively consistent water levels in 2022, despite drought conditions. The cause is unclear, but likely related to active water level management in the ditch system by local agricultural producers for irrigation purposes.

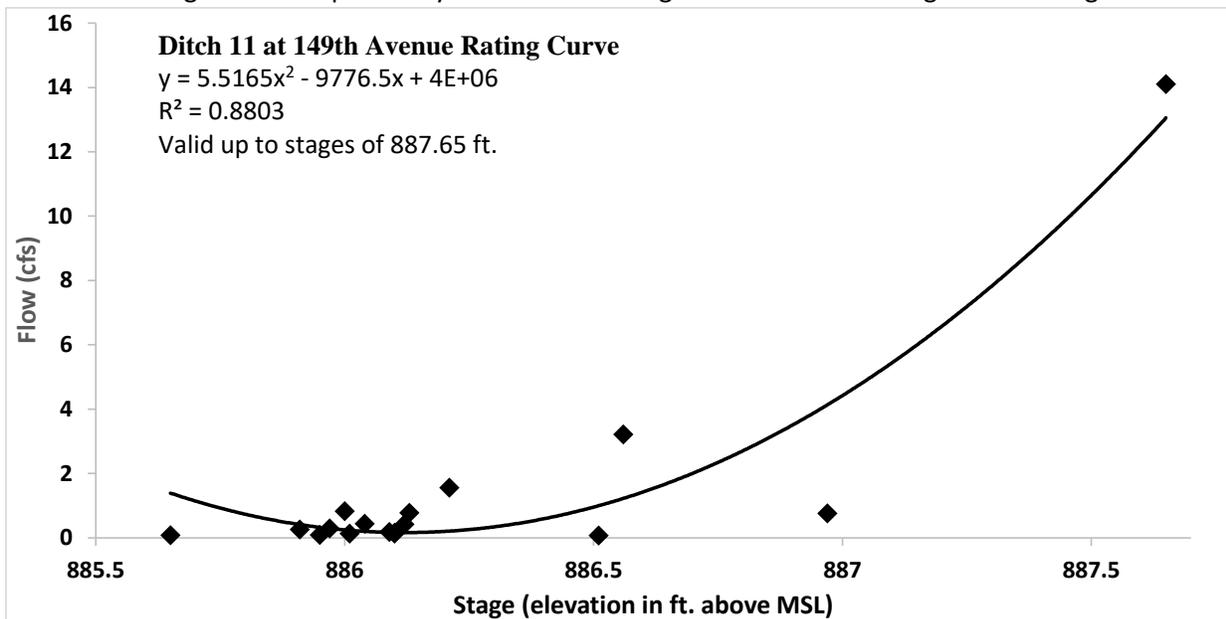
Note: this rating curve is impacted by water level management activities for agricultural irrigation

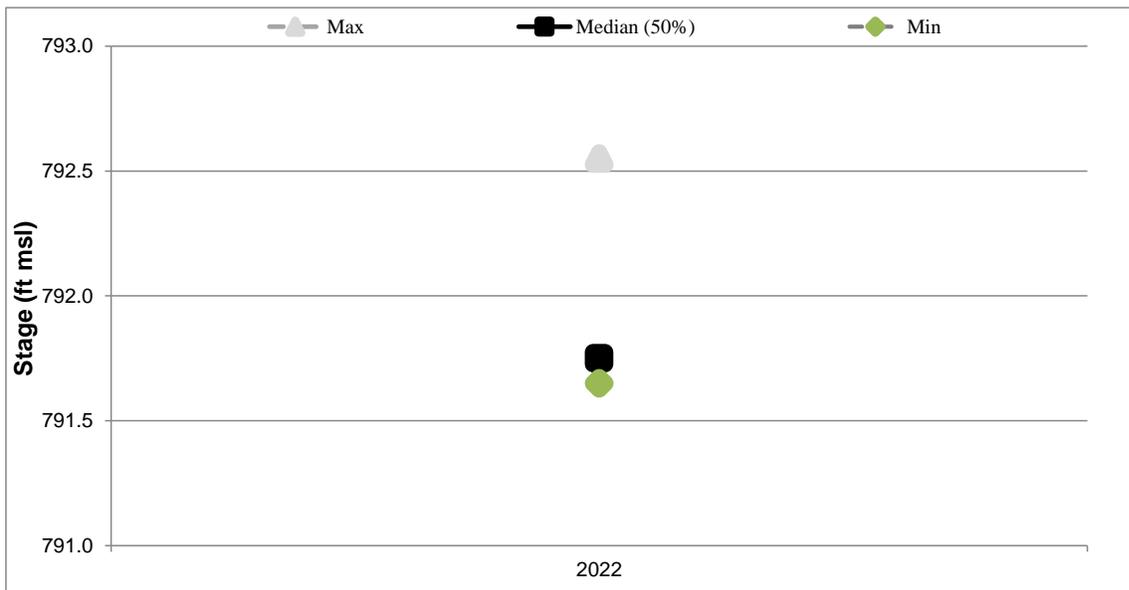
Percentiles	2022
Min	791.65
2.5%	791.66
10.0%	791.66
25.0%	791.69
Median (50%)	791.75
75.0%	791.84
90.0%	792.00
97.5%	792.15
Max	792.55

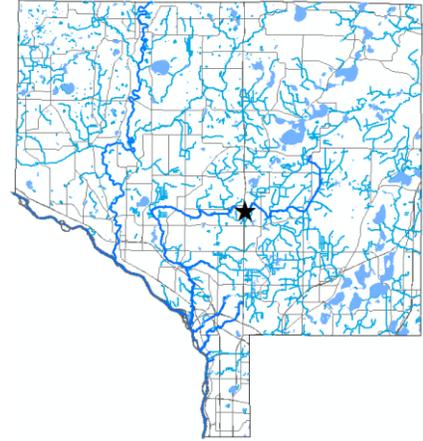
2022 was the second year monitoring was conducted at the Aberdeen Street site. This site is located at a newly constructed stream crossing, just upstream from Highway 65. During 2022 water levels fluctuated by 3.03ft between its minimum and maximum and reached a maximum 1.65ft higher than the previous year. Baseflow water elevation decreased through the first half of the season and then leveled out, fluctuating very little late in this drought season.

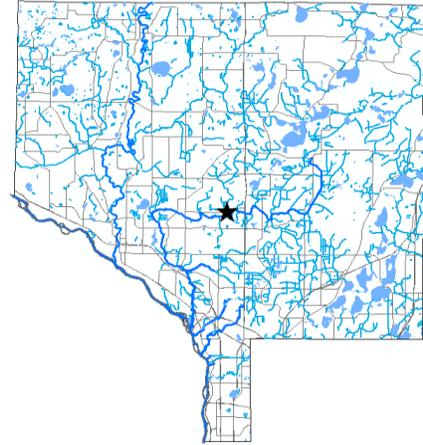
Ditch 58 at Andover Blvd has been monitored periodically since 2001. Baseflow water elevation steadily declined throughout the season due to drought and stage at this site fluctuated 1.62ft between its minimum and maximum. Water levels at this site averaged highest since 2014. Stage was quick to react to storm events at the beginning of the season but little fluctuation was observed late in the season in response to similar rain events.

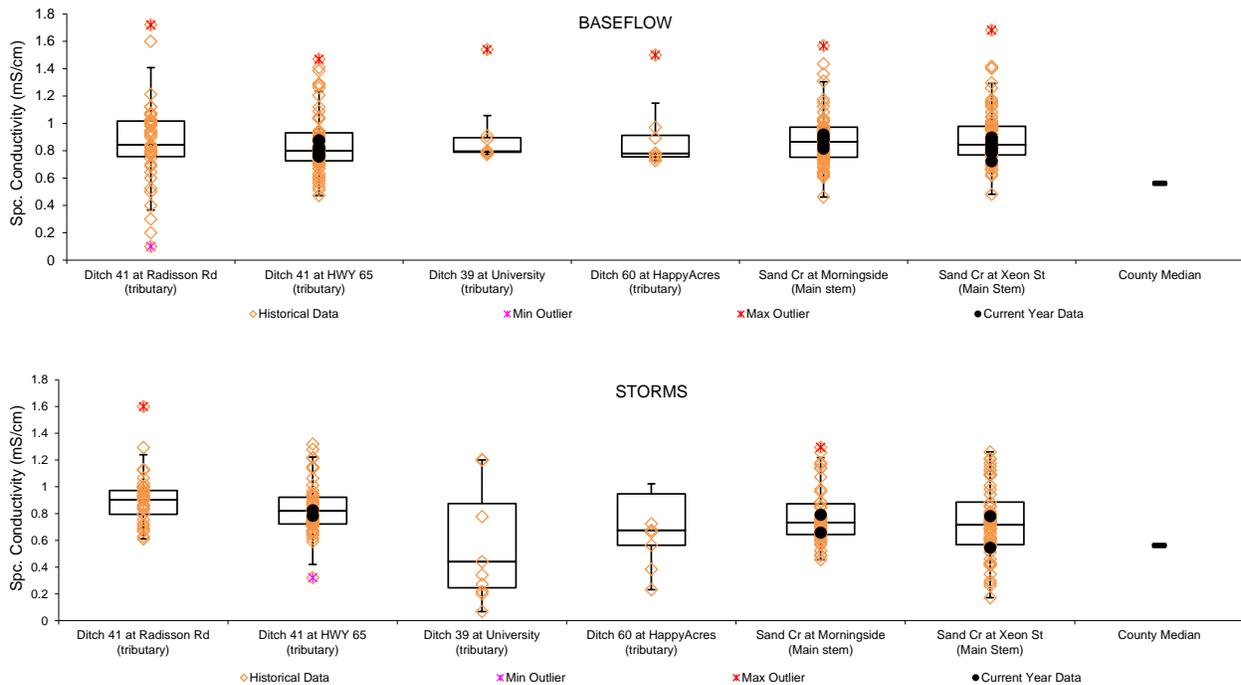
**Specific Conductivity at Sand Creek** Orange diamonds are historical data from previous years and black circles are 2022 readings. Box plots show the median (middle line), 25th and 75th percentile (ends of box), and 10th and 90th percentiles (floating outer lines) for all data collected at these sites.

Sand Creek's dissolved pollutant levels as measured by specific Conductivity are higher than levels found in Coon Creek, to which Sand Creek is tributary, and other streams in the county. The long-term median of specific Conductivity under all conditions in Sand Creek at Xeon St is 0.800 mS/cm compared to the median for all Anoka County streams of 0.561 mS/cm and 0.670 mS/cm at Coon Creek at Vale Street. Concentrations were similar during both baseflow conditions and following storm events, with baseflow having slightly increased conductivity. Previous chloride monitoring (2019) from the individual contributing ditch systems revealed that Ditch 60 consistently had the highest Conductivity of the three tributary ditches to Sand Creek.

Dissolved pollutants can easily infiltrate into the shallow groundwater that feeds stream systems during baseflow conditions. This can result in high levels of specific Conductivity that decline during storm events when dilution occurs. If stormwater runoff were the primary source of dissolved pollutants in the creek, one indicator would be higher Conductivity observed during storm events. The opposite was the case for specific Conductivity at Xeon Street which was higher during baseflow conditions. Storm runoff still contains dissolved pollutants, but the concentration is lower than what is found in the shallow groundwater feeding Sand Creek. From a management standpoint, it is important to remember that the sources of dissolved pollutants generated from both stormwater and baseflow are the same, and preventing the pollutants' initial release into the environment should be a high priority.

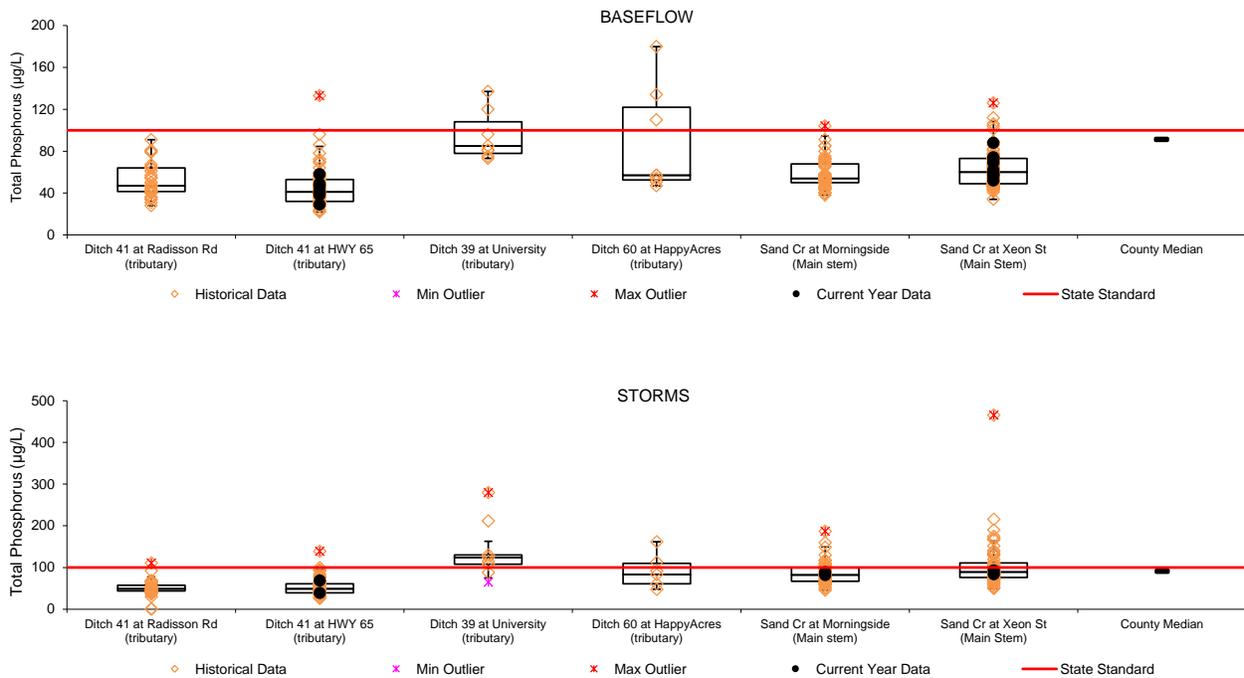
**Total phosphorus at Sand Creek** Orange diamonds are historical data from previous years and black circles are 2022 readings. Box plots show the median (middle line), 25th and 75th percentile (ends of box), and 10th and 90th percentiles (floating outer lines) for all data collected at these sites.

Phosphorus loading occurs throughout the Sand Creek watershed, but the Ditch 39 and Ditch 60 systems seem to degrade the water quality in Sand Creek more than Ditch 41. TP levels at the Ditch 41 at Hwy 65 site are mostly low during both baseflow and storm events. Minimal water quality data is available for Ditch 39 and Ditch 60. These ditches have only been monitored in 2009 and 2019. Both systems exceeded 100 µg/L during baseflow and storm sampling events.

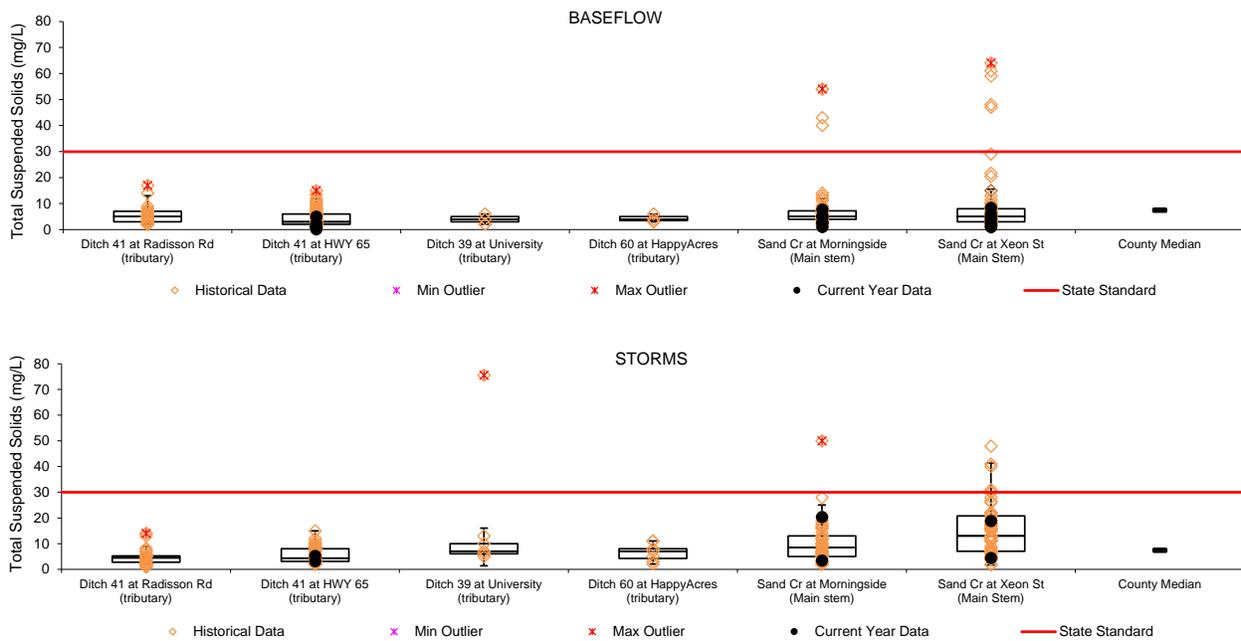
**Total suspended solids at Sand Creek** Orange diamonds are historical data from previous years and black circles are 2022 readings. Box plots show the median (middle line), 25th and 75th percentile (ends of box), and 10th and 90th percentiles (floating outer lines) for all data collected at these sites.

TSS is low throughout the system. It averages 12 mg/L has a median of 7mg/L across all conditions. In comparison, the state water quality standard is 30 mg/L. However, stormflow TSS levels do increase significantly between Morningside Memorial Gardens and Xeon Street, indicating there is more TSS loading in the downstream portion of the subwatershed. The highest TSS is found downstream of the three tributary ditches joining, around Morningside Memorial Gardens. Further upstream, large settling basins are suspected to keep TSS lower. TSS reductions are sought due to it being identified as a biotic stressor, and because TP and TSS reduction strategies can overlap.

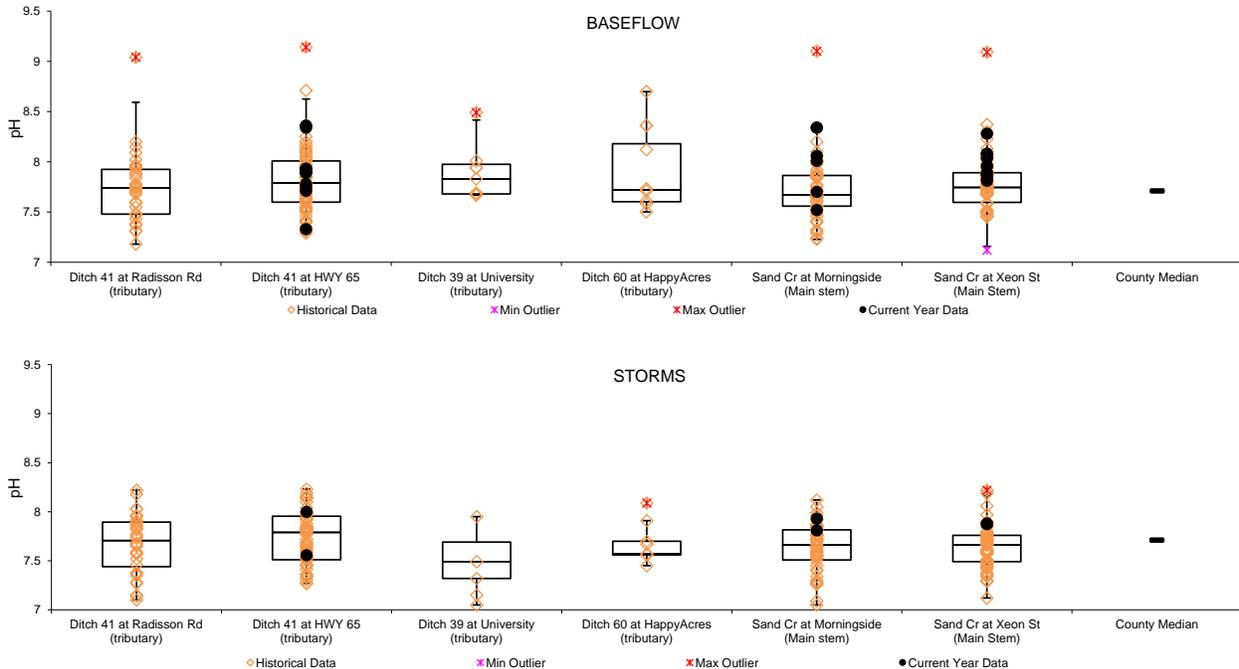
**pH at Sand Creek** Orange diamonds are historical data from previous years and black circles are 2022 readings. Box plots show the median (middle line), 25th and 75th percentile (ends of box), and 10th and 90th percentiles (floating outer lines) for all data collected at these sites.

In 2022, pH in Sand Creek remained within the acceptable range (6.5-8.5). Historically, individual outliers have included a few readings in excess of 9.0. The median for all conditions, all years, at Xeon St is 7.61. There is no water quality concern.

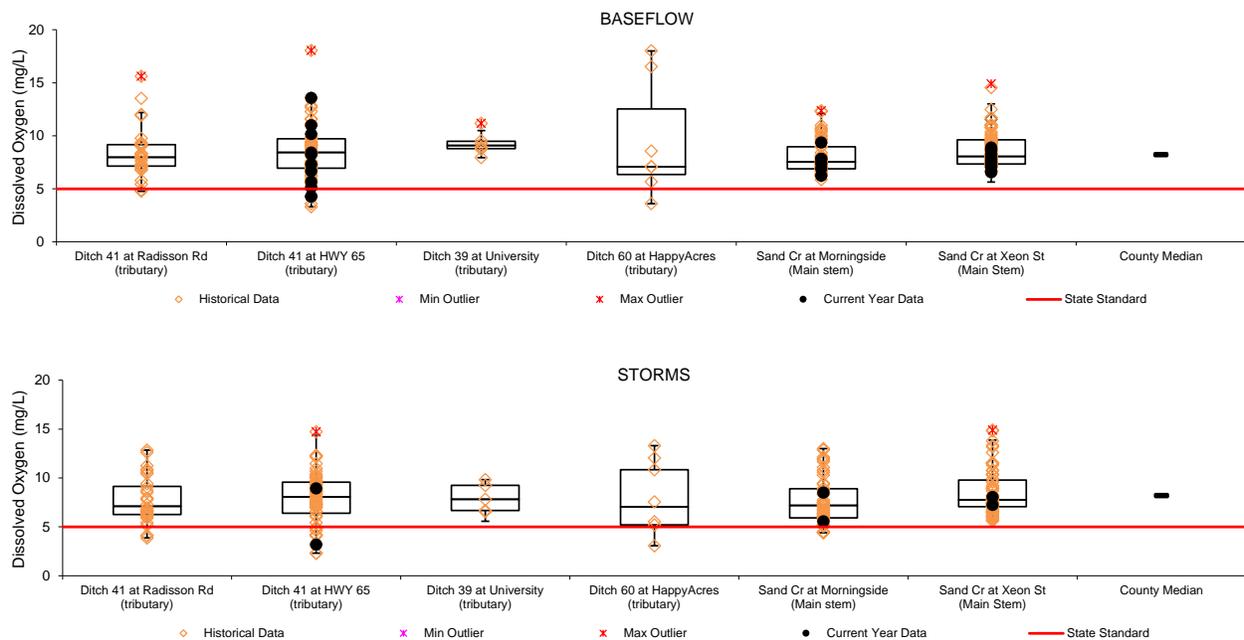
**Dissolved Oxygen at Sand Creek.** Orange diamonds are historical data from previous years and black circles are 2022 readings. Box plots show the median (middle line), 25th and 75th percentile (ends of box), and 10th and 90th percentiles (floating lines) for all data collected at these sites.

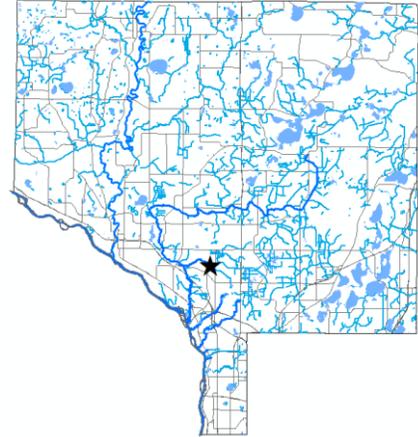
This site has been monitored for 12 years. Water levels fluctuated 1.59ft throughout the 2022 season, the second lowest range since monitoring began in 2010. Baseflow elevations decreased early in the season with a slight rebound observed in late-summer and fall. The creek is narrow at this site causing water levels to be flashy in response to rain events. Maximum stage at this site in 2022 was the second lowest on record.

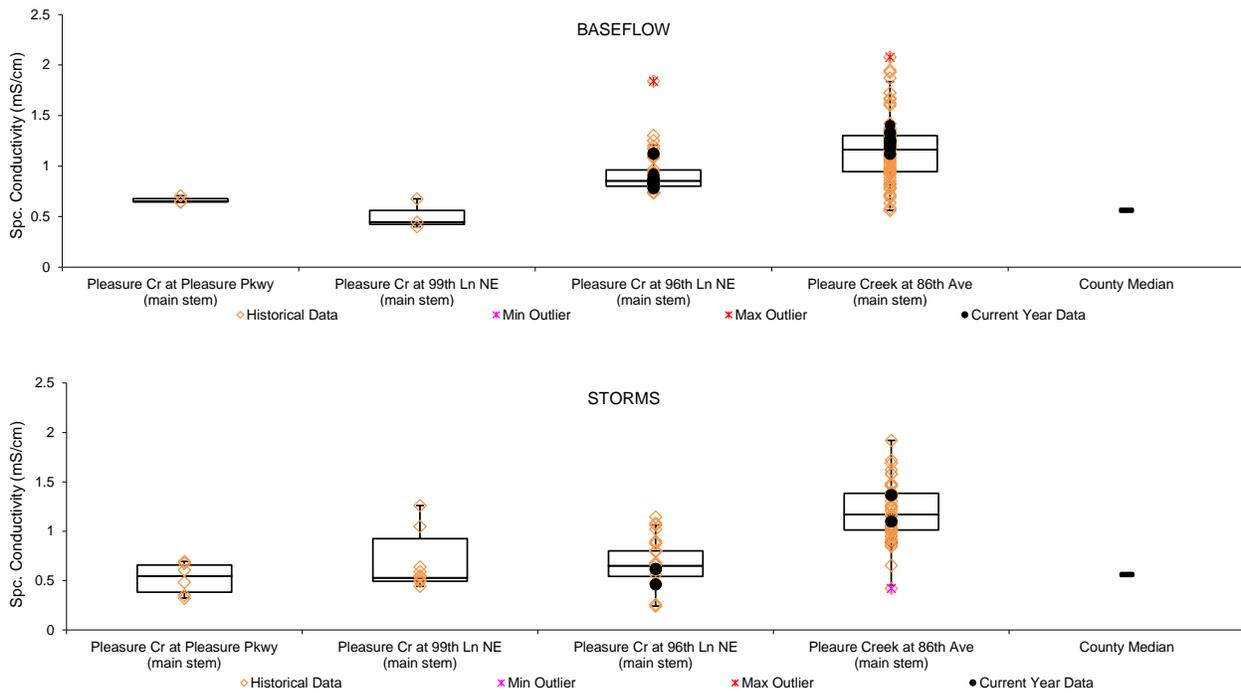
**Specific Conductivity at Pleasure Creek.** Orange diamonds are historical data from previous years and black circles are 2022 readings. Box plots show the median (middle line), 25th and 75th percentile (ends of box), and 10th and 90th percentiles (floating outer lines) for all data collected at these sites.

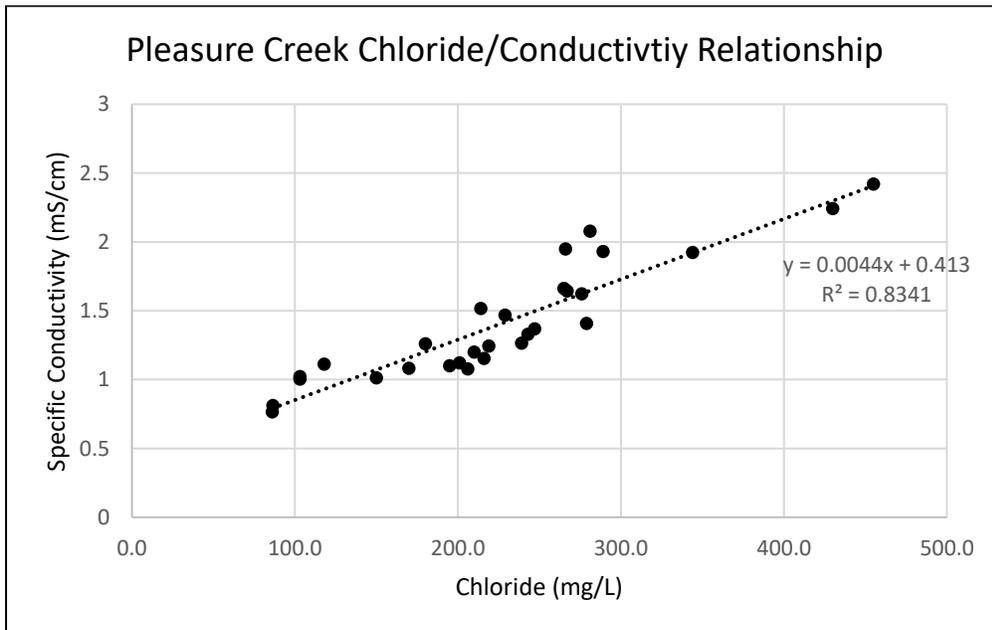
**Specific Conductivity/Chloride Relationship at Pleasure Creek.** In the Pleasure Creek system, conductivity measurements equal to or greater than 1.425 mS/cm indicate an exceedance of the State standard for Chloride (230 mg/L).

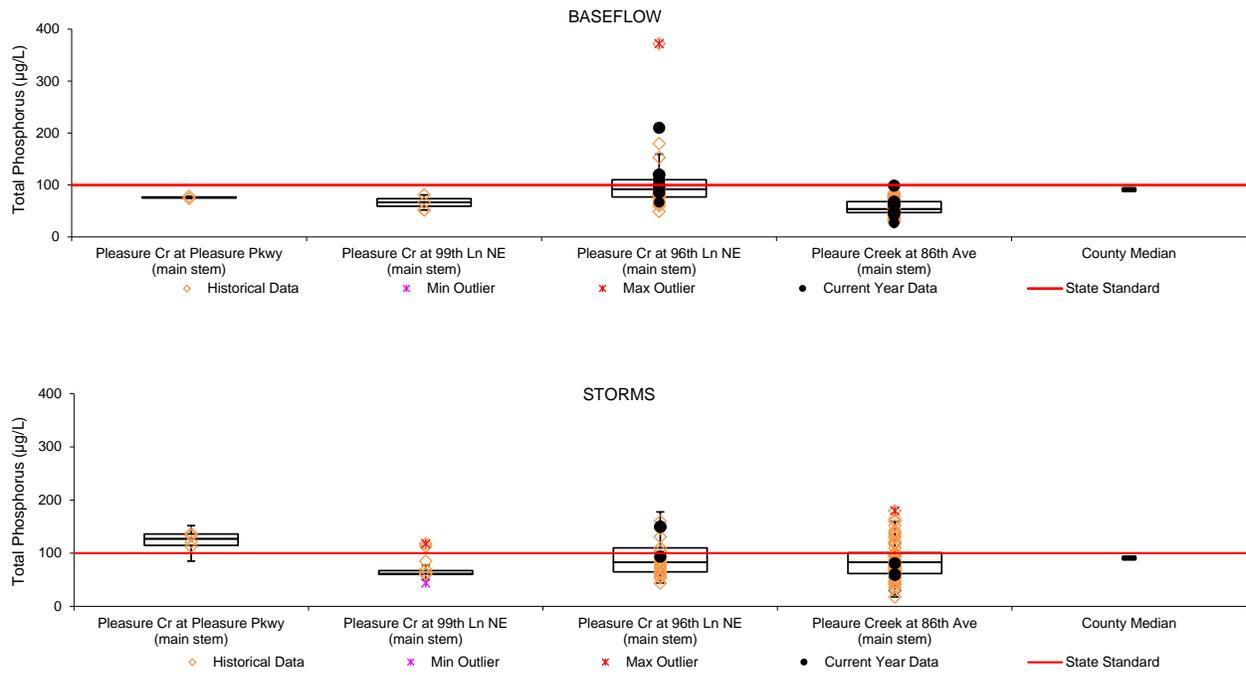
**Total phosphorus at Pleasure Creek.** Orange diamonds are historical data from previous years and black circles are 2022 readings. Box plots show the median (middle line), 25th and 75th percentile (ends of box), and 10th and 90th percentiles (floating outer lines) for all data collected at these sites.

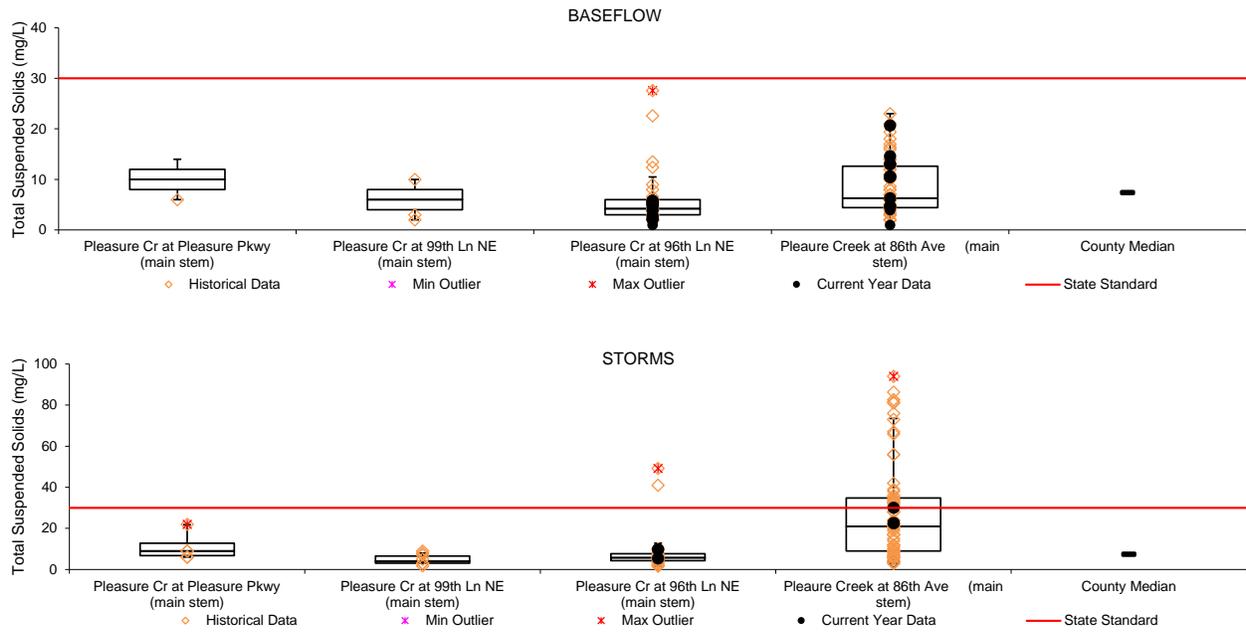
**Total suspended solids at Pleasure Creek.** Orange diamonds are historical data from previous years and black circles are 2022 readings. Box plots show the median (middle line), 25th and 75th percentile (ends of box), and 10th and 90th percentiles (floating outer lines) for all data collected at these sites.
