# Excerpt from the 2022 Water Almanac

## Chapter 6: Coon Creek Watershed

Prepared by the Anoka Conservation District

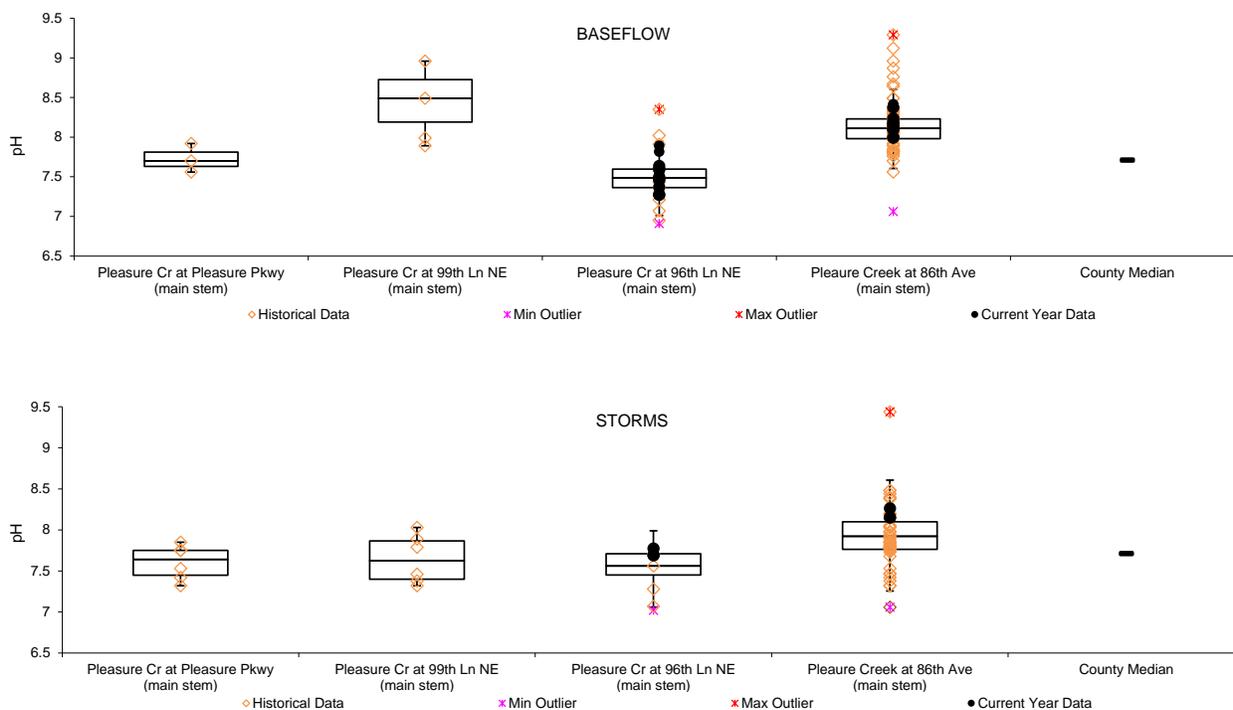
**pH at Pleasure Creek.** Orange diamonds are historical data from previous years and black circles are 2022 readings. Box plots show the median (middle line), 25th and 75th percentile (ends of box), and 10th and 90th percentiles (floating outer lines) for all data collected at these sites.

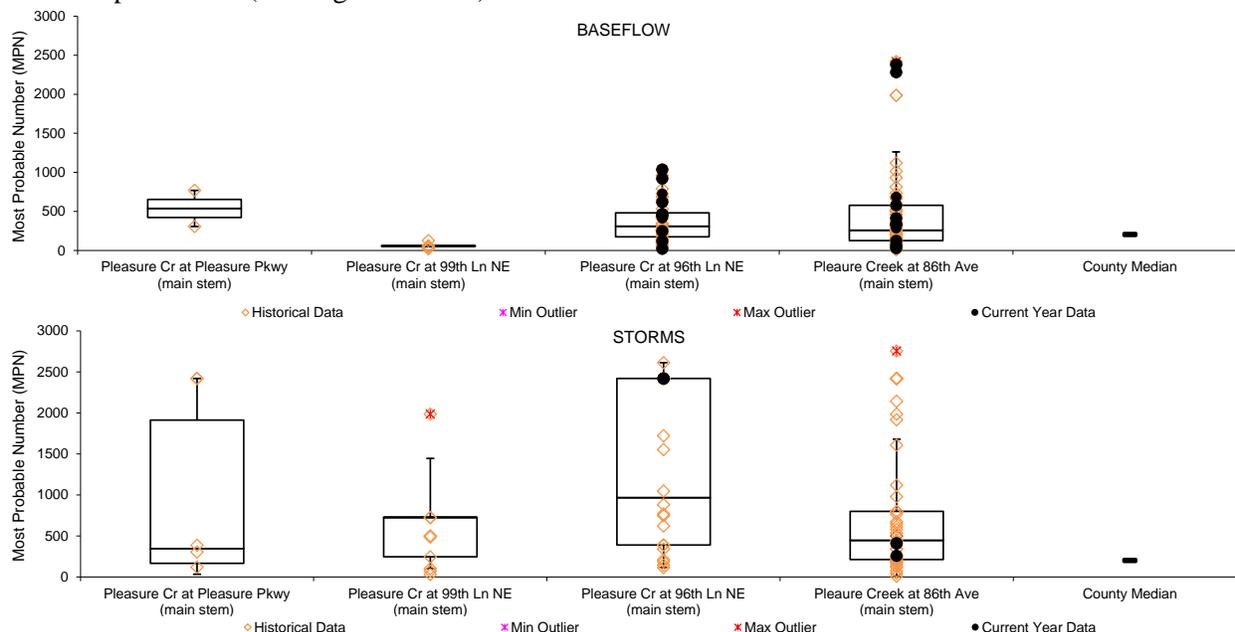
***E. coli* at Pleasure Creek.** Orange diamonds are historical data from previous years and black circles are 2022 readings. Box plots show the median (middle line), 25th and 75th percentile (ends of box), and 10th and 90th percentiles (floating outer lines) for all data collected at these sites.

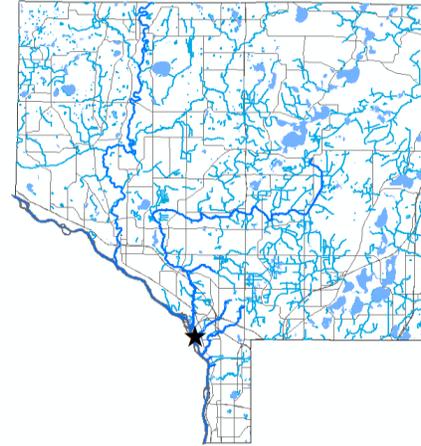
Stage at the Pleasure Creek at 86<sup>th</sup> Avenue suite fluctuated 1.79ft throughout the 2022 season. Water levels in the creek responded quickly to rain events and the creek maintained consistent water levels throughout most of the season, even during drought conditions.

There was a streambank stabilization project installed at this site in 2019. Streambanks and the streambed were both regraded during the project, changing the characteristics of the channel. These activities changed the base water levels compared to other monitoring years.

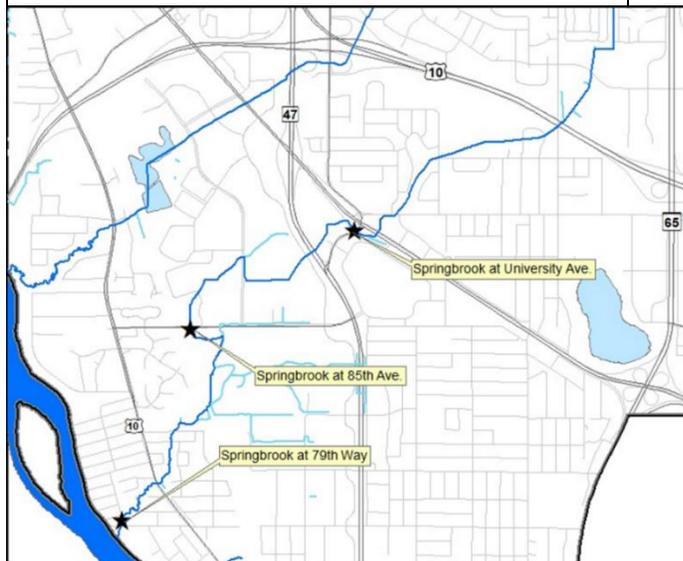
<b>Springbrook Creek (Ditch 17) Monitoring Sites</b>		
<b>Site Name/ SiteID</b>	<b>Years Monitored</b>	<b>2022 Data Collected</b>
Springbrook at University S007-542	2013-2022	Water Chemistry Grab Samples, Continuous Stage, Flow Measurements
Springbrook at 85 <sup>th</sup> Avenue S007-543	2013-2020	
Springbrook at 79 <sup>th</sup> Way S006-140	2012-2022	Water Chemistry Grab Samples, Continuous Stage, Flow Measurements

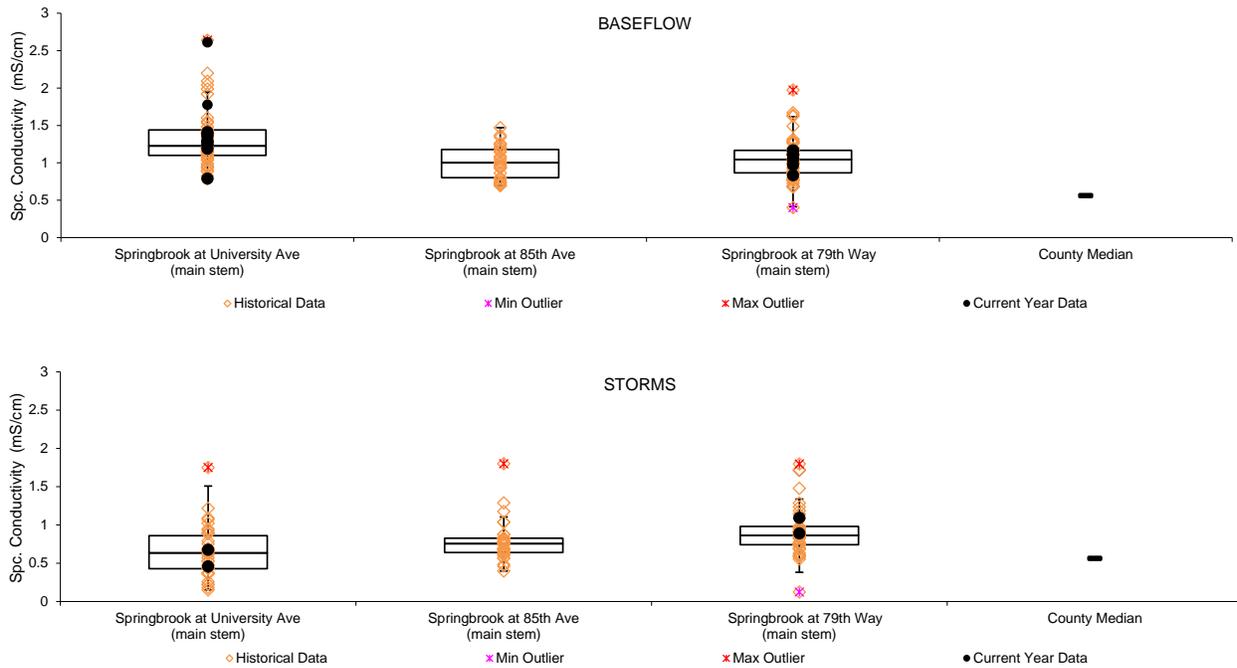
**Specific Conductivity at Springbrook Creek.** Orange diamonds are historical data from previous years and black circles are 2022 readings. Box plots show the median (middle line), 25th and 75th percentile (ends of box), and 10th and 90th percentiles (floating outer lines) for all data collected at these sites.

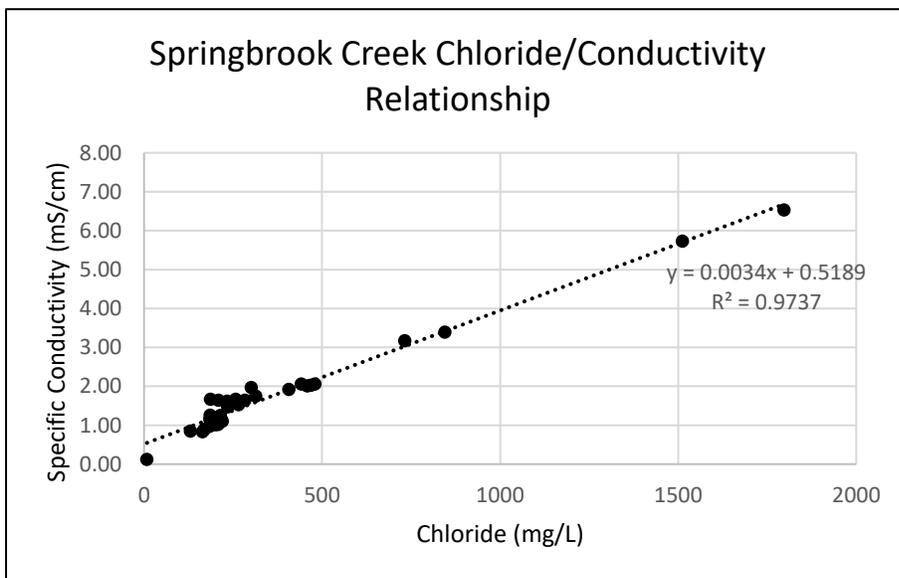
**Specific Conductivity/Chloride Relationship at Springbrook Creek.** In the Springbrook Creek system, conductivity measurements equal to or greater than 1.301 mS/cm indicate an exceedance of the State standard for Chloride (230 mg/L).

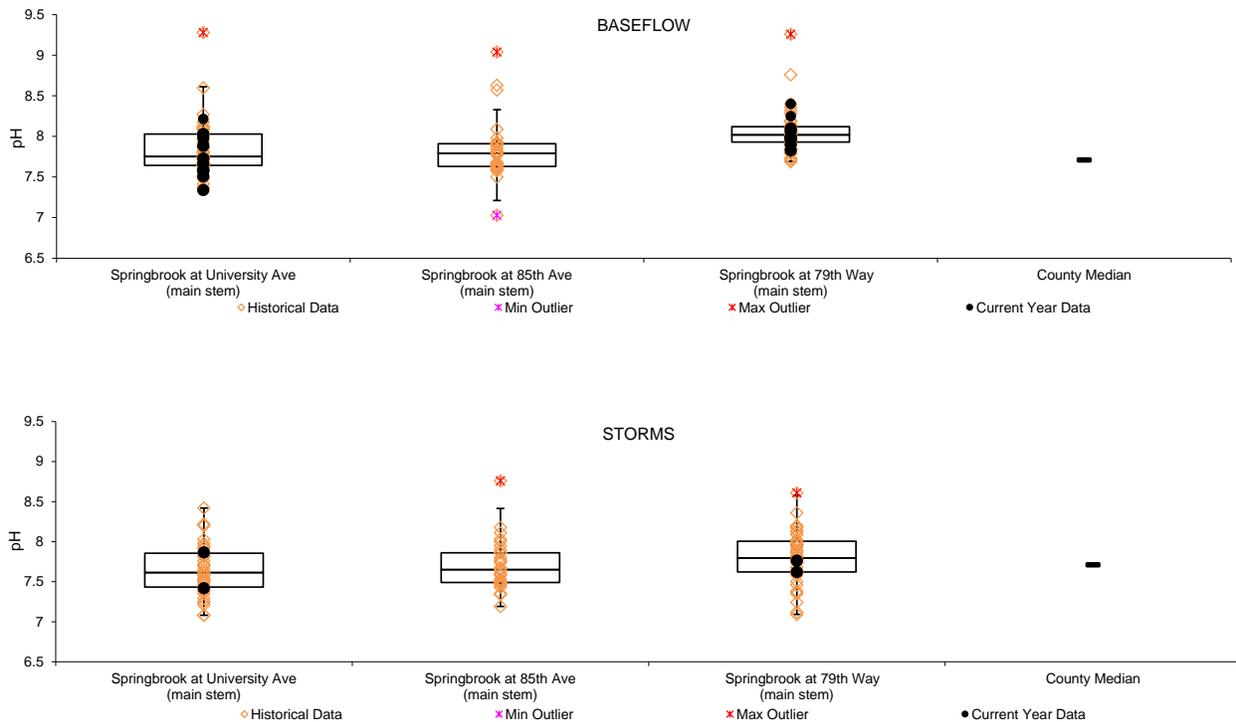
**pH at Springbrook Creek.** Orange diamonds are historical data from previous years and black circles are 2022 readings. Box plots show the median (middle line), 25th and 75th percentile (ends of box), and 10th and 90th percentiles (floating outer lines) for all data collected at these sites.
