Excerpt from the 2023 Anoka Water Almanac

Chapter 7: Mississippi Watershed

Prepared by the Anoka Conservation District

HIGHLAND LAKE AQUATIC VEGETATION REPORT

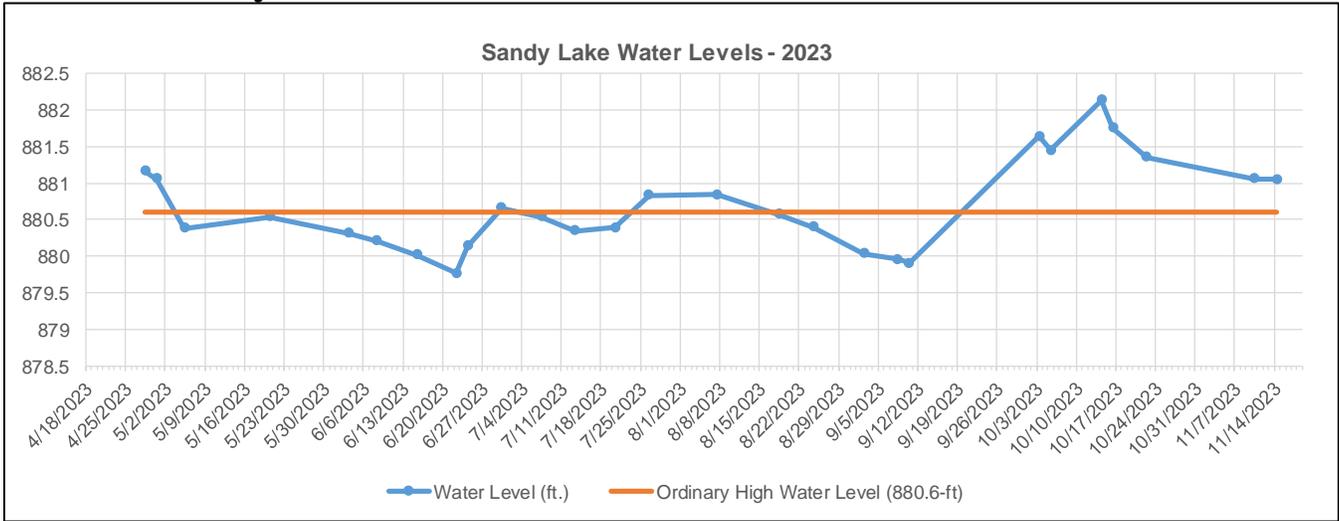
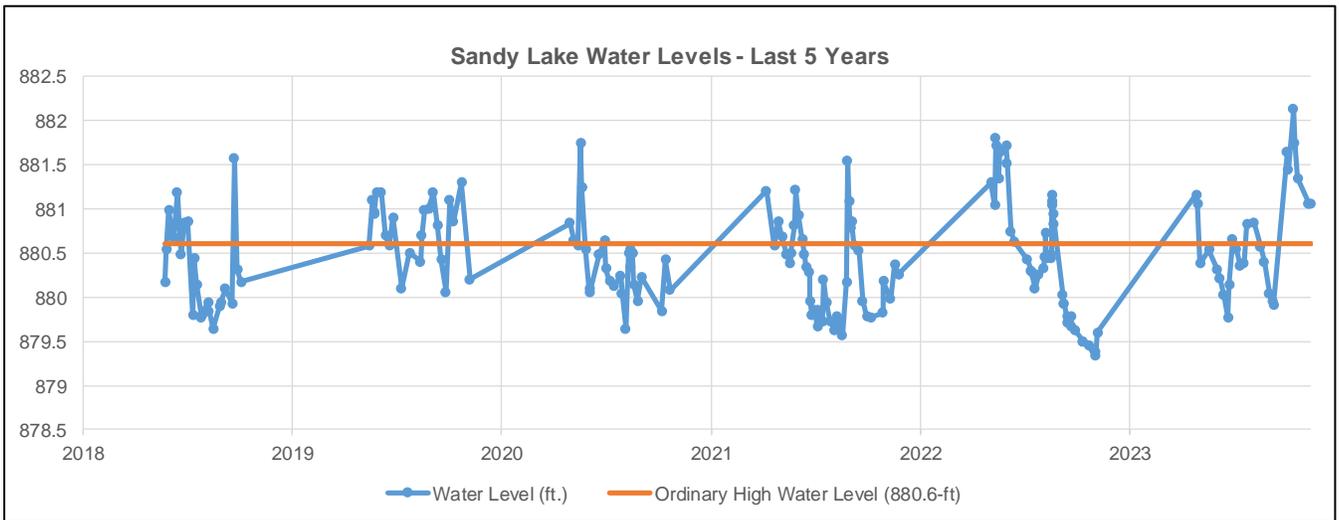
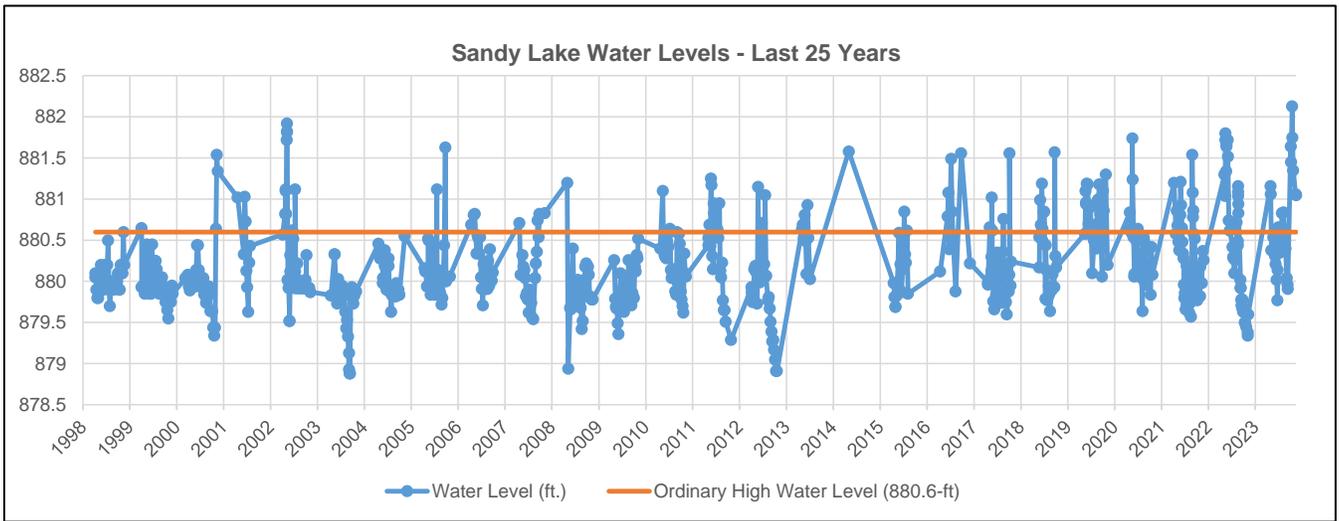
Sullivan/Sandy

Results: **Sullivan/Sandy.** In 2023, Sullivan water levels ranged 2.36 feet. It largely stayed within water levels commonly observed in most years, despite summer 2023 drought. However, in mid-October the water level briefly rose to its highest level ever observed since records began in 1992. Water levels on Sullivan Lake typically fluctuate rapidly, bouncing by half a foot in response to individual rainfall events. This is due to the volume of stormwater directed to the lake compared to the small basin size.

Description: Water level monitoring in lakes. Current year's, as well as historical data is available on the Minnesota DNR website using the "LakeFinder" feature (www.dnr.mn.us.state/lakefind/index.html). Ordinary High Water Levels (OHW) are listed for each lake on the graph below. Any work performed below this elevation requires a DNR permit.

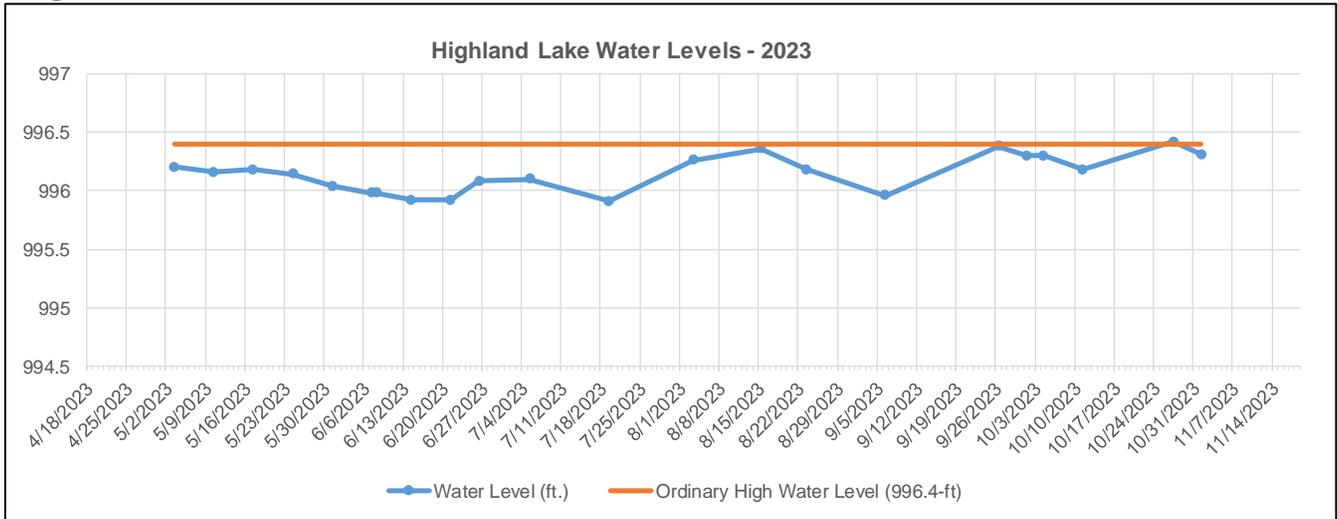
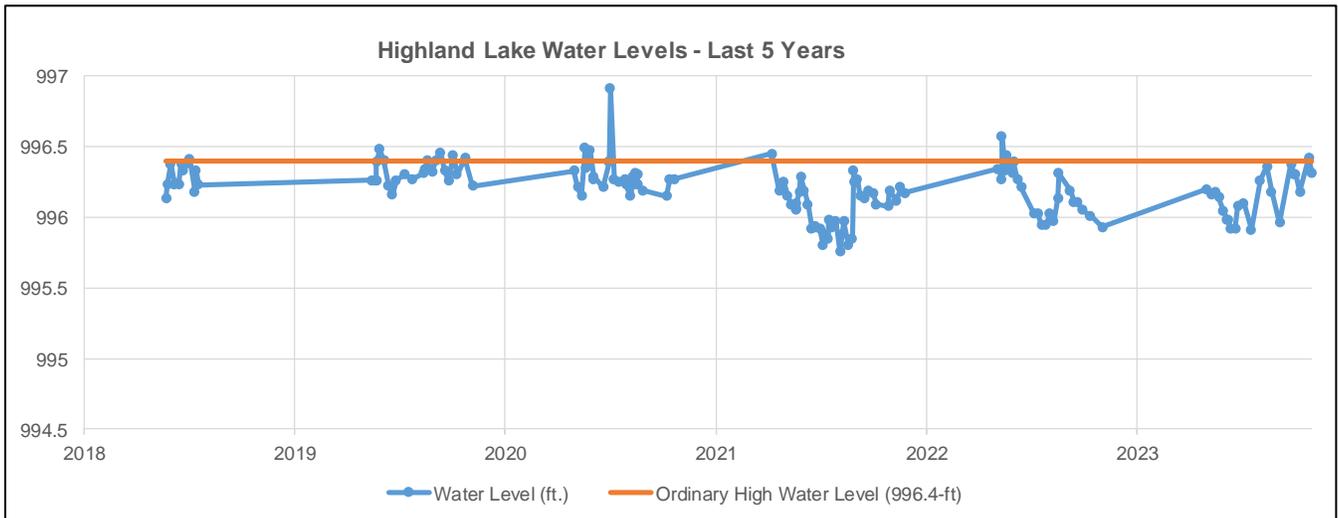
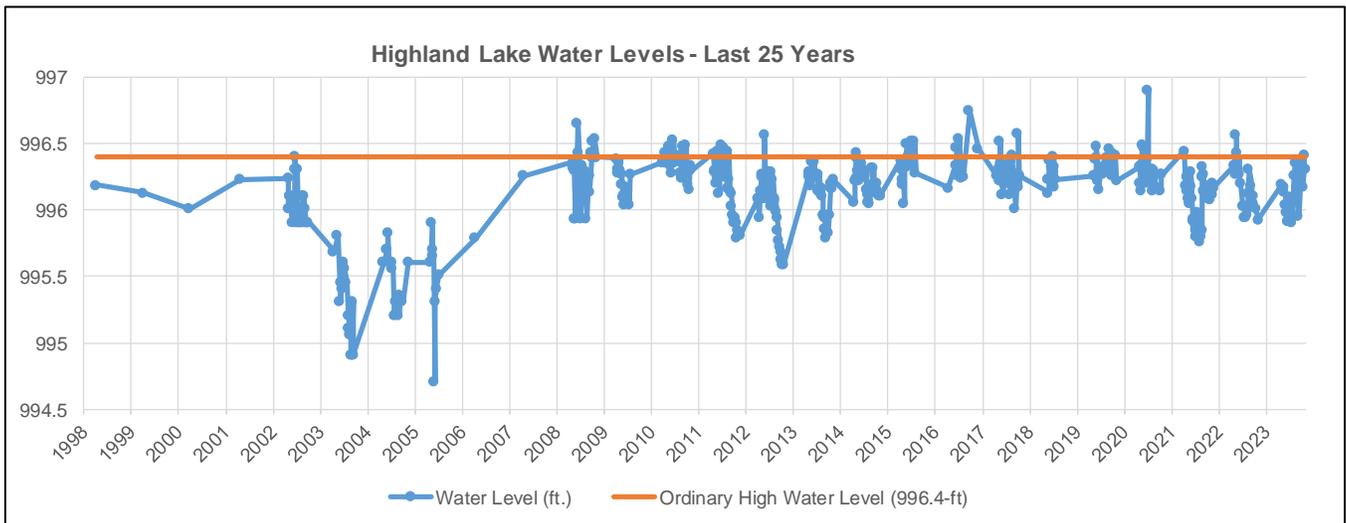
Highland. Water levels in Highland Lake fluctuated 0.51 feet during 2023. Water levels were within the range observed in many years, but also had some readings on the lower end of that range due to drought. Highland and Sullivan Lake each have controlled outlet structures in place which help manage water levels and help control how high water elevations can reach in order to prevent flooding.

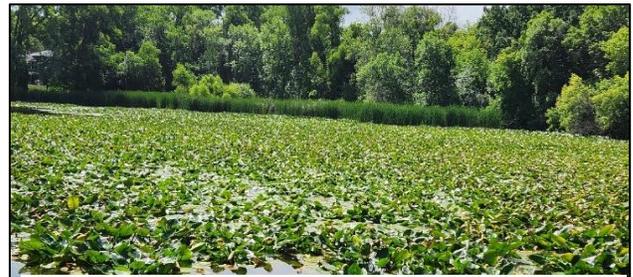
Figure 2. Dense Bullhead Water Lily (*Nuphar variegata*) growth in Highland Lake.

The native water lily *Nuphar variegata* (commonly known as Bullhead or Variegated Yellow Pond Lily) is the dominant aquatic plant in Highland Lake, and the only rooted floating species detected in this survey. Its floating leaves occupy approximately 85% of the lake's surface, typically growing so densely that they overlap or even rise above each other (Figure 2), shading out the water underneath entirely. *Nuphar variegata* is common in Minnesota and grows in quiet shallow waters with mucky bottoms. Water lilies spread through rhizomes underneath the sediment and are often abundant in nutrient-rich ponds and lakes with shallow water throughout. Common duckweed (*Lemna minor*), a free-floating plant, was also detected in Highland Lake but generally in low quantities amongst the stands of emergent vegetation. See Appendix A for a map of floating vegetation prevalence and abundance.

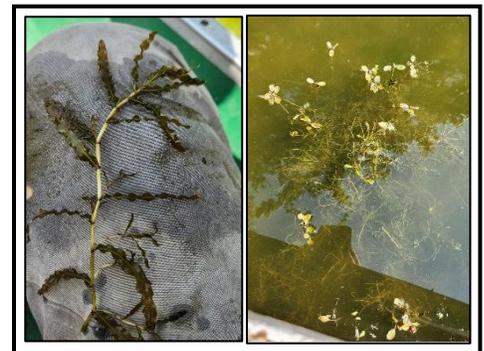
P. crispus (left) and dense P. vaseyi growth (right) detected in Highland Lake

Curly-leaf Pondweed (*Potamogeton crispus*): This is a prohibited invasive species in Minnesota which often grows in dense mats and outcompetes native aquatic vegetation (*Figure 2*). It was detected along Highland Lake's northern and western shorelines (Appendix D), but is present at low densities and often growing alongside Vasey's Pondweed. Curly-leaf pondweed growth was reduced in many metro area lakes this year due to heavy snow cover and late ice-off, so its growth in Highland Lake may typically be more abundant.

This is a narrow-leaf pondweed species which does not have existing herbarium or MNDNR survey records for Anoka County and is otherwise uncommon in the Twin Cities Metro Area. It was the most common submersed plant found in Highland Lake, occasionally growing in dense clusters (*Figure 3*). The leaves of Vasey's Pondweed are very fragile and thus susceptible to disturbance from boats or wave action; this may be one reason that it's able to persist in Highland Lake. Identification was confirmed with staff from the MN Biological Survey.

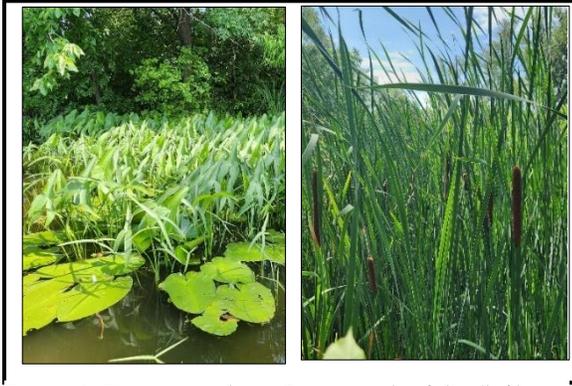
Figure 1. Emergent plants *Sagittaria latifolia* (left) and *Typha* spp. (right) observed in highland lake.

Cattails (*Typha* spp.) are the dominant emergent plant on Highland Lake. They occupy approximately 1/3 of the shoreline in dense but generally narrow fringes less than 50 feet wide. The dense growth patterns and flower characteristics of these cattails indicate that they are likely *Typha x glauca*, which is a hybrid of the native broad-leaved cattail and invasive narrow-leaved cattail. However, DNA analysis is typically needed to confirm the identification of this species. Hybrid cattails are increasingly common in lakes and wetlands, especially in those receiving nutrient-rich runoff. They often expand rapidly in shallow water via underground growth, choking out other aquatic vegetation in the process.

Broadleaf Arrowhead (*Sagittaria latifolia*) is present in small clusters along approximately 5% of the lake's shoreline. This emergent plant is native and common in Minnesota's aquatic ecosystems. The remainder of the lake's shoreline lacks emergent vegetation, instead containing a narrow zone of exposed sediment which quickly transitions to riparian shrubs upslope. See Appendix E for a map of emergent vegetation distribution.
