Mississippi River Stormwater Retrofit Analysis

Mississippi River Stormwater Retrofit Analysis: 2024

Prepared for the City of Anoka, the City of Coon Rapids, and the Lower Rum River Watershed Management Organization (LRRWMO) by:

Anoka Conservation District

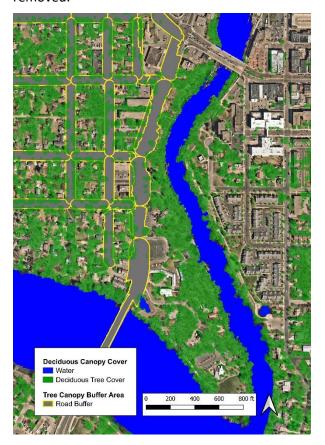
Figure 9: Roadway buffers, derived from MNDOT right-of-way widths, within which tree canopy cover was calculated.

Enhanced street sweeping is the incorporation of additional sweeping protocols, the timing and location of which are targeted to maximize water quality protection. One way to prioritize locations for enhanced sweeping is to quantify tree canopy cover overhanging and immediately adjacent to roadways; this is because tree canopy cover is highly correlated with the amount of recoverable organic materials on roadways (Kalinosky, 2015) and average total phosphorus concentrations in stormwater runoff (Janke et al. 2017). Tree canopy data can then be combined with stormwater infrastructure information to identify roadways likely contributing most to nutrient inputs derived from fallen tree materials.

referenced to generate a buffer around each roadway, and deciduous tree canopy abundance within these buffers (total % coverage) was quantified by intersecting them with the *Twin Cities Metro Area (TCMA) Urban Tree Canopy Classification* dataset; see Figure 9 for an example. Altogether, these processes allowed for canopy cover comparisons within the study areas, and correspondingly the prioritization of roadways most likely to contribute nutrient-rich stormwater derived from tree materials.

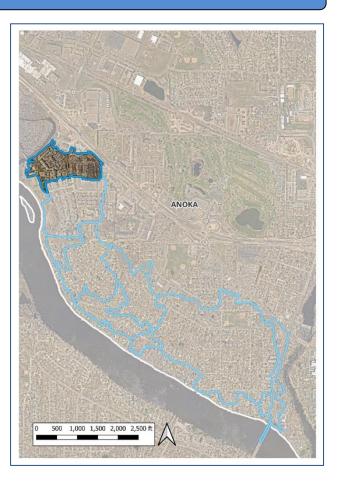
This catchment contains a stormwater pond at the outfall and several bioinfiltration / infiltration features amongst the commercial properties. Street cleaning is also conducted once in early spring and once in mid-summer by the City of Anoka.

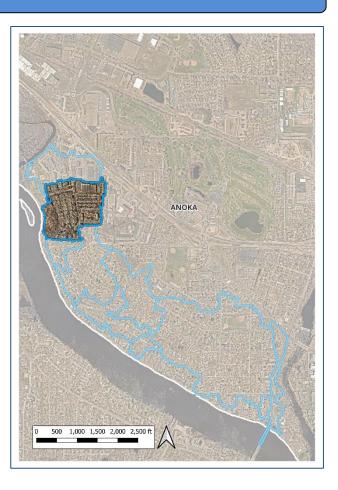
This catchment contains a stormwater pond at the outfall. Street cleaning is also conducted once in early spring and once in mid-summer by the City of Anoka. Present day stormwater pollutant loading and treatment is summarized in the table below.

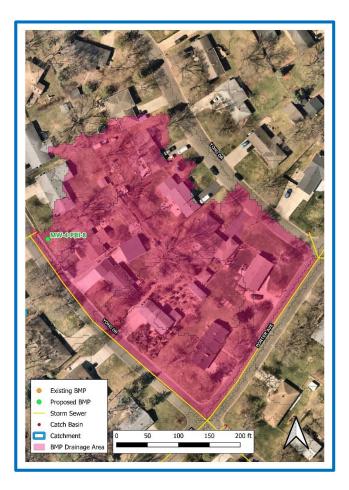
Site Specific Information – An opportunity for a bioinfiltration basin exists at this location. The proposed location is within the front yard of a private residential house. The proposed basin is a standard, single inlet rain garden that would treat stormwater collected from multiple properties along Yoho Dr. and Porter Ave. The table below provides pollutant removals and estimated costs.

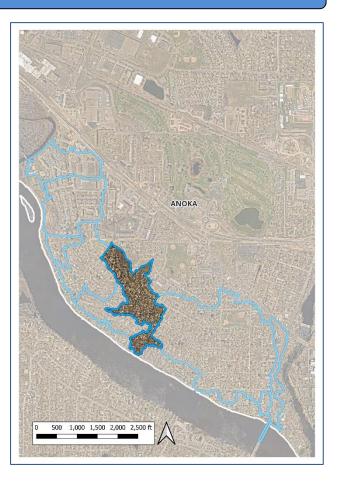
This catchment contains a hydrodynamic device near the outfall that treats the majority of the catchment. In addition, street cleaning is conducted once in early spring and once in mid-summer by the City of Anoka. Present day stormwater pollutant loading and treatment is summarized in the table below.

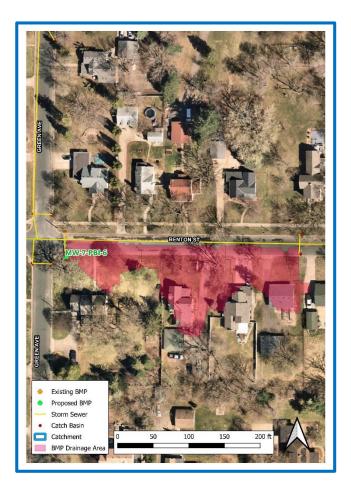
Site Specific Information – An opportunity for a bioinfiltration basin exists at this location. The proposed location is within the front yard of a private residential house. The proposed basin is a standard, single inlet rain garden that would treat stormwater collected along Benton St. to the east. The table below provides pollutant removals and estimated costs.

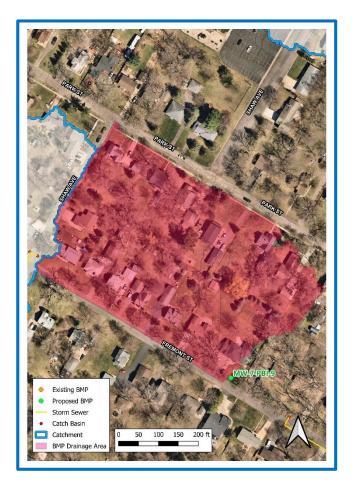
Site Specific Information – An opportunity for a bioinfiltration basin exists at this location. The proposed location is within the front yard of a private residential house. The proposed basin is a standard, single inlet rain garden that would treat stormwater collected along Fremont St. to the west. The table below provides pollutant removals and estimated costs.

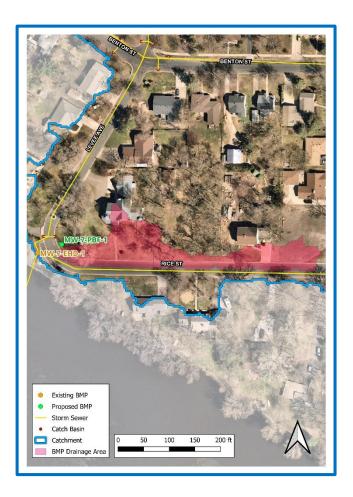
Site Specific Information — An opportunity for a biofiltration basin exists at this location. The proposed location is on the corner of Rice St. opposite of the Rice St. Beach. The proposed basin is a standard, single inlet rain garden that would treat stormwater collected along Rice St. to the east. Soils in this area are classified as Hydrologic Soil Group B, which have moderately low runoff potential. The proposed basin is in close proximity to the existing catch basin, which could serve as the connection point for the underdrain outlet. The table below provides pollutant removals and estimated costs.

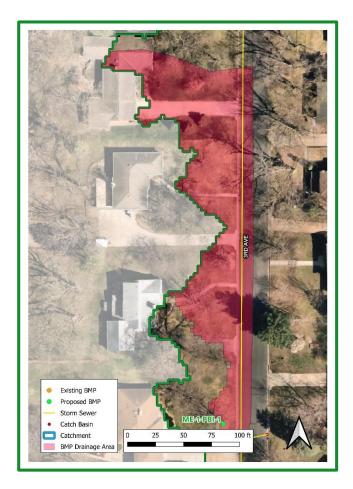
Project ID: ME-1-PBI-1

Site Specific Information – An opportunity for a bioinfiltration basin exists at this location. The proposed location is within the front yard of a private residential house. The proposed basin is a standard, single inlet rain garden that would treat stormwater collected along 3rd Ave. to the north. The table below provides pollutant removals and estimated costs.

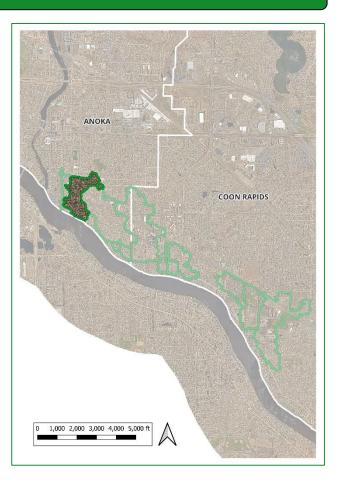
This catchment contains two bioinfiltration basins that provide treatment to a portion of the commercial properties on the northern side. These basins are naturally low-lying areas with curb-cuts installed to route stormwater runoff from the parking lots. Street cleaning is also conducted once in early spring and once in mid-summer by the City of Anoka. Present day stormwater pollutant loading and treatment is summarized in the table below.

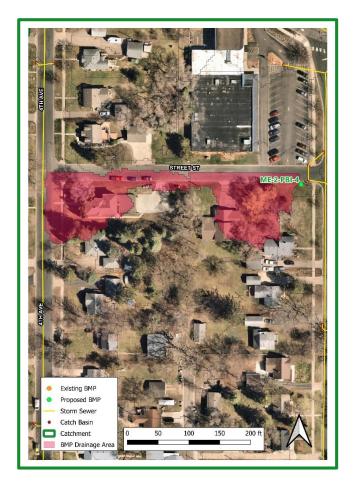
Site Specific Information — An opportunity for a bioinfiltration basin exists at this location. The proposed location is within the front yard of a private residential house. The proposed basin is a standard, single inlet rain garden that would treat stormwater collected along Street St. to the west. The table below provides pollutant removals and estimated costs.

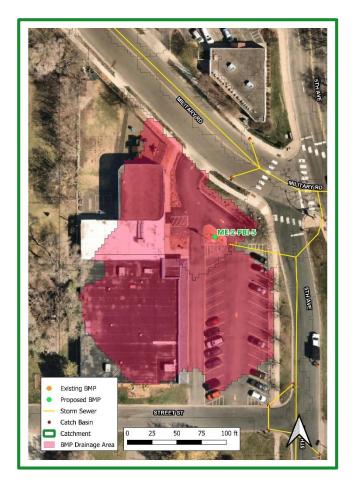
Site Specific Information – An opportunity for a bioinfiltration basin exists at this location. The proposed location is within a parking lot island near the catch basin. The proposed basin is a standard, single inlet rain garden that would treat stormwater collected from the majority of the parking lot and runoff from the roof. The table below provides pollutant removals and estimated costs.

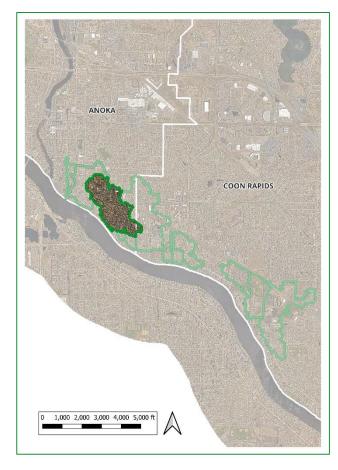
This catchment contains one bioinfiltration basin and one hydrodynamic device. The biofiltration device is located on the side of East River Rd. near Lincoln Elementary. The existing hydrodynamic device is located near the catchment outfall. Street

cleaning is also conducted once in early spring and once in mid-summer by the City of Anoka, and five times per year by the City of Coon Rapids. Present day stormwater pollutant loading and treatment is summarized in the table below.

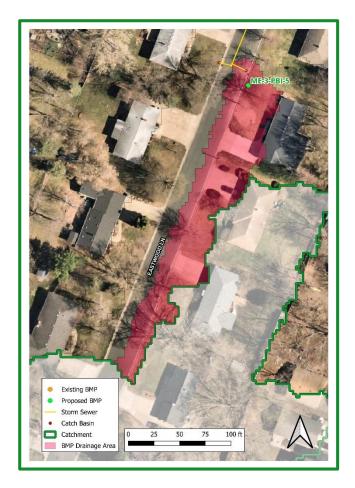
Site Specific Information – An opportunity for a bioinfiltration basin exists at this location. The proposed location is within the front yard of a private residential house. The proposed basin is a standard, single inlet rain garden that would treat stormwater collected along Eastwood Ln. to the south. The table below provides pollutant removals and estimated costs.

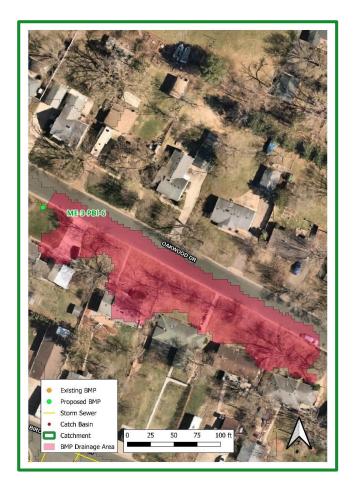
Site Specific Information – An opportunity for a bioinfiltration basin exists at this location. The proposed location is within the front yard of a private residential house. The proposed basin is a standard, single inlet rain garden that would treat stormwater collected along Oakwood Dr. to the east. The table below provides pollutant removals and estimated costs.

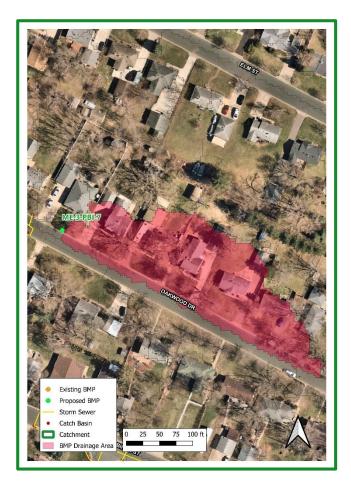
Site Specific Information — An opportunity for a bioinfiltration basin exists at this location. The proposed location is within the front yard of a private residential house. The proposed basin is a standard, single inlet rain garden that would treat stormwater collected along Oakwood Dr. to the east. The table below provides pollutant removals and estimated costs.

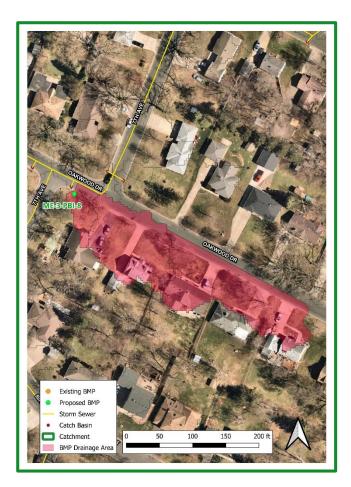
Oakwood Dr. **Bioinfiltration Basin**

Site Specific Information – An opportunity for a bioinfiltration basin exists at this location. The proposed location is within the front yard of a private residential house. The proposed basin is a standard, single inlet rain garden that would treat stormwater collected along Oakwood Dr. to the east. The table below provides pollutant removals and estimated costs.

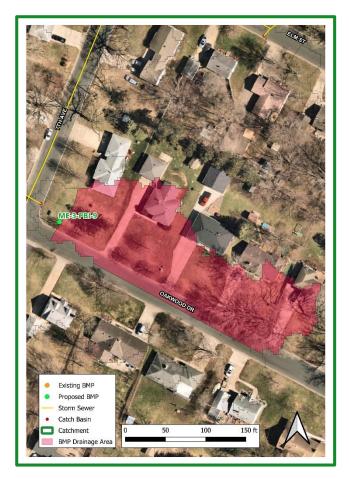
Oakwood Dr.
Bioinfiltration Basin

Site Specific Information — An opportunity for a bioinfiltration basin exists at this location. The proposed location is within the front yard of a private residential house. The proposed basin is a standard, single inlet rain garden that would treat stormwater collected along Oakwood Dr. to the east. A double inlet rain garden is not feasible in this location due to the existing electrical box. The table below provides pollutant removals and estimated costs.

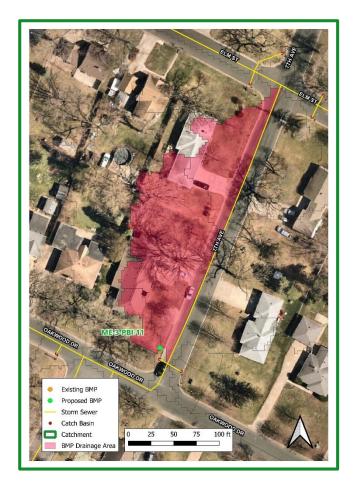
7th Ave. Bioinfiltration Basin

Site Specific Information – An opportunity for a bioinfiltration basin exists at this location. The proposed location is within the front yard of a private residential house. The proposed basin is a standard, single inlet rain garden that would treat stormwater collected along 7th Ave. to the north. The table below provides pollutant removals and estimated costs.

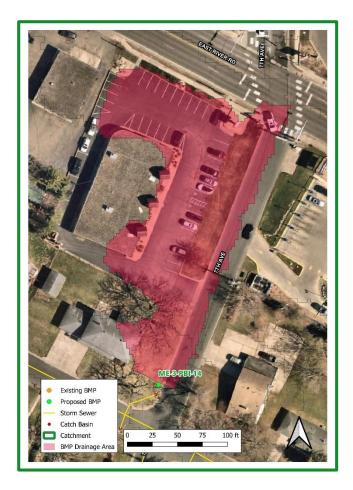
7th Ave. **Bioinfiltration Basin**

Site Specific Information – An opportunity for a bioinfiltration basin exists at this location. The proposed location is within the front yard of a private residential house. The proposed basin is a standard, single inlet rain garden that would treat stormwater collected along 7th Ave. to the north, which primarily includes the parking lot of the adjacent commercial property. The table below provides pollutant removals and estimated costs.

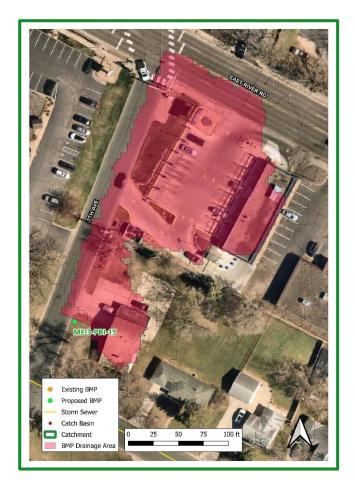
7th Ave. Bioinfiltration Basin

Site Specific Information – An opportunity for a bioinfiltration basin exists at this location. The proposed location is within the front yard of a private residential house. The proposed basin is a standard, single inlet rain garden that would treat stormwater collected along 7th Ave. to the north, which primarily includes the parking lot of the adjacent commercial property. The table below provides pollutant removals and estimated costs.

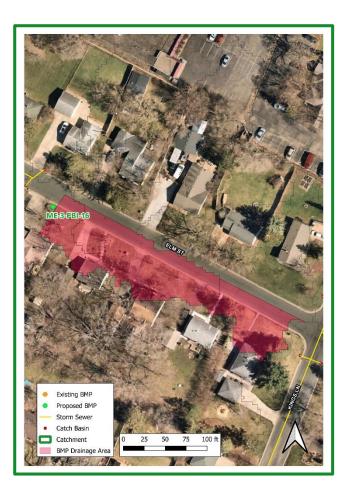
Elm St. **Bioinfiltration Basin**

Site Specific Information – An opportunity for a bioinfiltration basin exists at this location. The proposed location is within the front yard of a private residential house. The proposed basin is a standard, single inlet rain garden that would treat stormwater collected along Elm St. to the east. The table below provides pollutant removals and estimated costs.

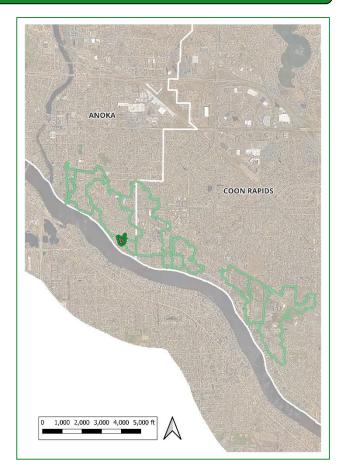
This catchment contains an existing hydrodynamic device at the outfall that provides treatment to the entire catchment. Street cleaning is also conducted once in early spring and once in mid-summer by the City of Anoka. Present day stormwater pollutant loading and treatment is summarized in the table below.

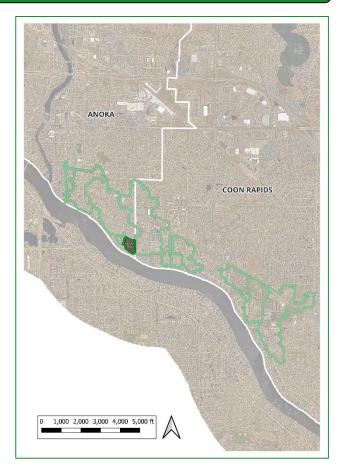
This catchment contains an existing hydrodynamic device at the outfall that provides treatment to the entire catchment. Street cleaning is also conducted once in early spring and once in mid-summer by the City of Anoka. Present day stormwater pollutant loading and treatment is summarized in the table below.

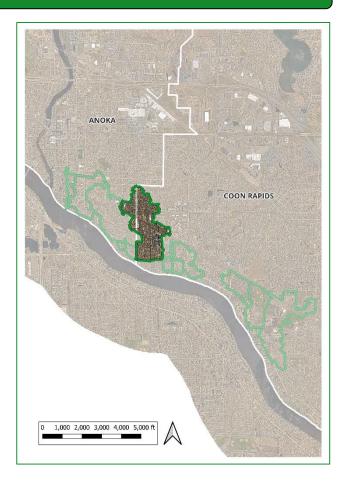
This catchment contains multiple existing stormwater treatment practices. Three bioinfiltration basins treat stormwater runoff from the northern side of the catchment, and one

natural bioinfiltration basin at Elm St. Park treats stormwater runoff from a nearby parking lot. There are also two grass swales on both sides of Coon Rapids Blvd. adjacent to Mercy Hospital. In addition, the hospital itself contains two subsurface stormwater treatment systems that provide treatment to parking lot runoff. One of these subsurface systems recently replaced the stormwater pond previously present at the southwestern corner of Mercy Hospital due to the need for increased parking capacity. These subsurface systems were not modeled due to the lack of information.

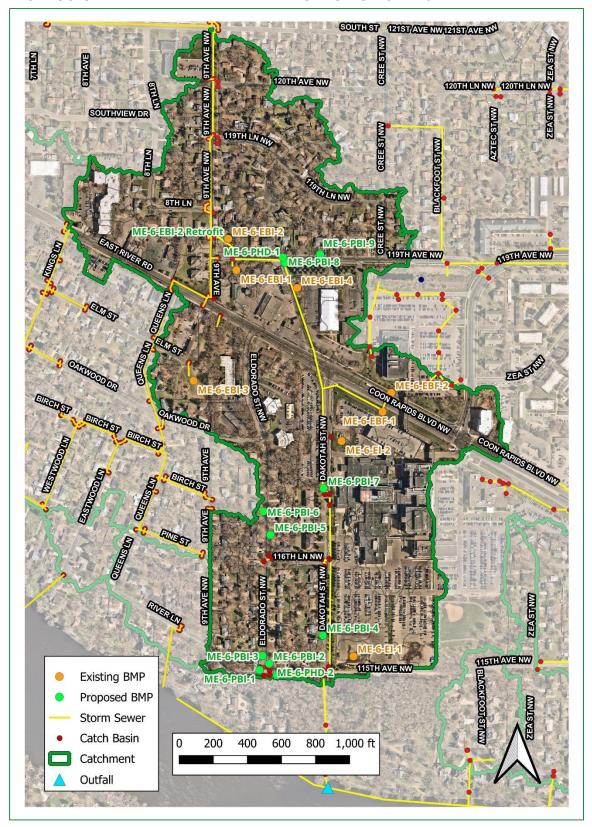
EXISTING STORMWATER TREATMENT AND RETROFIT OPPORTUNITIES

Multiple stormwater treatment practices are proposed within this catchment. They include nine bioinfiltration basins, two hydrodynamic devices, and a retrofit to an existing stormwater pond to increase ponding depth.

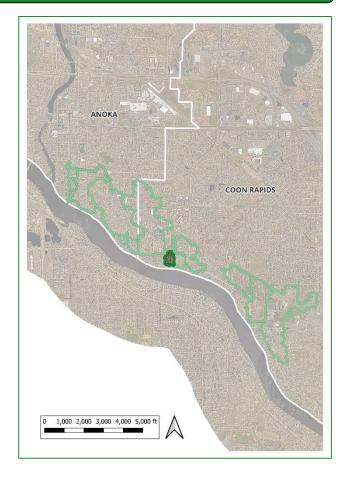
Street cleaning is conducted five times per year by the City of Coon Rapids. No other existing treatment was identified in this catchment. Present day stormwater pollutant loading and treatment is summarized in the table below.

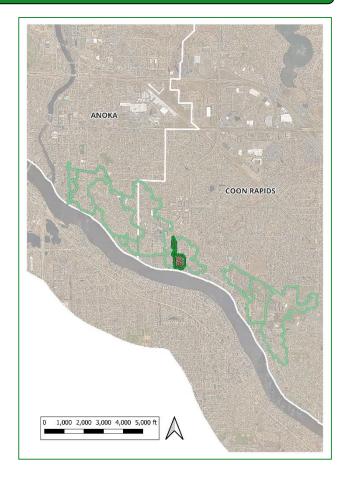
Street cleaning is conducted five times per year by the City of Coon Rapids. No other existing treatment was identified in this catchment. Present day stormwater pollutant loading and treatment is summarized in the table below.

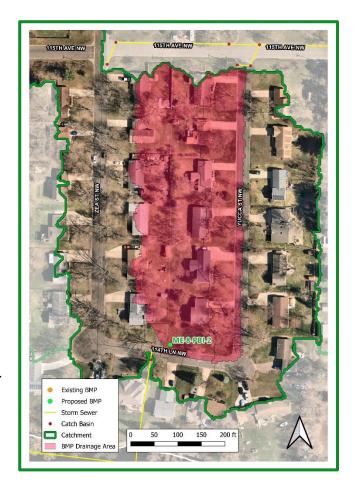
Site Specific Information – An opportunity for a bioinfiltration basin exists at this location. The proposed location is within the front yard of a private residential house. The proposed basin is a standard, single inlet rain garden that would treat stormwater collected along Yucca St. to the north. The table below provides pollutant removals and estimated costs.

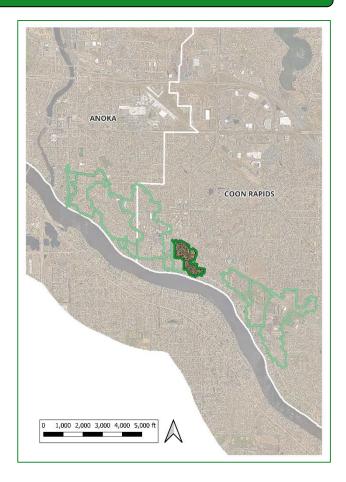
Street cleaning is conducted five times per year by the City of Coon Rapids. No other existing treatment was identified in this catchment. Present day stormwater pollutant loading and treatment is summarized in the table below.

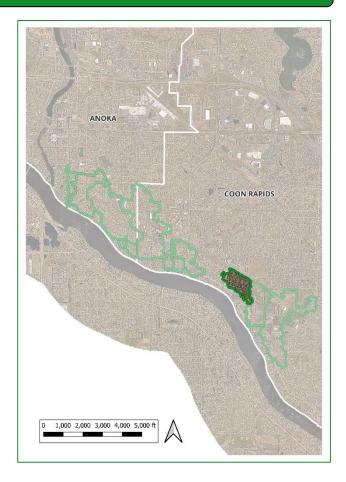
Street cleaning is conducted five times per year by the City of Coon Rapids. No other existing treatment was identified in this catchment. Present day stormwater pollutant loading and treatment is summarized in the table below.

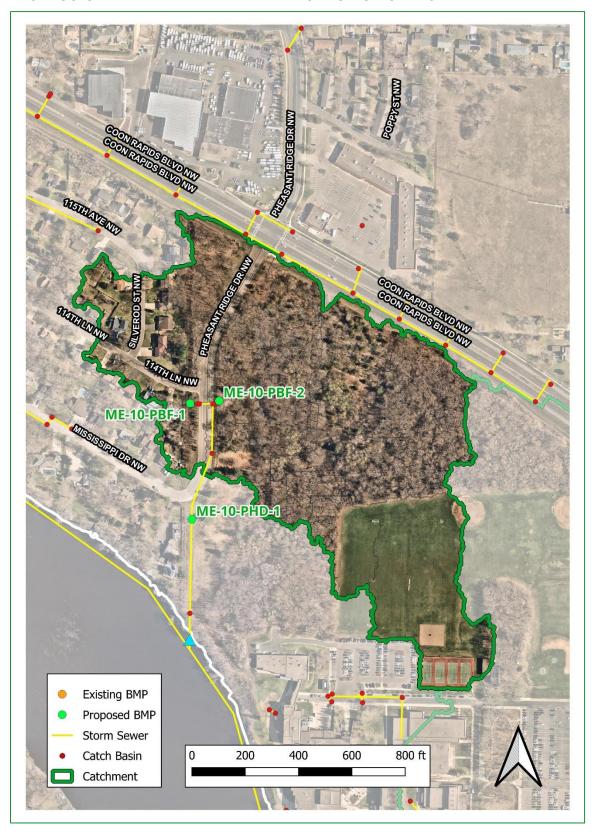
EXISTING STORMWATER TREATMENT AND RETROFIT OPPORTUNITIES

Two biofiltration basins and one hydrodynamic device are proposed within this catchment.

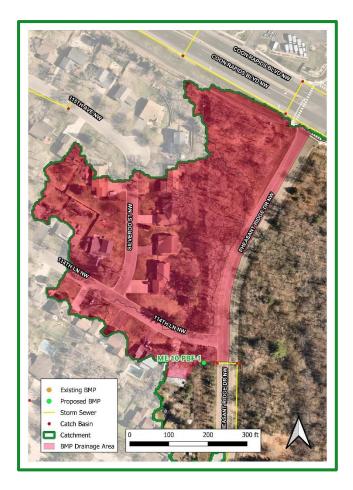
Project ID: ME-10-PBF-1

Site Specific Information – An opportunity for a biofiltration basin exists at this location. The proposed location is near the catch basin on a narrow stretch of land along the west side of Pheasant Ridge Dr. that is owned by the Anoka-Ramsey Community College. The proposed basin is a standard, single inlet rain garden that would treat stormwater collected along Shaw Ave. to the north. Soils in this area are classified as Hydrologic Soil Group C, which have moderately high runoff potential. The proposed basin is in close proximity to the existing catch basin, which

could serve as the connection point for the underdrain outlet. The table below provides pollutant removals and estimated costs.

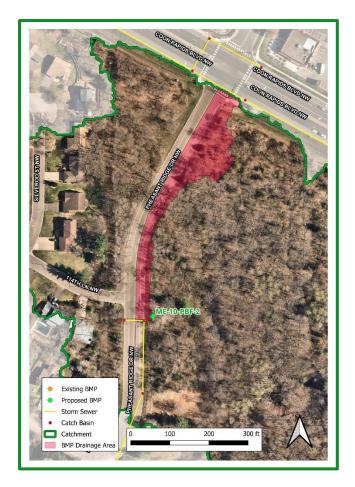
Site Specific Information – An opportunity for a biofiltration basin exists at this location. The proposed location is near the catch basin on the east side of Pheasant Ridge Dr. on forested land that is owned by the Anoka-Ramsey Community College. The proposed basin is a standard, single inlet rain garden that would treat stormwater collected along Shaw Ave. to the north. Soils in this area are classified as Hydrologic Soil Group C, which have moderately high runoff potential. The proposed basin is in close proximity to the existing catch basin, which could serve as the

connection point for the underdrain outlet. The table below provides pollutant removals and estimated costs.

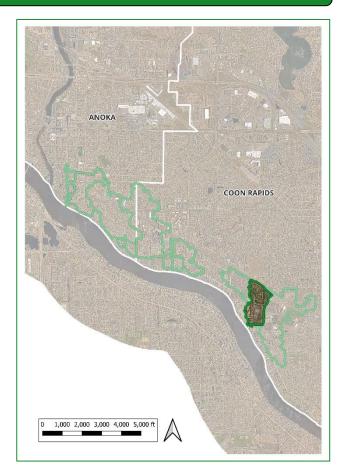
This catchment contains one existing bioinfiltration basin, however, this basin appears to primarily collect stormwater runoff from a small portion of the campus roof and the adjacent field. Because the upstream drainage area for this existing bioinfiltration basin is small and does not include any of the parking lot runoff, this basin has not been modeled as an existing stormwater treatment practice. In addition, street cleaning is conducted five times per year by the City of Coon Rapids.

Modification to the existing bioinfiltration basin to a wet pond was considered as a potential project, however, based on field assessments, the existing stormwater infrastructure is too deep for an appropriately-sized wet pond in this location while also maintaining available green space for the Anoka-Ramsey Community College campus.

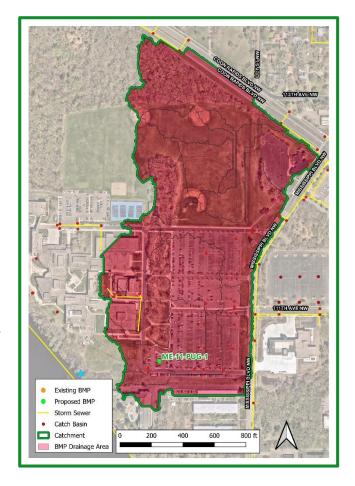
Project ID: ME-11-PUG-1

Anoka Ramsey Community College Underground Structure

Site Specific Information – An underground structure is proposed near this location. The structure would provide treatment to stormwater runoff from the majority of the catchment, depending on the location of stormwater infrastructure. It is recommended that an underground structure is paired with any potential road or parking lot rehabilitation projects for cost effectiveness. Soils in this area are classified as Hydrologic Soil Group C, which have moderately high runoff potential and reduces the effectiveness of the underground

structure. In addition, based on field assessments, the existing stormwater infrastructure appears to be fairly deep below surface, which significantly increases the cost of installing an underground structure. The table below provides pollutant removals and estimated costs.

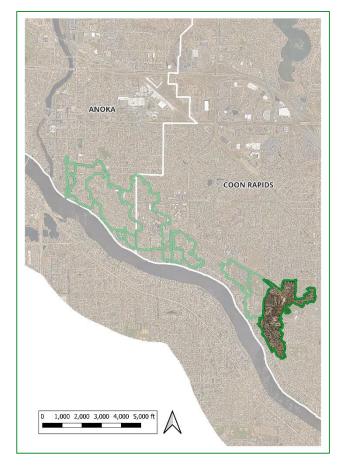
This catchment is located in Coon Rapids. It is a relatively large catchment that is divided into two sections for the purposes of modeling and analysis. The northern half of the catchment is primarily commercial property and contains several existing stormwater treatment practices, while the southern half of the catchment is primarily residential property with no known existing treatment. For this report, due to the abundance of existing treatment in the northern half of the catchment, only the southern portion of the catchment has been modeled with proposed stormwater treatment practices.
