Rum River Stormwater Retrofit Analysis

Rum River Stormwater Retrofit Analysis: 2024

Prepared for the City of Anoka, the City of Andover, the City of Ramsey, and the Lower Rum River Watershed Management Organization (LRRWMO) by:

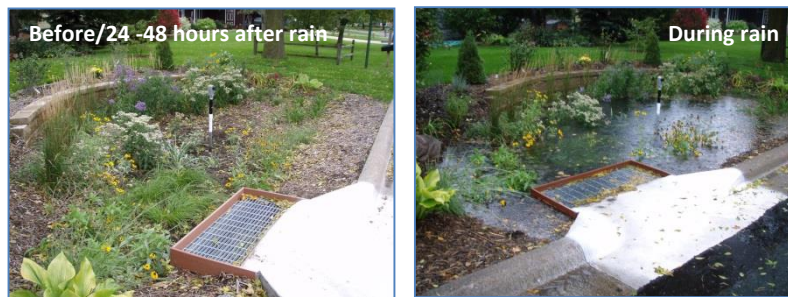
Figure 9: Rain garden before/after and during a rainfall event

Curb-cut rain gardens capture stormwater that is in roadside gutters and redirects it into shallow roadside basins. These curb-cut rain gardens can provide treatment for impervious surface runoff from one-to-many properties and can be located anywhere sufficient space is available. Because curb-cut rain gardens capture water that is already part of the stormwater drainage system, they are more likely to provide higher benefits. Generally, curb-cut rain gardens were proposed in areas without sufficient existing stormwater treatment and located immediately upgradient of a catch basin serving a large drainage area.

All curb-cut rain gardens were presumed to have pretreatment, mulch, and perennial ornamental and native plants. The useful life of the project was assumed to be 30 years and so all costs are amortized over that time period. Additional costs were included for rehabilitation of the gardens at years 10 and 20. Rehabilitation includes removal of accumulated sediment and supplemental planting. Annual maintenance was assumed to be completed by the landowner of the property at which the rain garden could be installed.

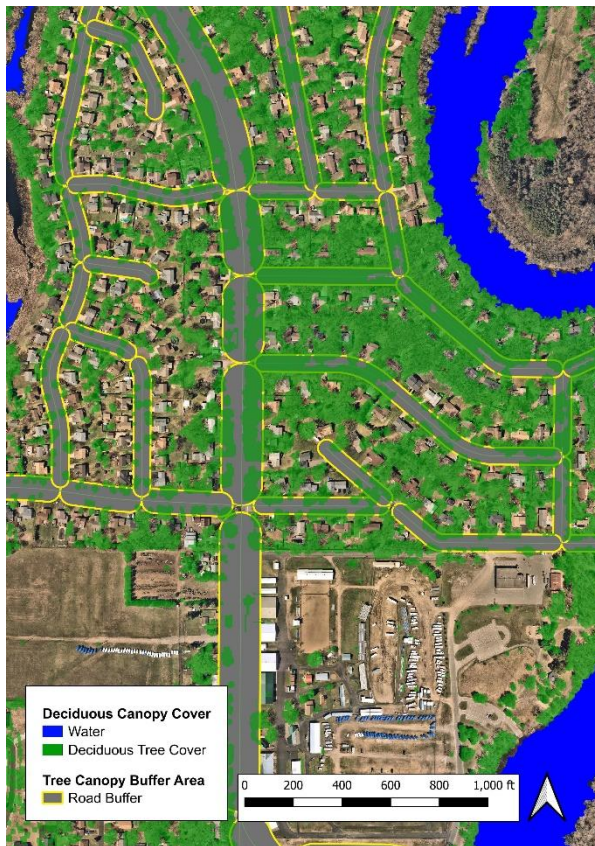
Figure 10: Roadway buffers, derived from MNDOT right-of-way widths, within which tree canopy cover was calculated.

referenced to generate a buffer around each roadway, and deciduous tree canopy abundance within these buffers (total % coverage) was quantified by intersecting them with the *Twin Cities Metro Area (TCMA) Urban Tree Canopy Classification* dataset; see Figure 10 for an example. Altogether, these processes allowed for canopy cover comparisons within the study areas, and correspondingly the prioritization of roadways most likely to contribute nutrient-rich stormwater derived from tree materials.

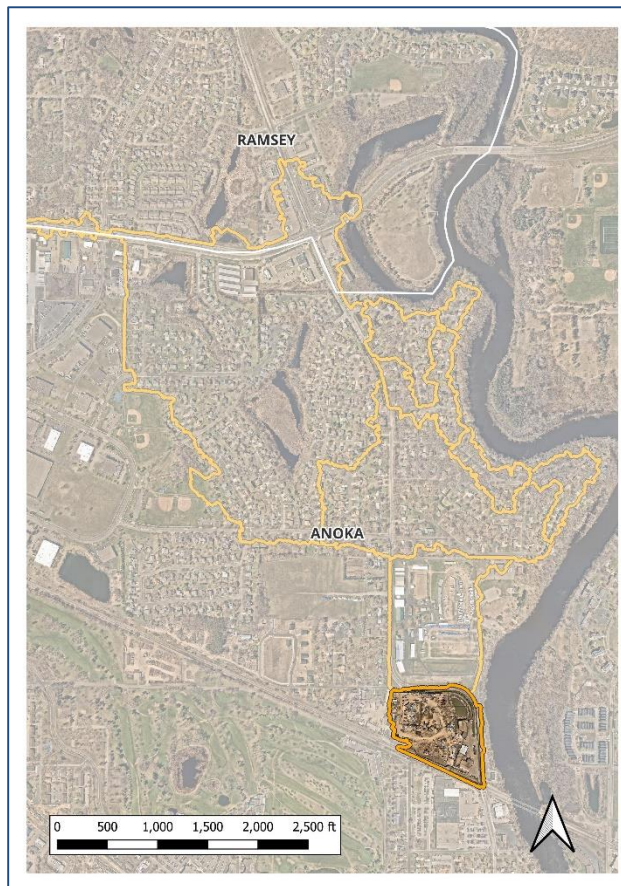
A private pond located within the metal recycling center provides stormwater treatment for the property. Prior to discharging into the Rum River, stormwater from the wet pond passes through a Structural Pollution Control Device (SPCD). Detailed information on the SPCD could not be found, therefore, it has not been included for modeling purposes. In addition, street cleaning is conducted once in early spring and once in mid-summer by the City of Anoka. Present day stormwater pollutant loading and treatment is summarized in the table below.

<i>Existing Conditions</i>		Base Loading	Treatment	Net Treatment %	Existing Loading
<i>Treatment</i>	Number of BMPs	2			
	BMP Types	Street Cleaning, Wet Pond (EWP-1)			
	TP (lb/yr)	11.80	5.24	44%	6.56
	TSS (lb/yr)	7,510	4,420	59%	3,090
	Volume (acre-feet/yr)	14.7	0.57	4%	14.1

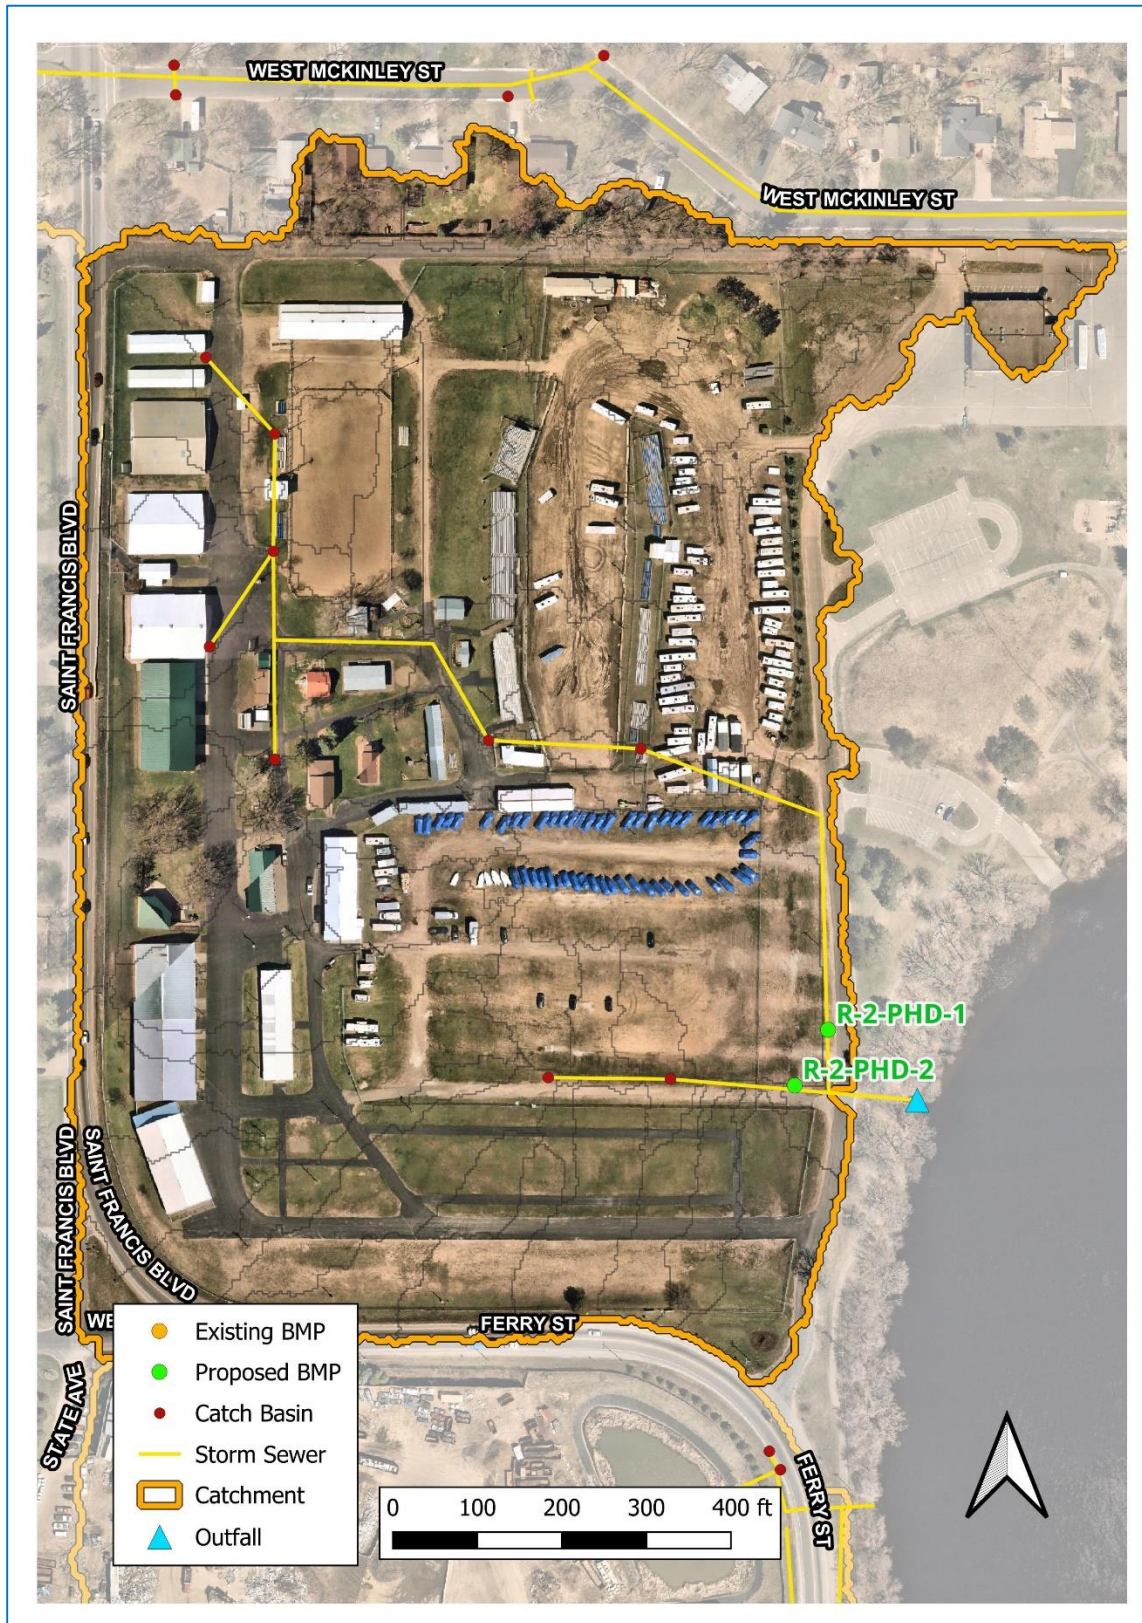
EXISTING STORMWATER TREATMENT AND RETROFIT OPPORTUNITIES

Two hydrodynamic separators are proposed within this catchment. One structure would treat the northern half of the catchment, and one structure would treat the southern half of the catchment. Given the limited space available, underground structures were deemed appropriate.

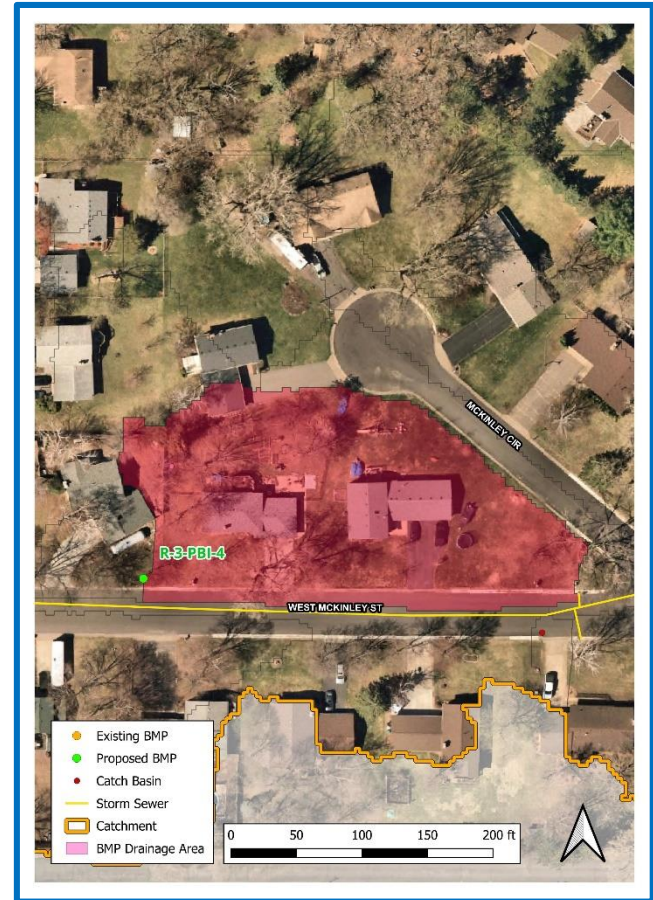
Site Specific Information – An opportunity for a bioinfiltration basin exists at this location. The proposed basin is a standard, single inlet rain garden. The table below provides pollutant removals and estimated costs.

Curb-Cut Bioinfiltration			
Cost/Removal Analysis		New Treatment	% Reduction
Treatment	Total Size of BMP	250	sq ft
	TP (lb/yr)	0.37	1.5%
	TSS (lb/yr)	116	1.5%
	Volume (acre-feet/yr)	0.28	1.4%
Cost	Administration & Promotion Costs*	\$664	
	Design & Construction Costs**	\$9,820	
	Total Estimated Project Cost (2023)	\$10,484	
	Annual O&M***	\$225	
Efficiency	30-yr Average Cost/lb-TP	\$1,553	
	30-yr Average Cost/1,000lb-TSS	\$4,952	
	30-yr Average Cost/ac-ft Vol.	\$2,050

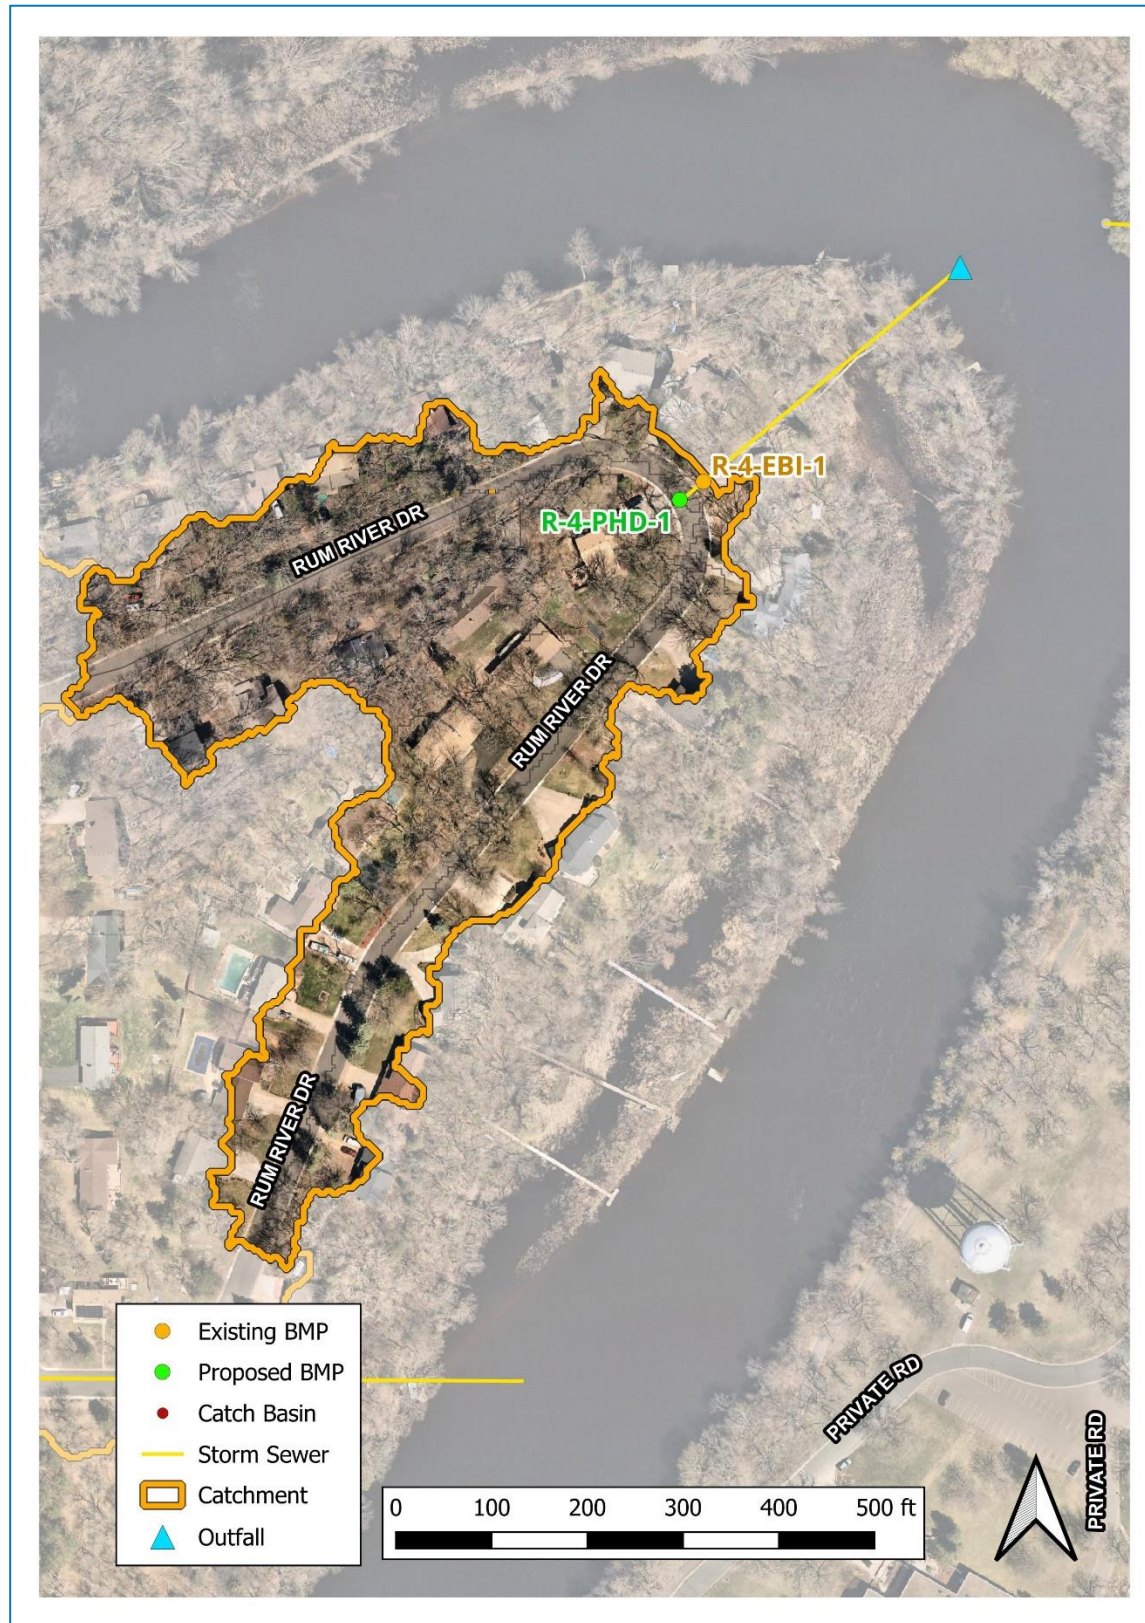
EXISTING STORMWATER TREATMENT AND RETROFIT OPPORTUNITIES

One hydrodynamic separator is proposed within this catchment. Given the limited space available, an underground structure was deemed appropriate.

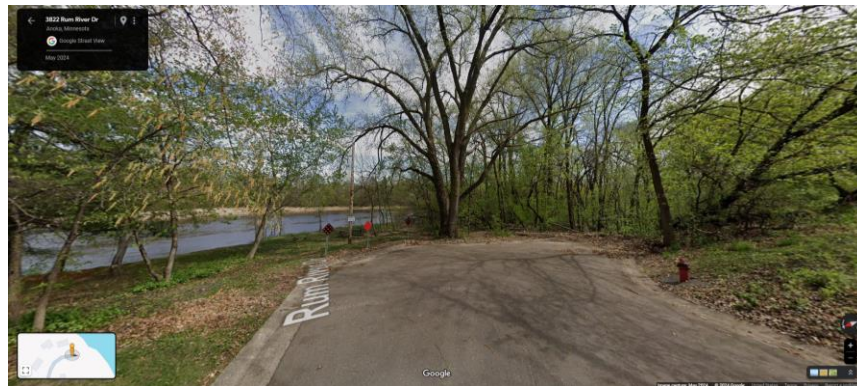
Stormwater runoff from Rum River Dr. and Coolidge St. flows into a curb cut which allows water to pass through a heavily vegetated / gently sloped upland area before discharging into the Rum River; see Google Street View image below from May 2024. In addition, street cleaning is conducted once in early spring and once in mid-summer by the City of Anoka.

Stabilization projects near the curb cut were considered, but site visits noted there were no signs of channelization or erosion from surface runoff in this area. Due to existing treatment and limited space for new projects, no candidate BMPs were identified in this catchment. As such, this catchment and the existing treatment practices were not modeled in WinSLAMM.

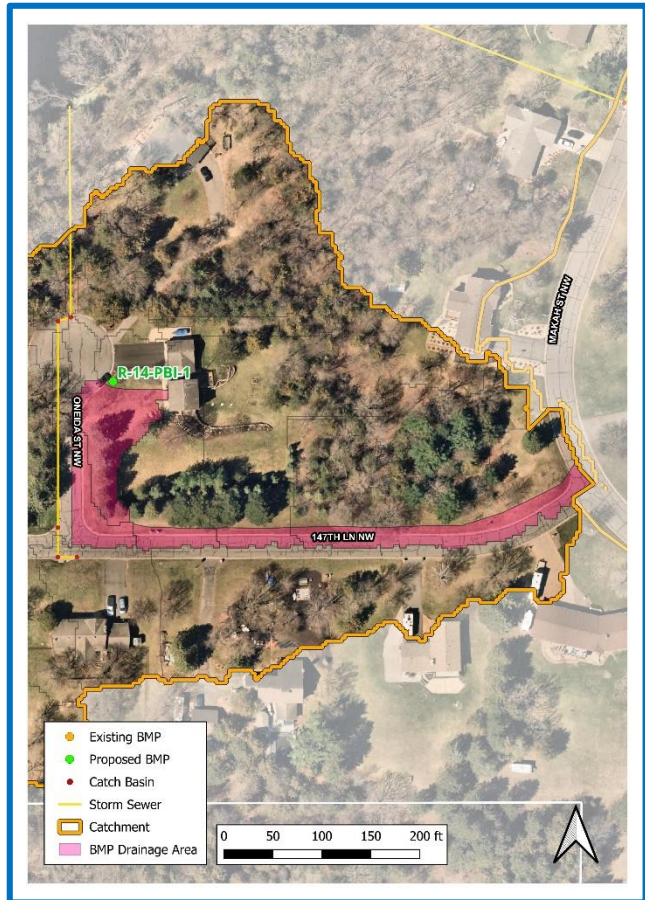
Site Specific Information – An opportunity for a bioinfiltration basin exists at this location. The proposed basin is a standard, single inlet rain garden. The table below provides pollutant removals and estimated costs.

Curb-Cut Bioinfiltration			
Cost/Removal Analysis		New Treatment	% Reduction
Treatment	Total Size of BMP	250 sq. ft.	
	TP (lb/yr)	0.25	3.7%
	TSS (lb/yr)	82	4.0%
	Volume (acre-feet/yr)	0.17	3.2%
Cost	Administration & Promotion Costs*		\$664
	Design & Construction Costs**		\$9,820
	Total Estimated Project Cost (2023)		\$10,484
	Annual O&M***		\$225
Efficiency	30-yr Average Cost/lb-TP	\$2,307	
	30-yr Average Cost/1,000lb-TSS	\$7,006	
	30-yr Average Cost/ac-ft Vol.	\$3,429

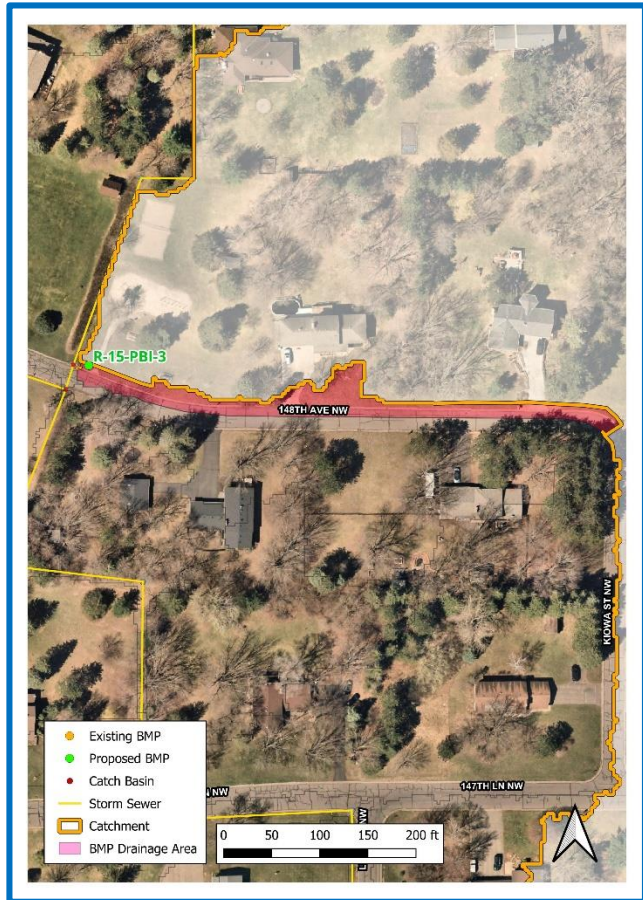
Site Specific Information – An opportunity for a bioinfiltration basin exists at this location. The proposed basin is a standard, single inlet rain garden. The table below provides pollutant removals and estimated costs.

Curb-Cut Bioinfiltration			
Cost/Removal Analysis		New Treatment	% Reduction
Treatment	Total Size of BMP	250	sq. ft.
	TP (lb/yr)	0.13	0.6%
	TSS (lb/yr)	37	0.5%
	Volume (acre-feet/yr)	0.09	0.5%
Cost	Administration & Promotion Costs*	\$664	
	Design & Construction Costs**	\$9,820	
	Total Estimated Project Cost (2023)	\$10,484	
	Annual O&M***	\$225	
Efficiency	30-yr Average Cost/lb-TP	\$4,419	
	30-yr Average Cost/1,000lb-TSS	\$15,526	
	30-yr Average Cost/ac-ft Vol.	\$6,049

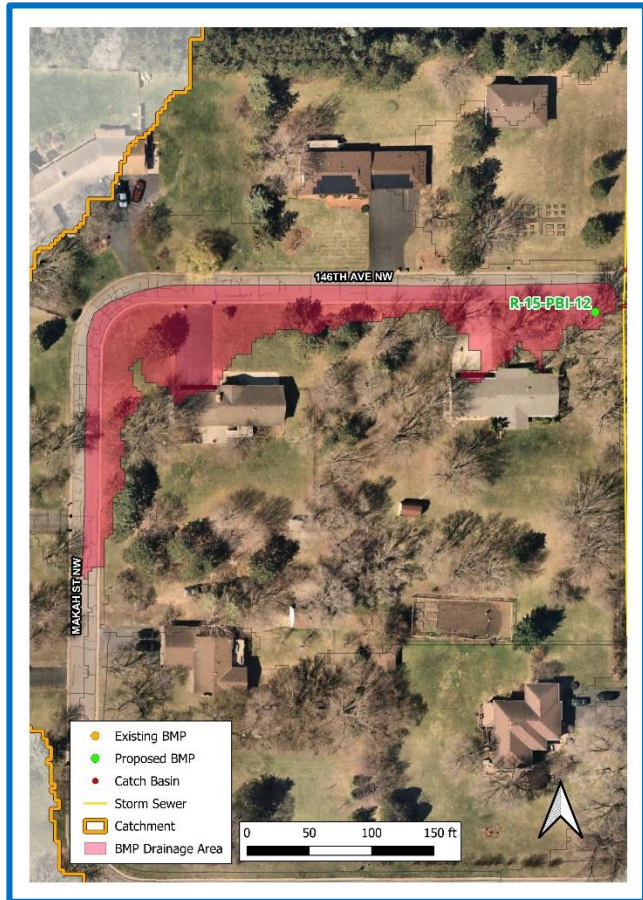
Site Specific Information – An opportunity for a bioinfiltration basin exists at this location. The proposed basin is a standard, single inlet rain garden. The table below provides pollutant removals and estimated costs.

Curb-Cut Bioinfiltration			
Cost/Removal Analysis		New Treatment	% Reduction
Treatment	Total Size of BMP	250	sq. ft.
	TP (lb/yr)	0.26	1.1%
	TSS (lb/yr)	80	1.2%
	Volume (acre-feet/yr)	0.20	1.1%
Cost	Administration & Promotion Costs*	\$664	
	Design & Construction Costs**	\$9,820	
	Total Estimated Project Cost (2023)	\$10,484	
	Annual O&M***	\$225	
Efficiency	30-yr Average Cost/lb-TP	\$2,209	
	30-yr Average Cost/1,000lb-TSS	\$7,181	
	30-yr Average Cost/ac-ft Vol.	\$2,931

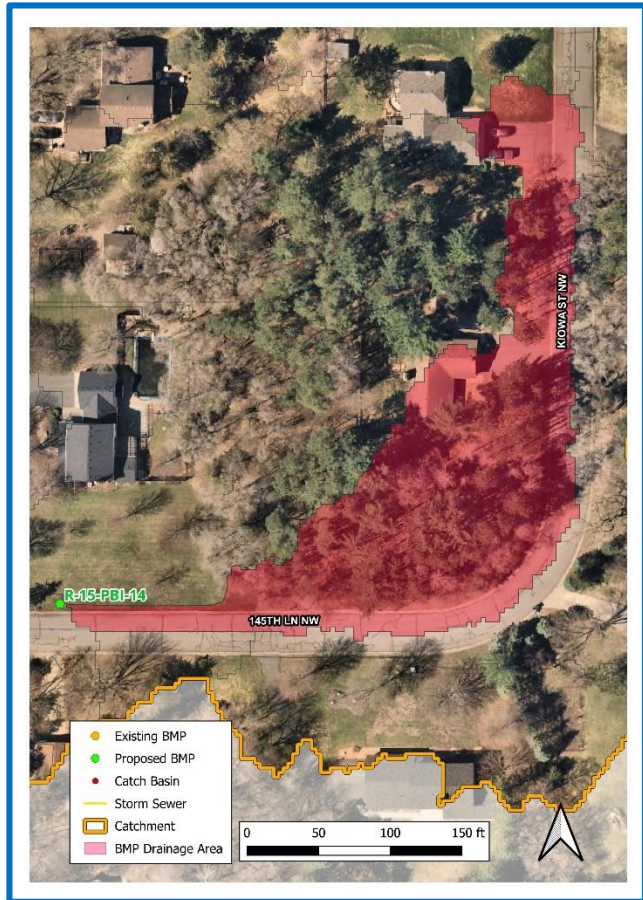
Site Specific Information – An opportunity for a bioinfiltration basin exists at this location. The proposed basin is a standard, single inlet rain garden. The table below provides pollutant removals and estimated costs.

Curb-Cut Bioinfiltration			
Cost/Removal Analysis		New Treatment	% Reduction
Treatment	Total Size of BMP	250	sq. ft.
	TP (lb/yr)	0.35	1.5%
	TSS (lb/yr)	109	1.6%
	Volume (acre-feet/yr)	0.27	1.5%
Cost	Administration & Promotion Costs*	\$664	
	Design & Construction Costs**	\$9,820	
	Total Estimated Project Cost (2023)	\$10,484	
	Annual O&M***	\$225	
Efficiency	30-yr Average Cost/lb-TP	\$1,641	
	30-yr Average Cost/1,000lb-TSS	\$5,270	
	30-yr Average Cost/ac-ft Vol.	\$2,166

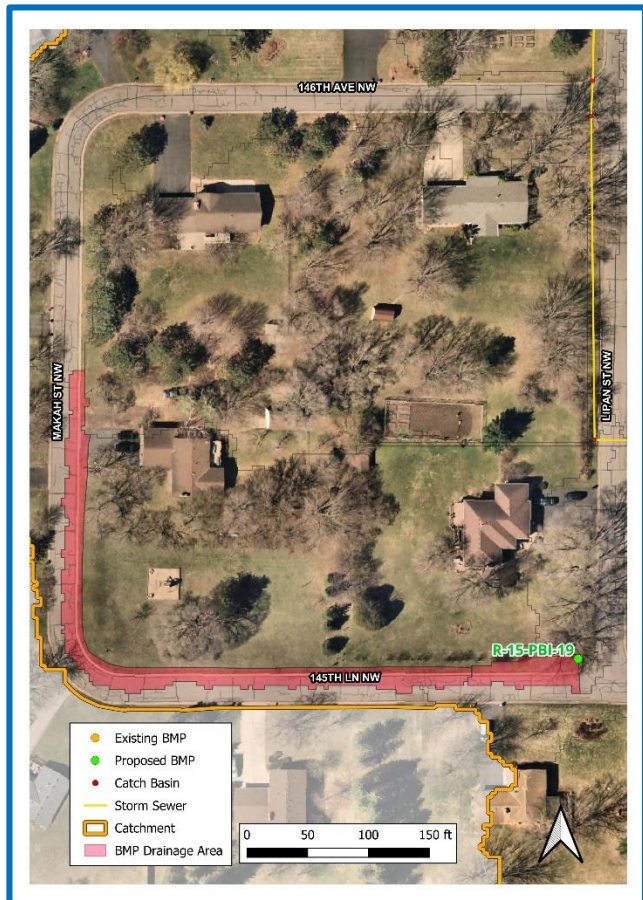
Site Specific Information – An opportunity for a bioinfiltration basin exists at this location. The proposed basin is a standard, single inlet rain garden. The table below provides pollutant removals and estimated costs.

Curb-Cut Bioinfiltration			
Cost/Removal Analysis		New Treatment	% Reduction
Treatment	Total Size of BMP	250	sq. ft.
	TP (lb/yr)	0.13	0.6%
	TSS (lb/yr)	38	0.6%
	Volume (acre-feet/yr)	0.10	0.6%
Cost	Administration & Promotion Costs*	\$664	
	Design & Construction Costs**	\$9,820	
	Total Estimated Project Cost (2023)	\$10,484	
	Annual O&M***	\$225	
Efficiency	30-yr Average Cost/lb-TP	\$4,419	
	30-yr Average Cost/1,000lb-TSS	\$15,118	
	30-yr Average Cost/ac-ft Vol.	\$5,849

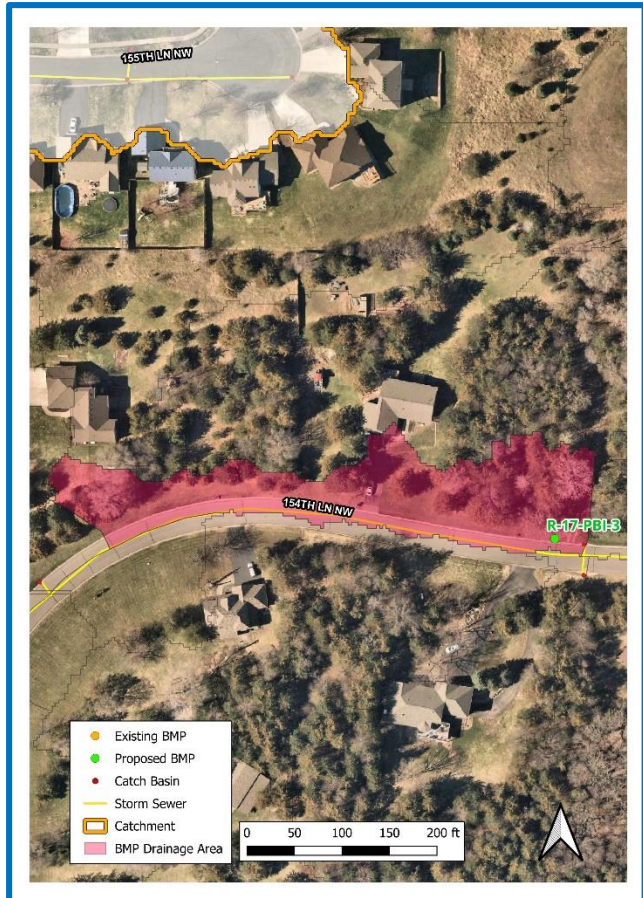
Site Specific Information – An opportunity for a bioinfiltration basin exists at this location. The proposed location is within the front yard of a private residential house. The proposed basin is a standard, single inlet rain garden that would treat stormwater collected on 154th Ln. from the west. The table below provides pollutant removals and estimated costs.

Curb-Cut Bioinfiltration			
Cost/Removal Analysis		New Treatment	% Reduction
Treatment	Total Size of BMP	250	sq. ft.
	TP (lb/yr)	0.13	1.2%
	TSS (lb/yr)	41	1.4%
	Volume (acre-feet/yr)	0.11	1.2%
Cost	Administration & Promotion Costs*	\$664	
	Design & Construction Costs**	\$9,820	
	Total Estimated Project Cost (2023)	\$10,484	
	Annual O&M***	\$225	
Efficiency	30-yr Average Cost/lb-TP	\$4,419	
	30-yr Average Cost/1,000lb-TSS	\$14,011	
	30-yr Average Cost/ac-ft Vol.	\$5,401

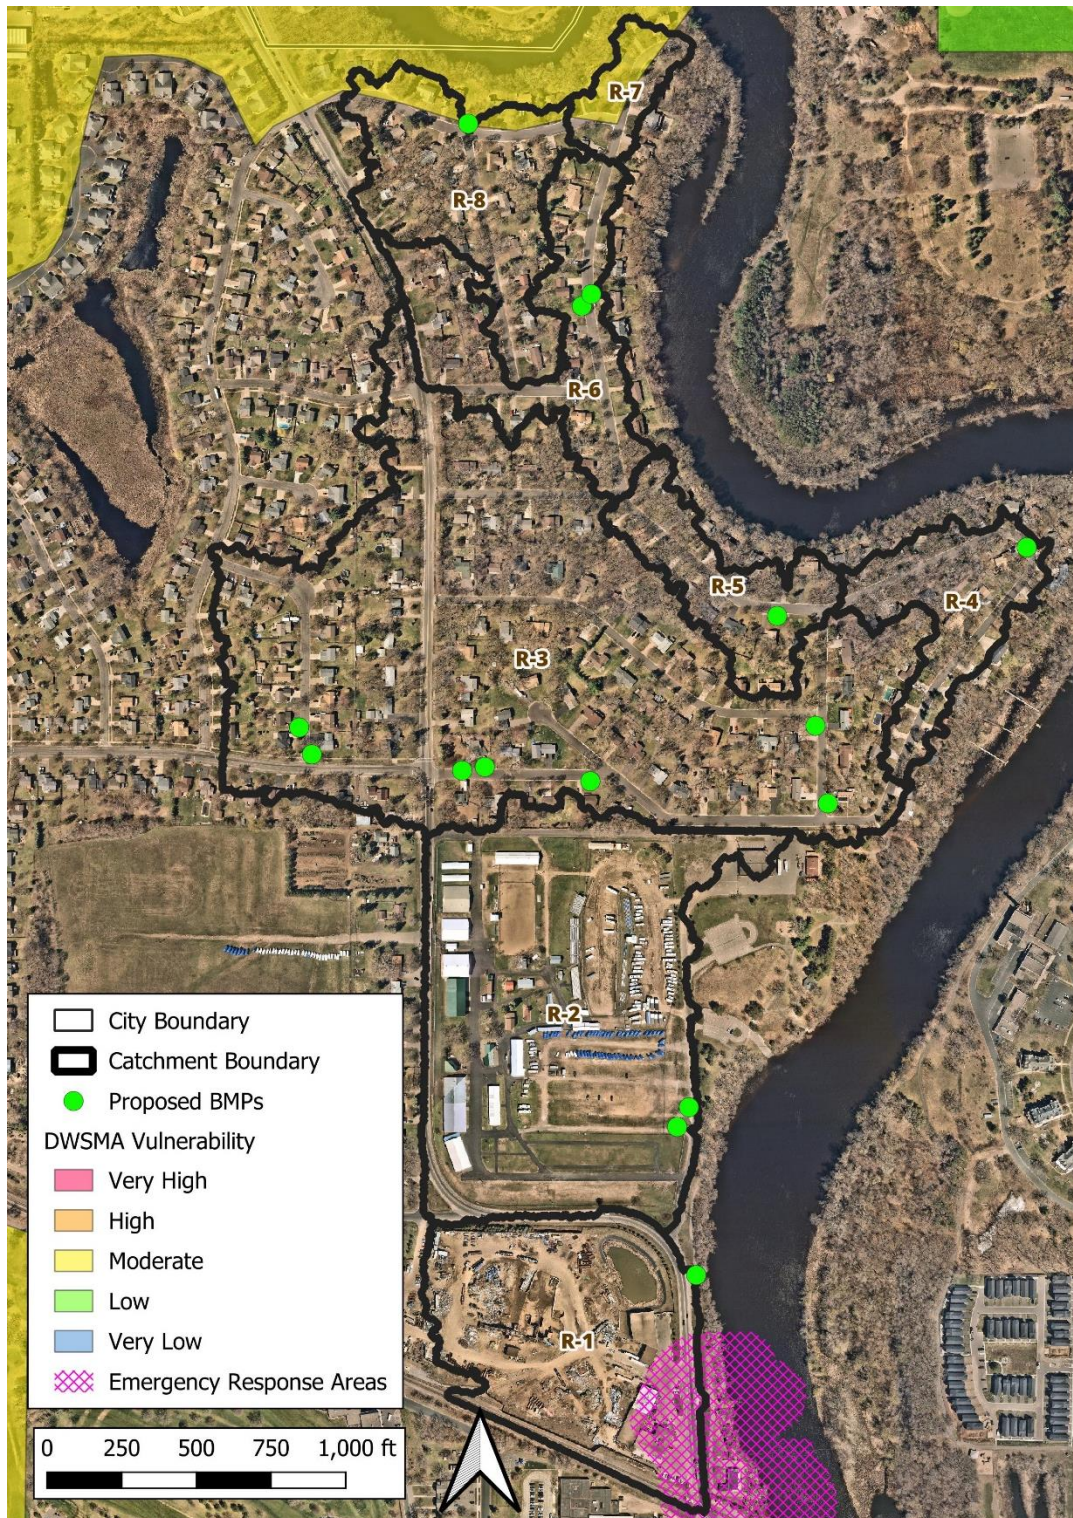
Figure 30: Rum River (Anoka) subwatershed Drinking Water Supply Management Area (DWSMA) Vulnerability and Emergency Response Areas.

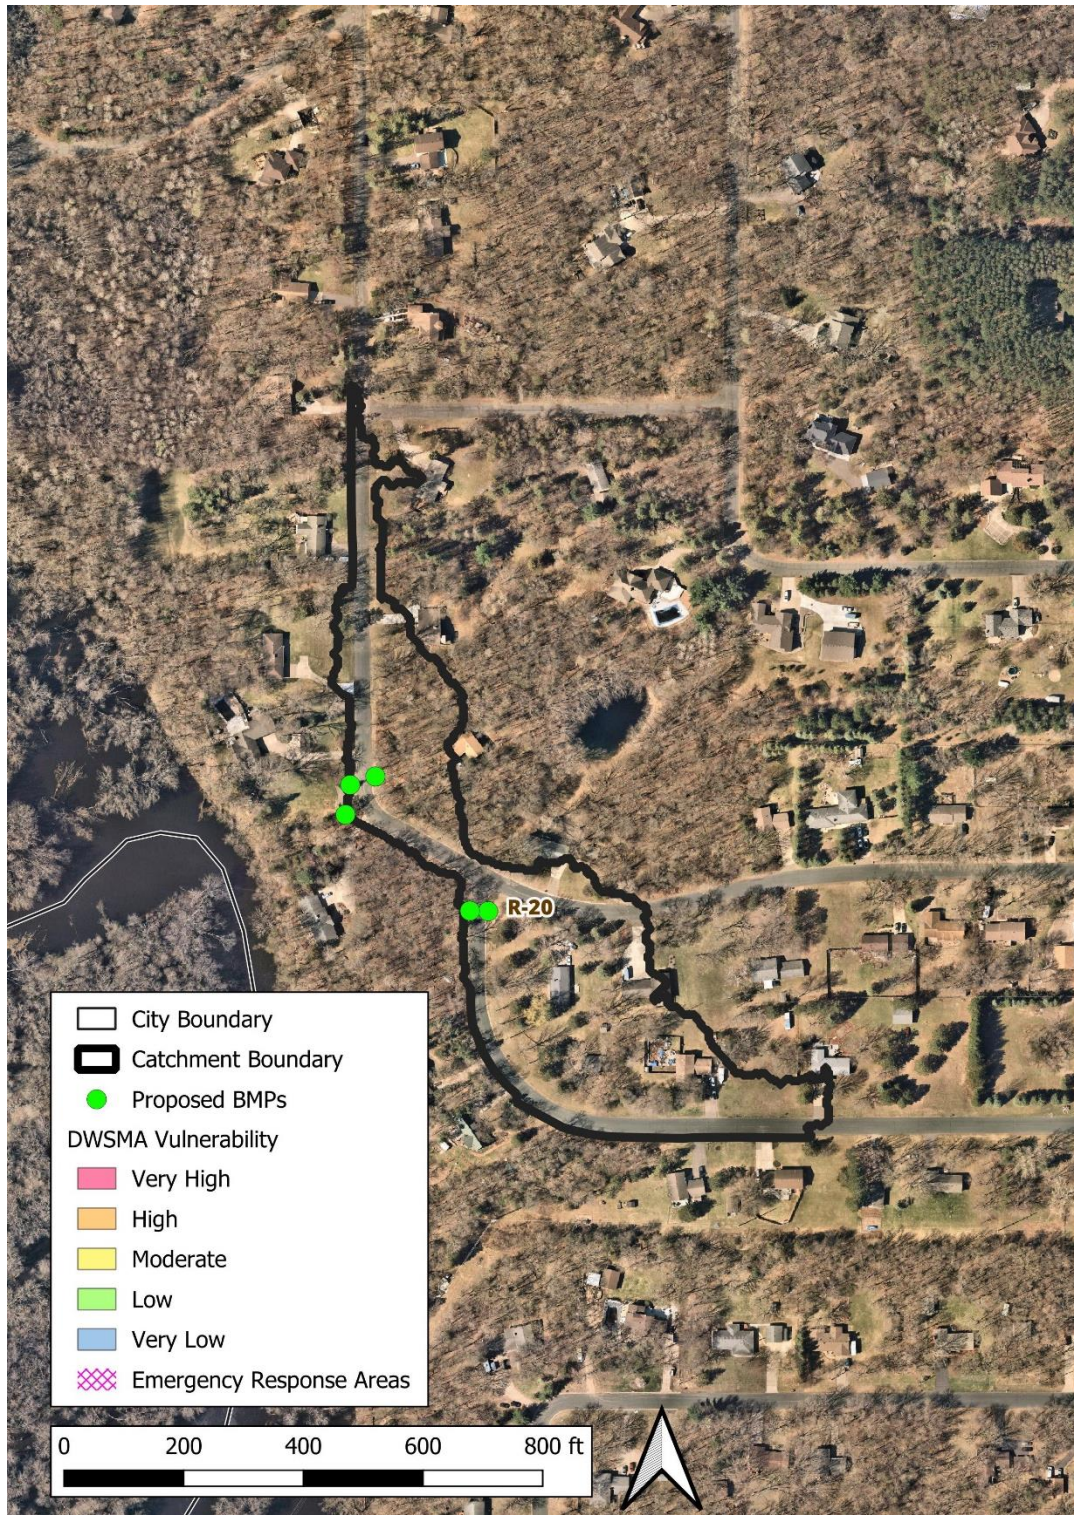
Figure 32: Rum River (northern Andover) subwatershed Drinking Water Supply Management Area (DWSMA) Vulnerability and Emergency Response Areas.
