Stream Water Quality

Stream water quality monitoring was conducted with the purpose of detecting water quality trends and diagnosing the cause of changes. Summary sheets for each stream are provided below. Additional data and trend analysis can be found on the Anoka Conservation District's Water Almanac:

2024 Stream Water Quality Summary

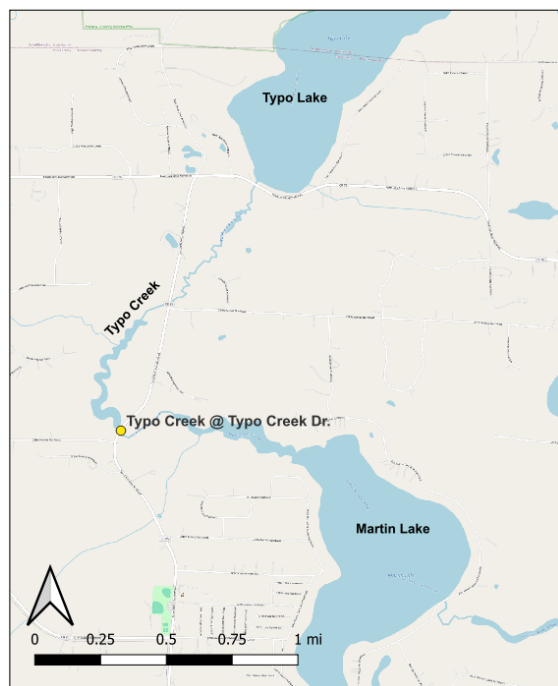
The northern inlet to Martin Lake, also called Typo Creek, flows south from the outlet of Typo Lake about 1.9 miles where it enters into Martin Lake. This creek is the primary inlet to Martin Lake. The watershed is mostly undeveloped. Upstream water quality projects including carp barriers and carp harvests are aimed at improving water quality in this stream and the Sunrise River chain of lakes. Typo Creek connects Typo Lake and Martin Lake, both listed as impaired for excess nutrients, but can also be viewed as part of the West Branch of the Sunrise River which inlets into Typo Lake and outlets from Martin Lake eastward.

- Typo Creek @ Typo Creek Dr. (southern crossing)

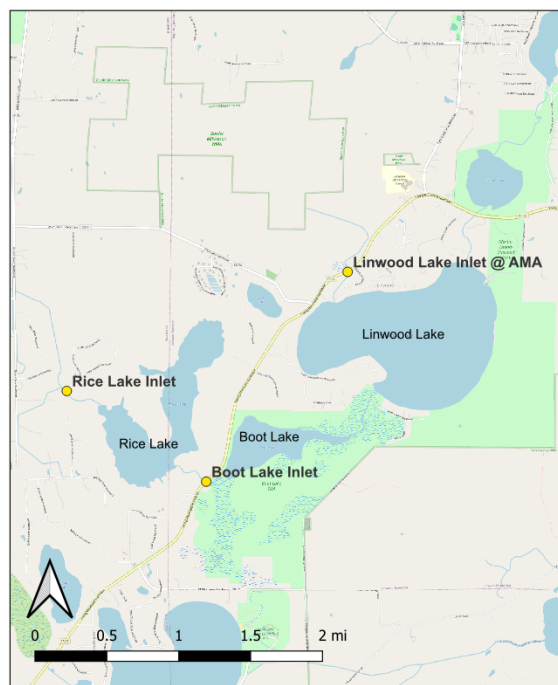
Linwood Lake is listed as impaired for aquatic recreation with excessive nutrients identified as a stressor. The Linwood Lake watershed is composed of three distinct subwatersheds, therefore one site was selected per subwatershed to represent the water quality conditions of that particular subwatershed. The purpose was to identify subwatersheds with the greatest phosphorous concentrations, thereby determining if a subwatershed analysis study should be conducted to identify and rank water quality improvement projects.

- Rice Lake Inlet
- Linwood Lake Inlet @ AMA
- Boot Lake Inlet

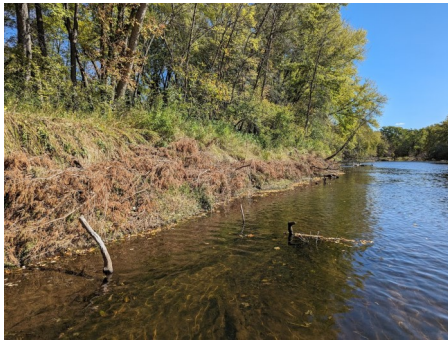
Rum Central Regional Park - Cedar Tree
Revetments

In 2023, several projects led by the Anoka Conservation District were completed that help reduce sediment and phosphorous loading into the Rum River. ACD and partners currently have a well-funded riverbank stabilizations program because it offers multiple benefits to water quality, habitat, and protecting property.
