City of Ramsey Mississippi River Bank Condition Inventory

*for
the City of Ramsey
February 2016*

Executive Summary

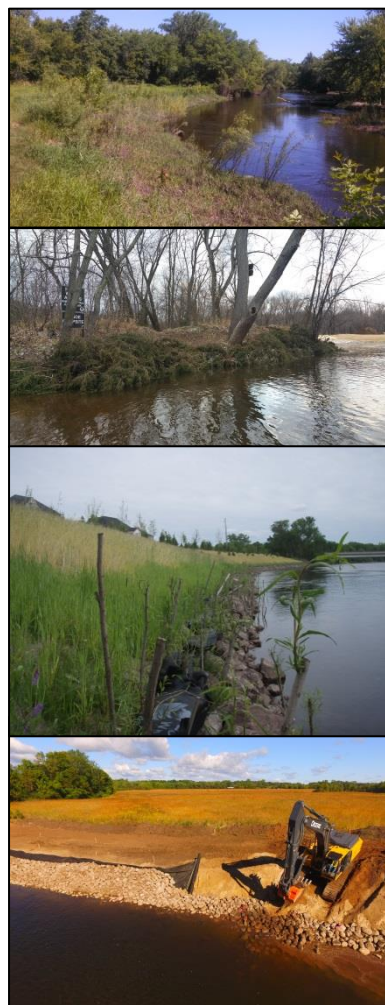
- Hard Armoring – Hard armoring of the bank may be necessary along riverbanks on large systems that experience the greatest erosive forces (e.g. outside bends). However, it is often not necessary to hard armor the entire bank from the toe of the slope to the top of the bank. Rather, the hard armoring can extend to a predetermined elevation (e.g. 2-year or 5-year flood elevation), above which could be stabilized using the establishment of native vegetation. Furthermore, the sections that are hard armored can often be live staked to provide additional stabilization value, wildlife habitat, and improved shoreline aesthetics.

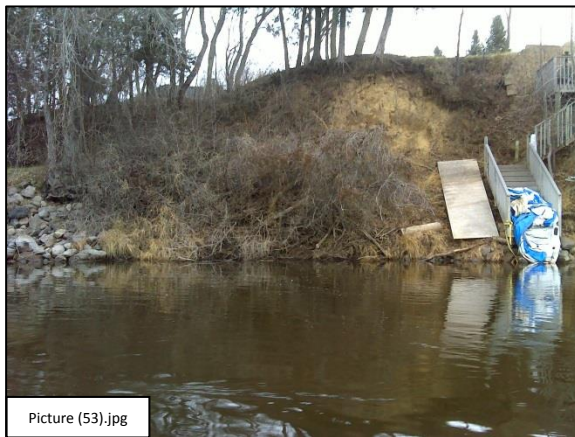
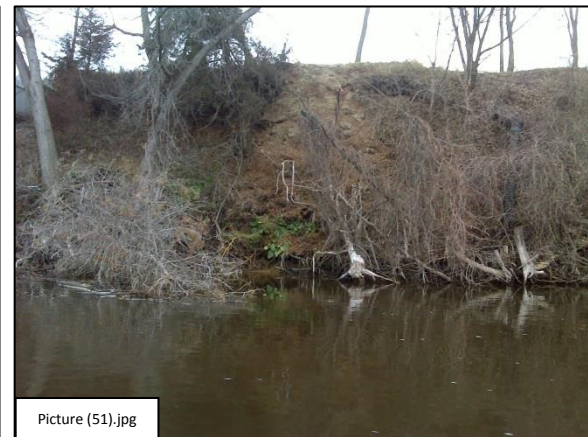
Additional Information: This site consists of five properties, four of which are private and one public (Anoka County).

Potential Solution: Preservation of some of the severely undercut trees could be difficult, and reshaping the bank may be necessary. Stabilization could be accomplished using hard armoring at the toe of the slope and bioengineering on the upper portions of the bank. Cedar tree revetments may also be an option.

Site Information	Ownership	Erosion Length (ft) Severe/Very Severe	Height (ft)	Depth (ft)	Slope (H:V)	Soil Loss (tons/yr)
	Private/Anoka County	566	6 - 10	22 - 40	3.7 - 4.2	323.7

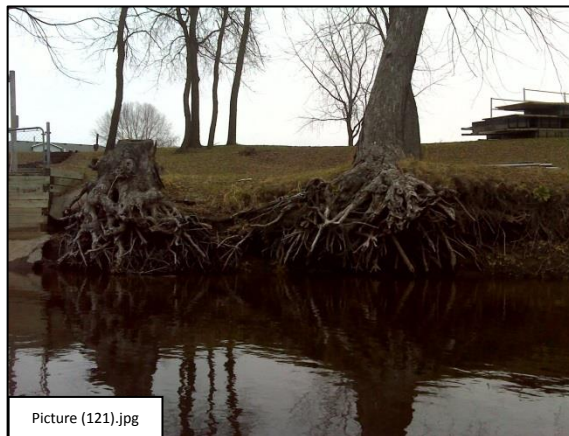
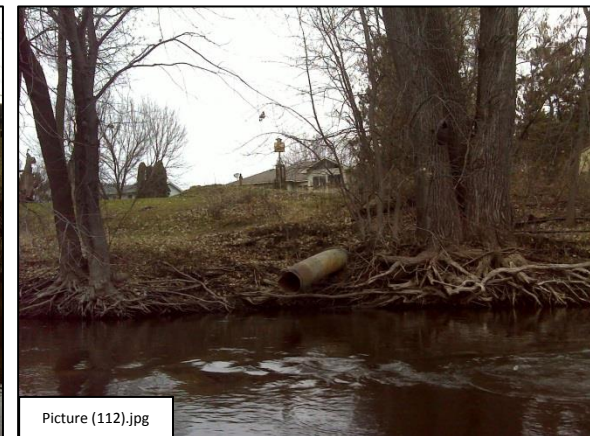
Additional Information: This site consists of three parcels, all of which are owned by Anoka County. Erosion ranged from severe to very severe along this section with one small area categorized as moderate. The large sections of bare bank were categorized as very severe.

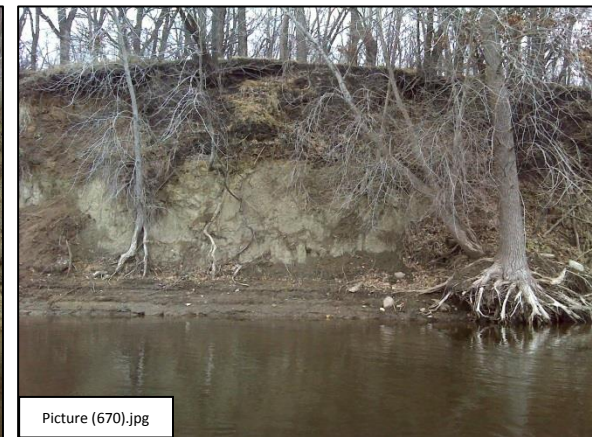
Potential Solution: Most of the erosion sections are very severe and will likely require regrading of the bank. Hard armoring of the slope toe up to a modest elevation (e.g. 2-year or 5-year flood elevation) with native vegetation establishment on the remaining areas higher up the bank may be an effective stabilization option.

Site Information	Ownership	Erosion Length (ft) Severe/Very Severe	Height (ft)	Depth (ft)	Slope (H:V)	Soil Loss (tons/yr)
	Private	589	8 - 22	12 - 33	1.5 - 1.9	653.5

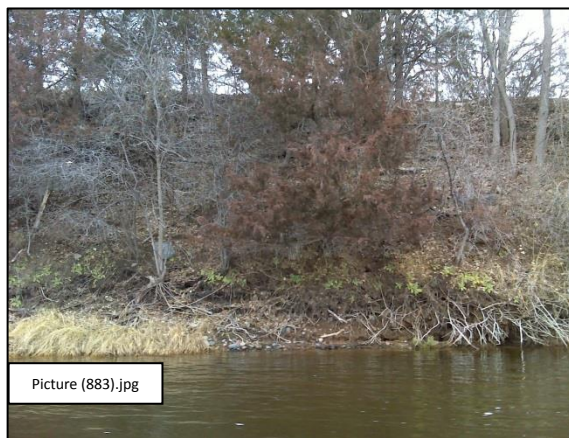
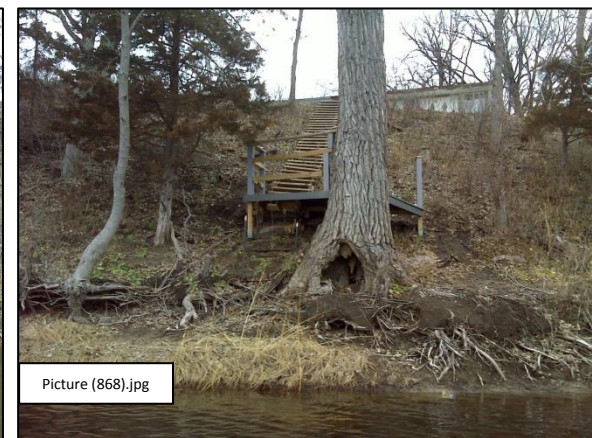
Potential Solution: Much of the erosion could possibly be addressed using cedar tree revetments inter-planted with native vegetation (e.g. Sandbar Willow or Buttonbush). Areas with more severe undercutting may need to be regraded and may warrant hard armoring at the toe with native vegetation higher on the bank.

Site Information	Ownership	Erosion Length (ft)	Height (ft)	Depth (ft)	Slope (H:V)	Soil Loss (tons/yr)
	Private	Severe/Very Severe	325	6 - 8	11 - 14	1.8
