REYNOLDS RESIDENCE

Pre-Rain Garden Conditions

Rain Garden Installation

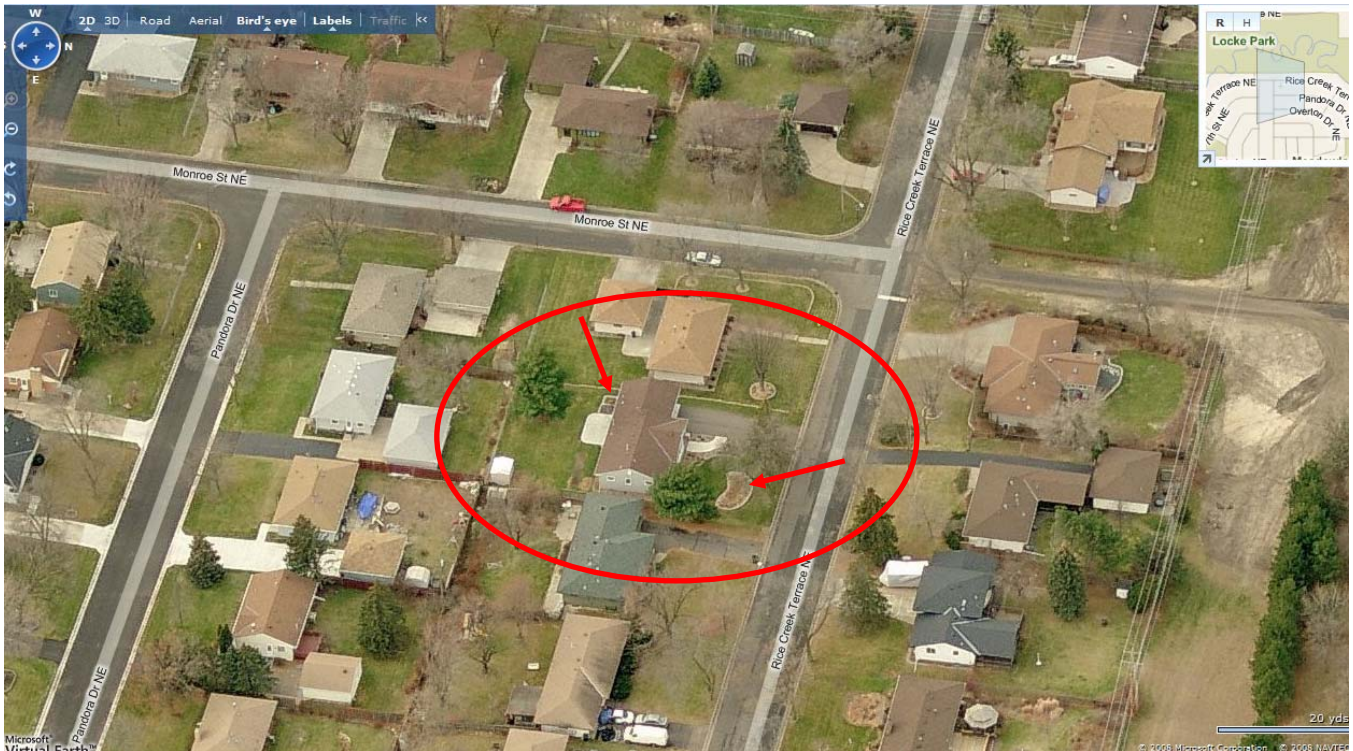
Rain falling on the roof of the Reynolds residence was directed by downspouts, unfiltered, into the street, eventually making its way to the Mississippi River via the storm sewer system. This excess runoff from impervious surfaces can cause:

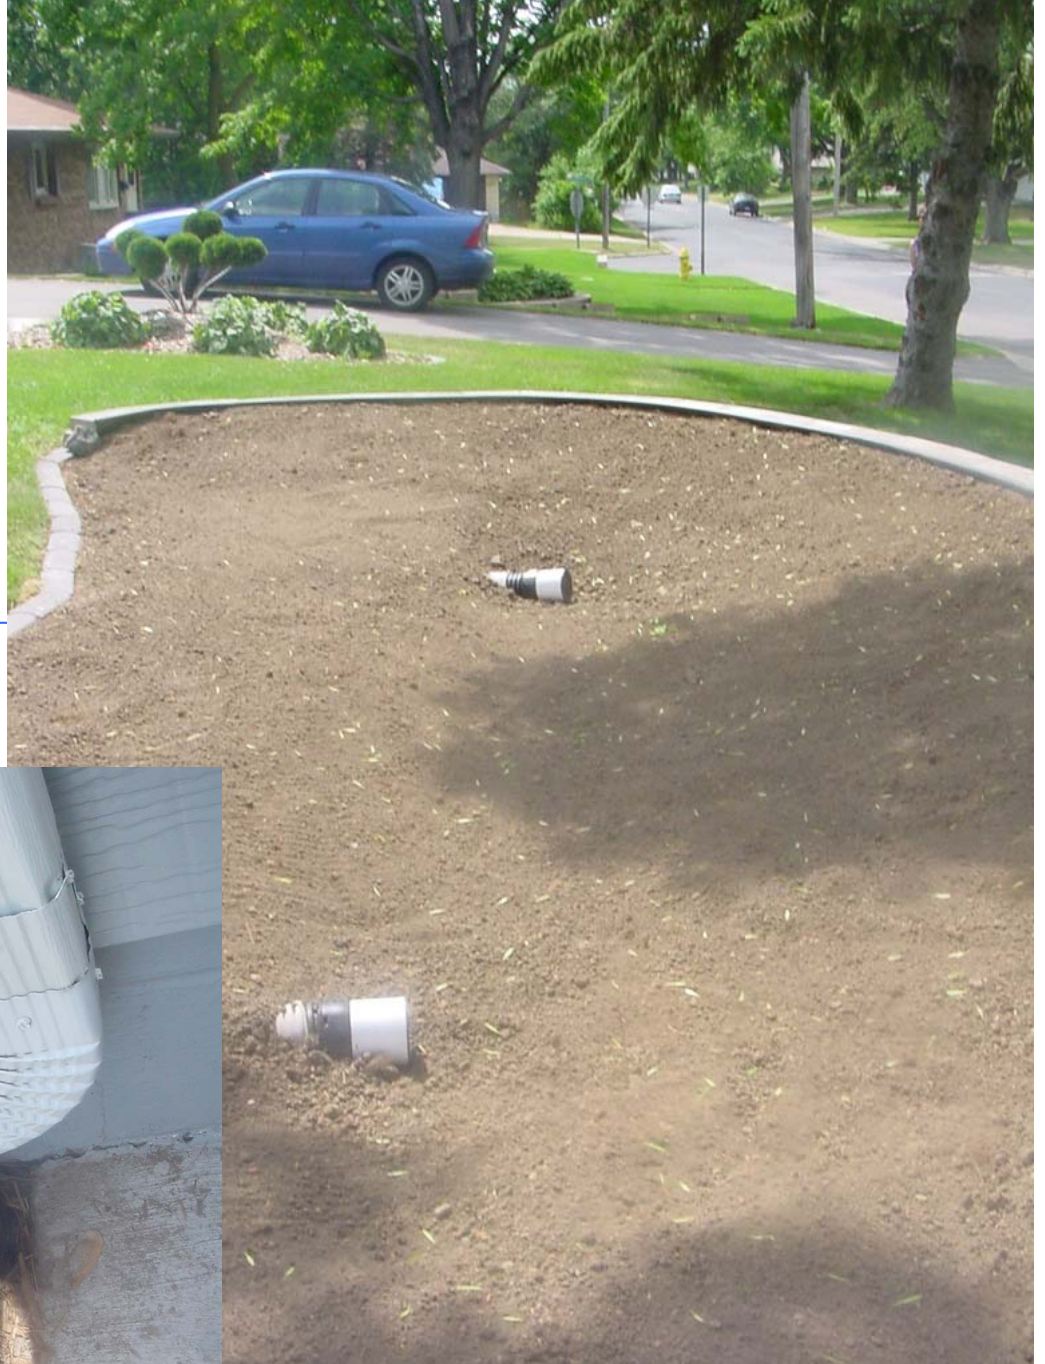
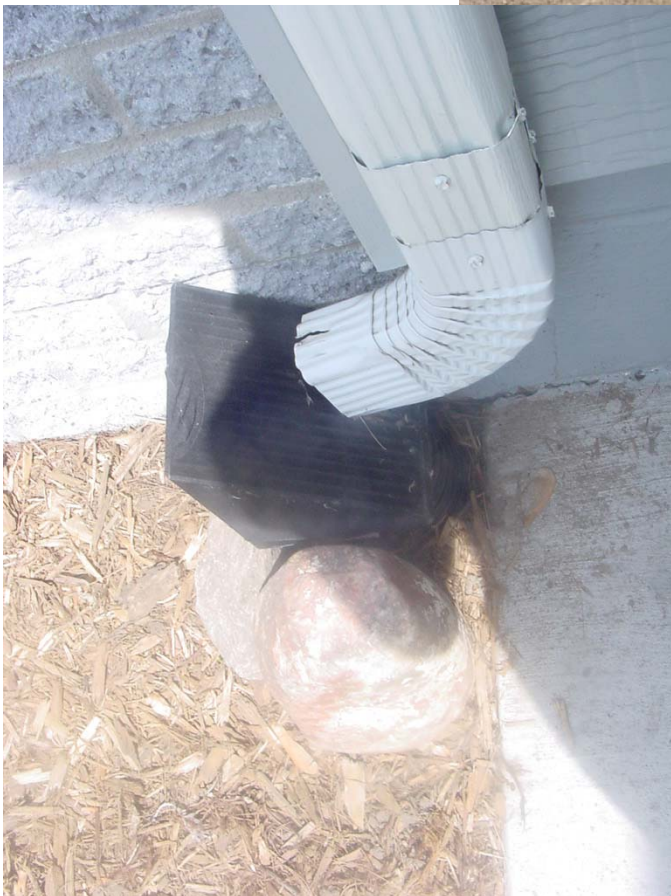
Both rain gardens were designed to capture stormwater falling on the roof of the residence. Stormwater was directed from the downspouts to the rain gardens by drainage tile. Because homeowner labor was estimated at \$1,350.00—greater than half the total project cost—their cash contribution was \$0.00. The cost share program funded by the Met Council covered the remaining cost of the project.

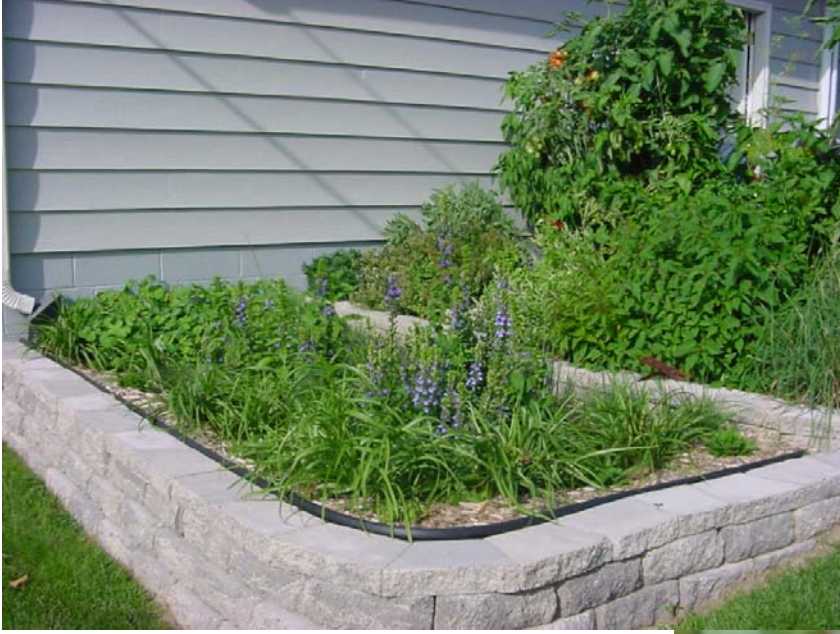
After Rain Garden Installation

Rain falling on the roof is directed by drain tile to the rain gardens for treatment.

The rain gardens can treat up to 81 ft³ of water, reducing pollution and nutrient input to the River.
