# SEARING RESIDENCE

Rain Garden

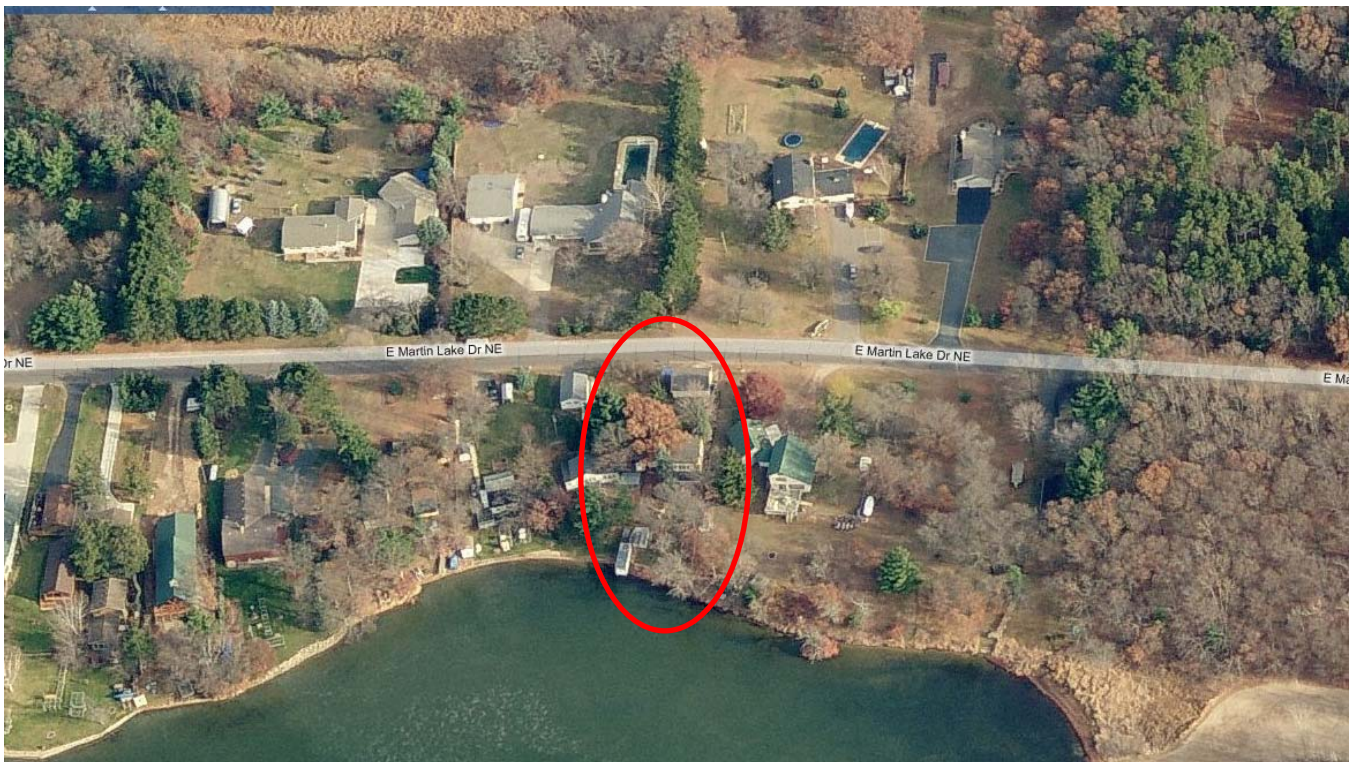
Rain falling on the roof of the Searing residence was directed by downspouts, unfiltered, onto the property and into Martin Lake, and eventually into the Sunrise River. This excess runoff from impervious surfaces can cause:

- An increased risk of flooding and bank erosion
- An influx of sediments, nutrients and pollutants
- An increase in water temperatures.

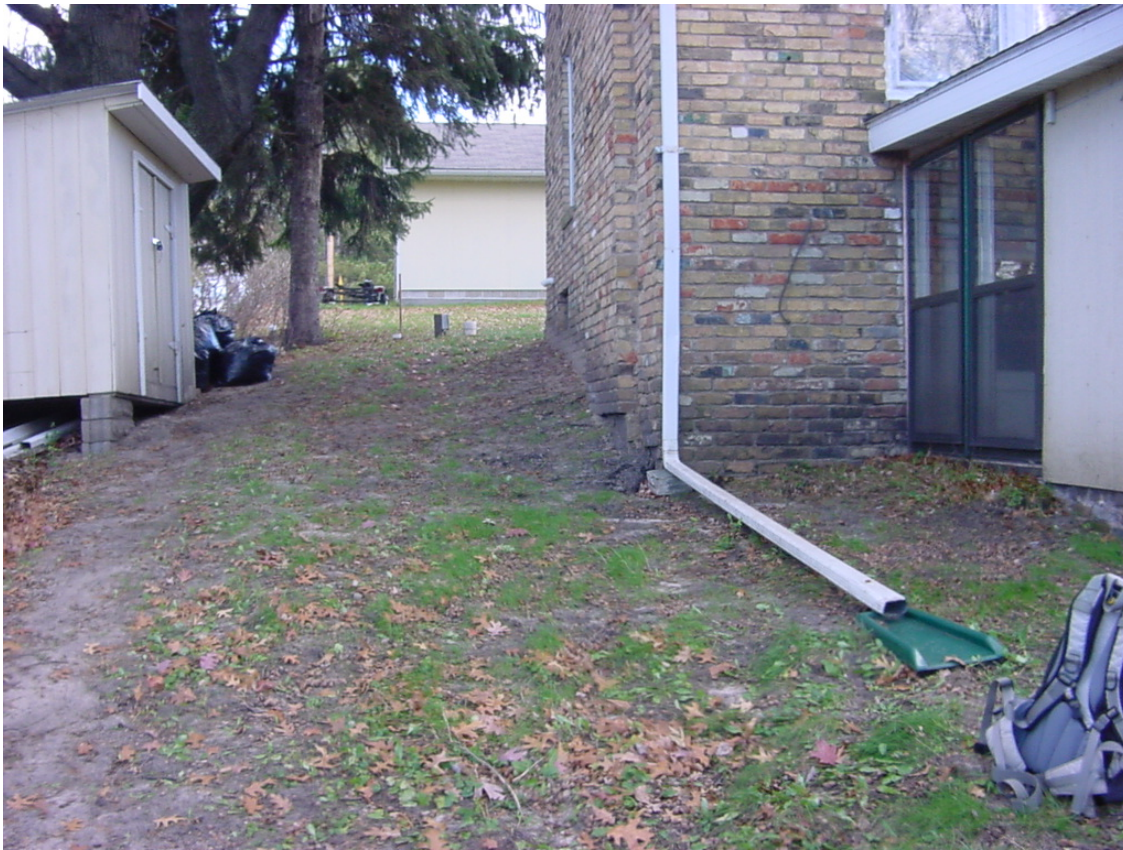
November 2005

Rain falling on the roof is directed by downspout onto the lawn and downhill to Martin lake. Increased runoff to the lake can increase water temperature and add unwanted pollution and nutrients.

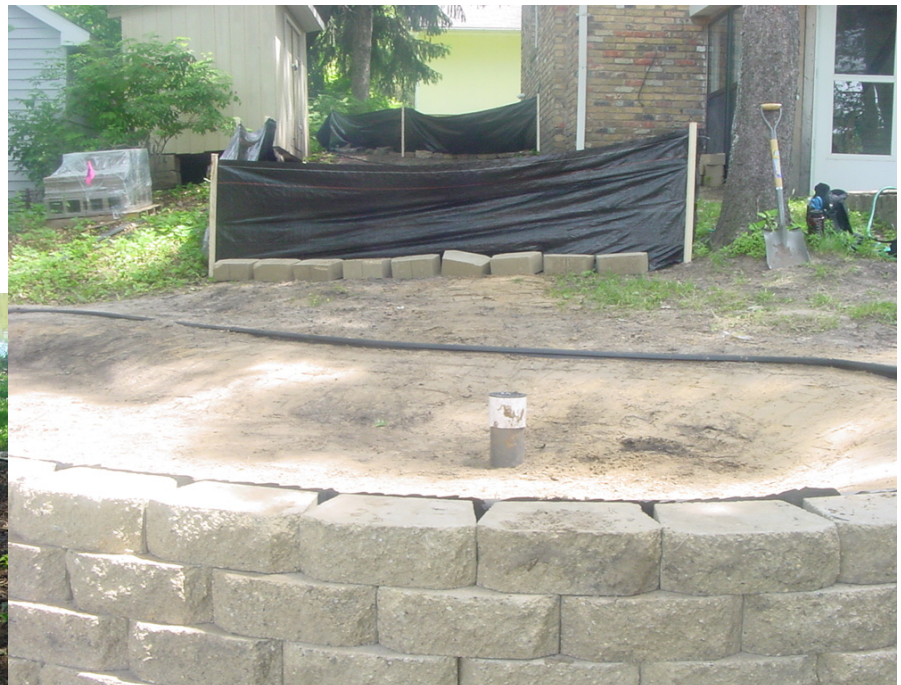
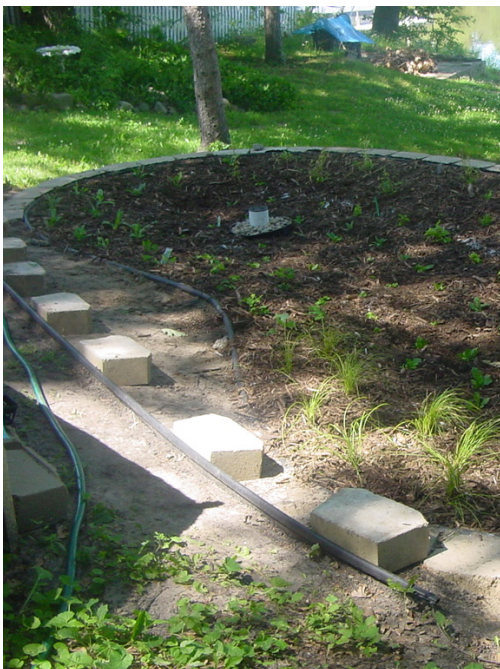
June 2006

The rain gardens can treat up to 69 ft<sup>3</sup> of water, reducing pollution and nutrient input to the River..
