# FICENKO & SCHULTZ PROPERTIES

## Pre-Buffer Conditions

## After Lakeshore Restoration

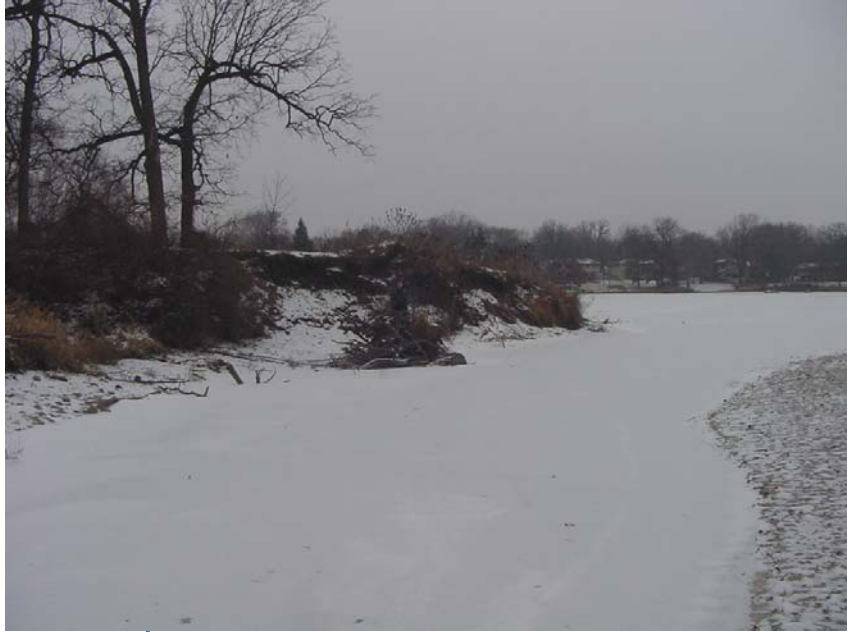
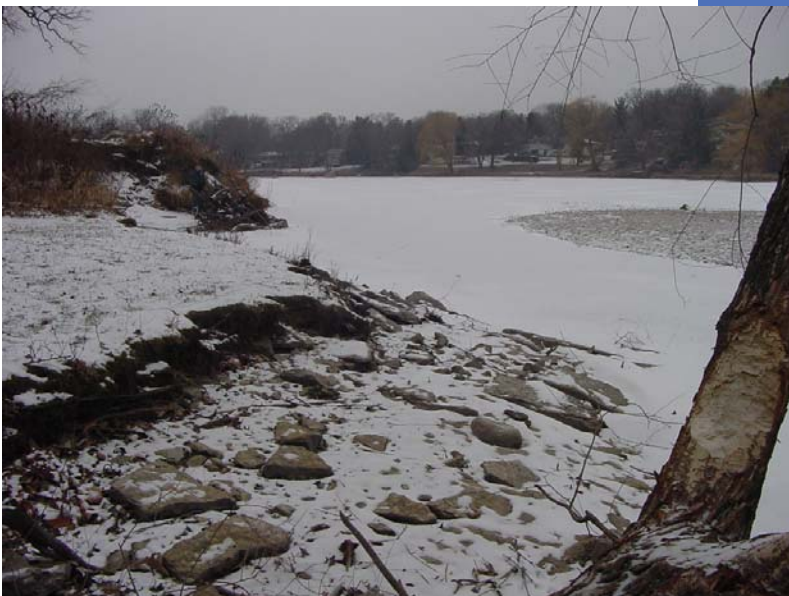
The Ficenko and Schultz properties lie at the inlet of Rice Creek into Locke Lake. The site was undergoing active severe erosion along the toe of the slope and the entire sections of the bank:

- Active shoreline erosion due to limited root structure to withstand wave action and animal activity
- Direct conveyance of nutrients and pollution from the property into the lake, increasing algae and unwanted aquatic vegetation blooms
- Limited plant diversity
- Limited wildlife habitat

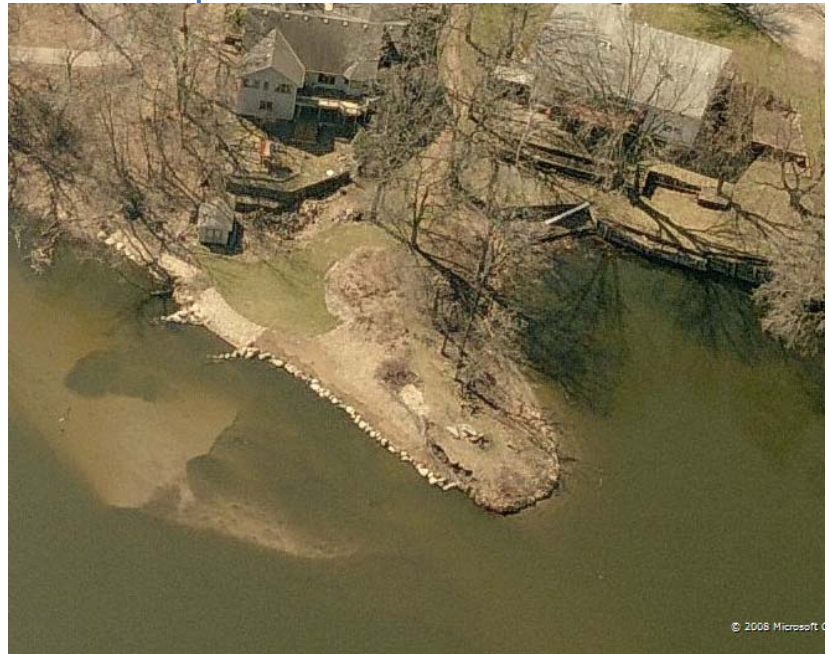
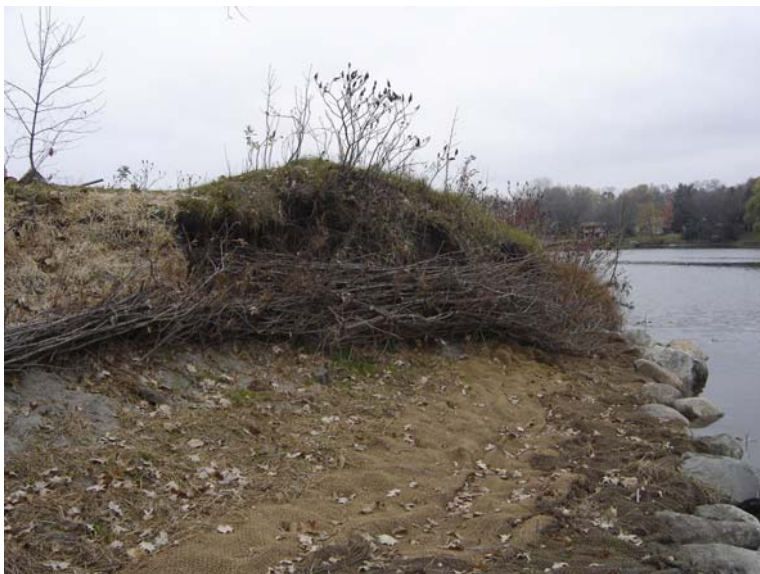
The toe of the slope was armored with riprap and the bank was re-graded. Boulder vanes were installed to deflect flows from Rice Creek away from the site. Biologs were installed in areas with less severe erosion to further buffer wave action and allow aquatic plants to establish. Finally, live willow stakes and wattles were installed in front of the exposed portion of the bank to reduce erosion and increase stability. The project has many benefits, including;
