MOORE LAKE

Pre-Buffer Conditions

**ANOKA
CONSERVATION
DISTRICT**

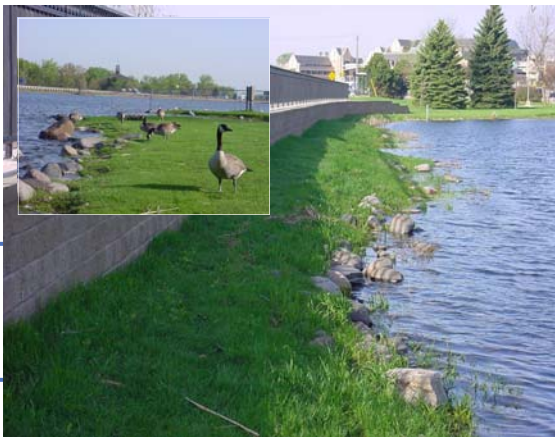
Moore Lake restoration site prior to buffer installation (June 2001)

The Moore Lake site was previously maintained with mown turf down to the lake edge. This practice resulted in:

- Erosion of the lake edge due to loss of root structure to hold the soil together
- Over-population of Canada Geese and an abundance of goose feces
- Loss of plant diversity
- Loss of wildlife habitat

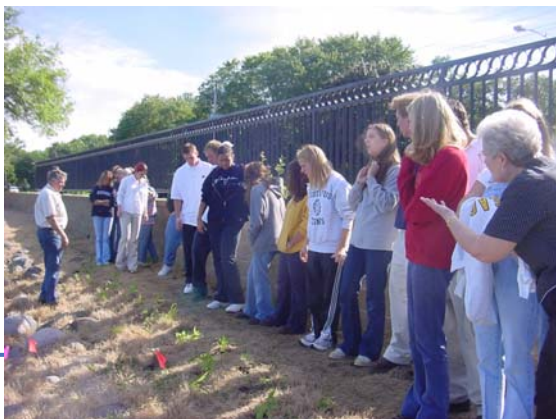
Students from Totino Grace and Fridley High School help plant native grasses and wildflowers (September 2001)

The site was prepared by eliminating the existing vegetation through application of glyphosate (e.g. Rodeo®). The dead thatch was left onsite to act as a mulch. Native wet meadow plugs were planted through the thatch by students from Totino Grace and Fridley High School.

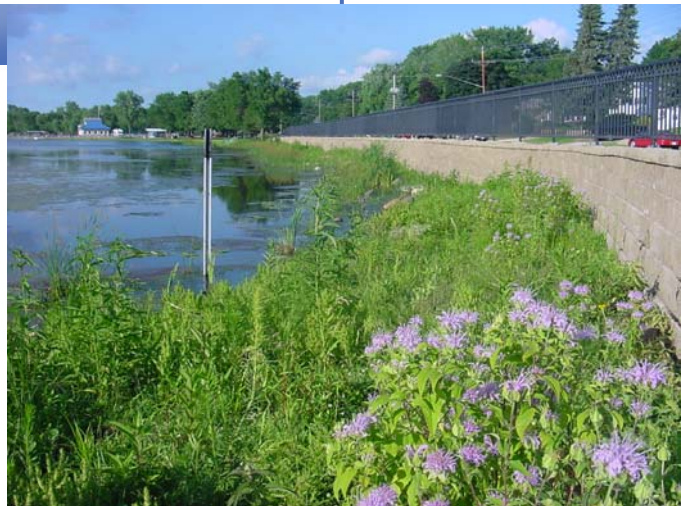
July 2002 ▶

Most of the plant growth occurs beneath the soil as plants put down roots. Wildflowers begin blooming within the first year after planting. Occasional weeding of thistle and reed canary grass keeps competition to a minimum.

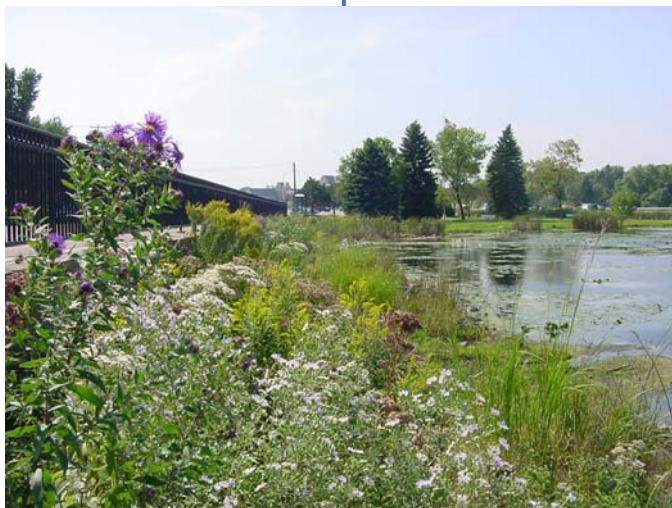
◀ September 2004

A wide variety of flowers such as Asters, Goldenrods, and Joe-Pye are blooming by the third year. The plants have begun to fill in gaps in the planting. Bi-annual weedings will continue through at least year 5 to allow the natives to become well established.
