# PERCY RESIDENCE

## Pre-Rain Garden Conditions

## PROJECT SPECS

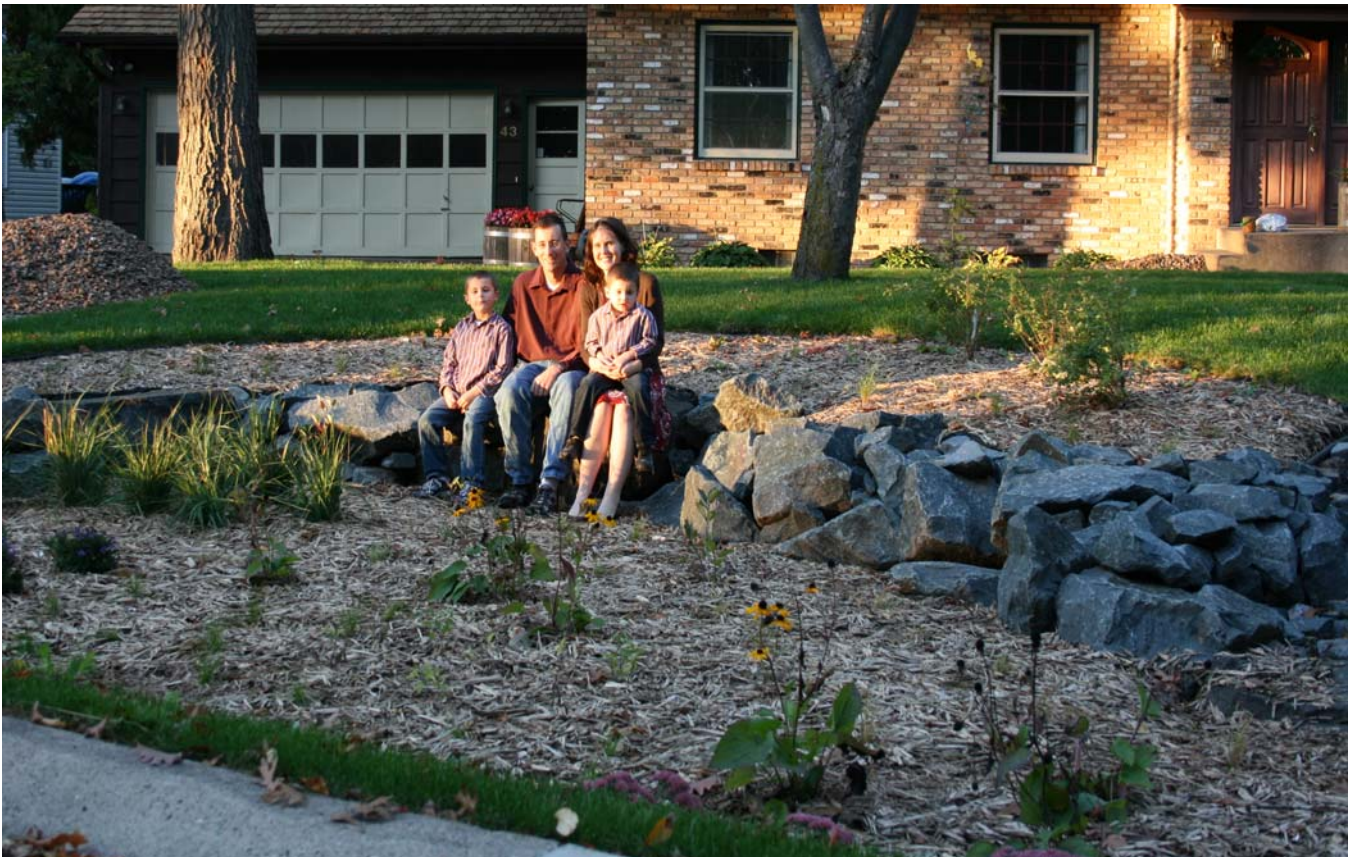
A curb cut rain garden was installed on the Percy property to treat storm water from both the property and offsite. Prior to installation, rain falling on the roof of the residence was directed, unfiltered, onto the yard and road. The storm water eventually made its way to Golden Lake via the storm sewer system. This excess runoff from impervious surfaces can cause:

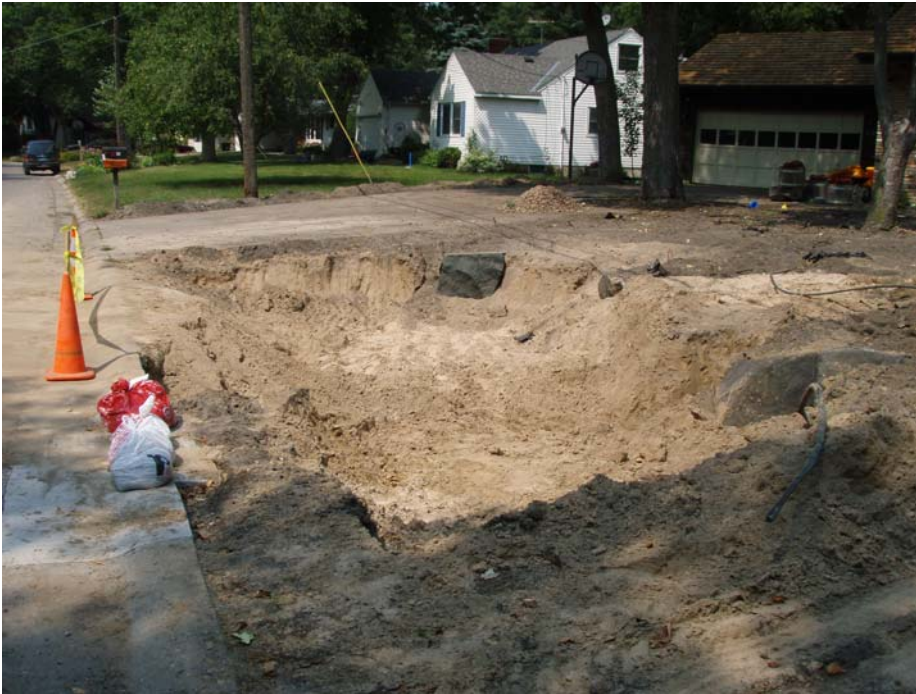
## Curb Cut Rain Garden

The site was deeply excavated and backfilled with rain garden soil to provide a high water treatment and detention capacity.

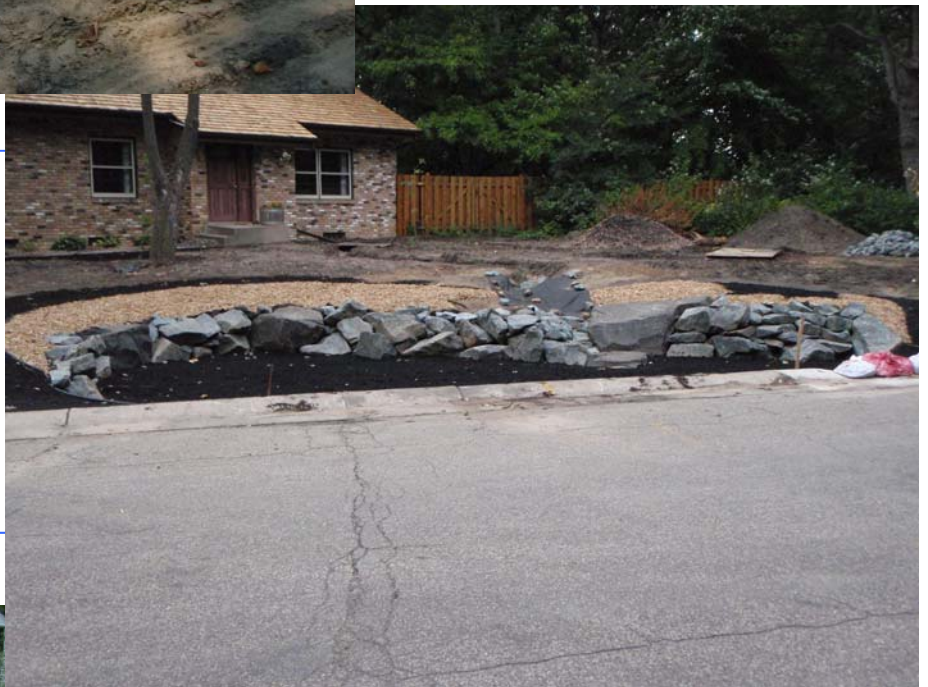
The rain garden was designed with a dry creek bed supplying rain water from the roof into the back of the rain garden. Storm water falling on the roof is directed into the creek bed by downspout.

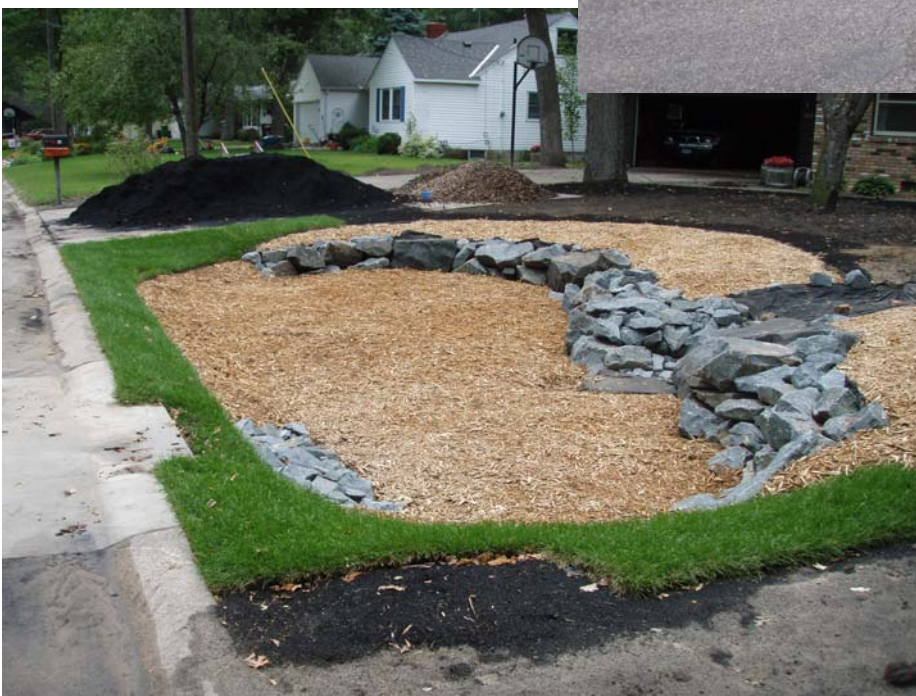
The curb cut rain garden is designed to treat storm water from offsite as well. Storm water is directed from the street-side gutter into the rain garden for treatment.
