# DENMAN LAKESHORE RESTORATION

COLUMBIA HEIGHTS, MN

Lakeshore Restoration

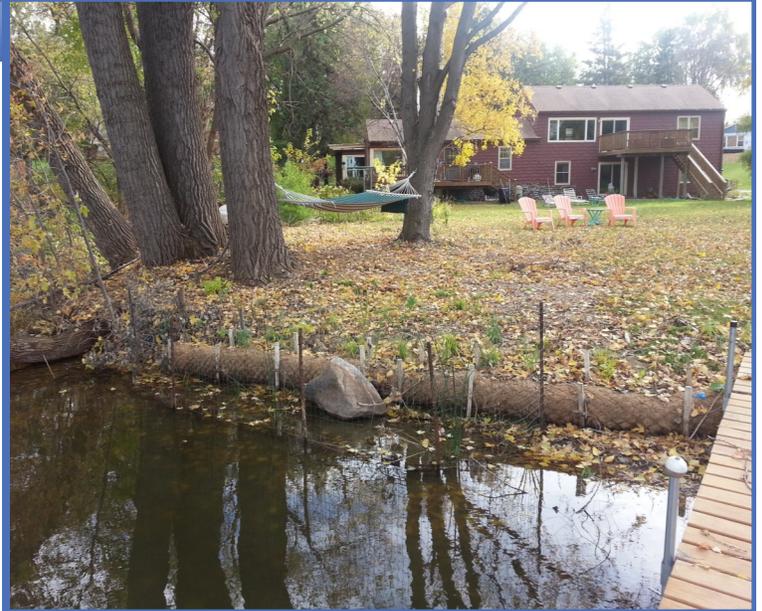
Completed project in the fall of 2013.

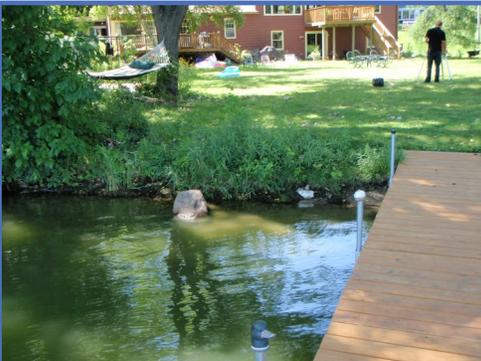
Pre-restoration conditions consisted of undercutting on the bank, leading to erosion. The lakeshore provided no benefits to water quality, wildlife habitat, or shoreline stability.

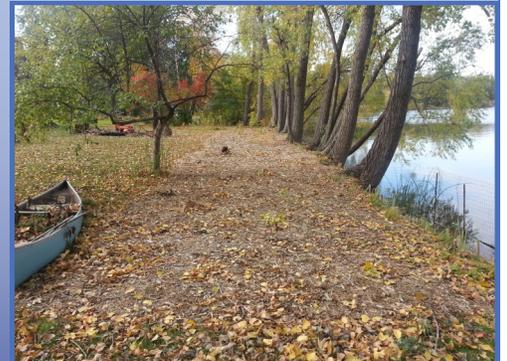
This buffer will benefit habitat and water quality while still allowing for a great view of the lake. In addition, the deep root system of the established native plant community will increase shoreline stability.
